Technical Service Bulletin

Date Issued	Model Year(s) Affected	Model(s) Affected	TSB #
02/04/2011	2010-2011	Diesel Pushers	382
Brand			Type
All <input type="checkbox"/>	American Star <input type="checkbox"/>	Mountain Aire <input checked="" type="checkbox"/>	All <input type="checkbox"/> T T <input type="checkbox"/>
Cypress <input type="checkbox"/>	Dutch Star <input checked="" type="checkbox"/>	Kountry Aire <input type="checkbox"/>	F W <input type="checkbox"/> C A <input type="checkbox"/>
Northern Star <input type="checkbox"/>	Kountry Star <input type="checkbox"/>	Essex <input checked="" type="checkbox"/>	D P <input checked="" type="checkbox"/> D B <input type="checkbox"/>
Scottsdale <input type="checkbox"/>	King Aire <input checked="" type="checkbox"/>	London Aire <input type="checkbox"/>	
All Star ME <input type="checkbox"/>	Ventana <input checked="" type="checkbox"/>	Bay Star <input type="checkbox"/>	
<div style="display: flex; justify-content: space-between;"> <div> <input type="checkbox"/> Air Conditioning & Heating <input type="checkbox"/> Appliances & Accessories <input type="checkbox"/> Cabinets & Furniture <input checked="" type="checkbox"/> Chassis Components <input type="c

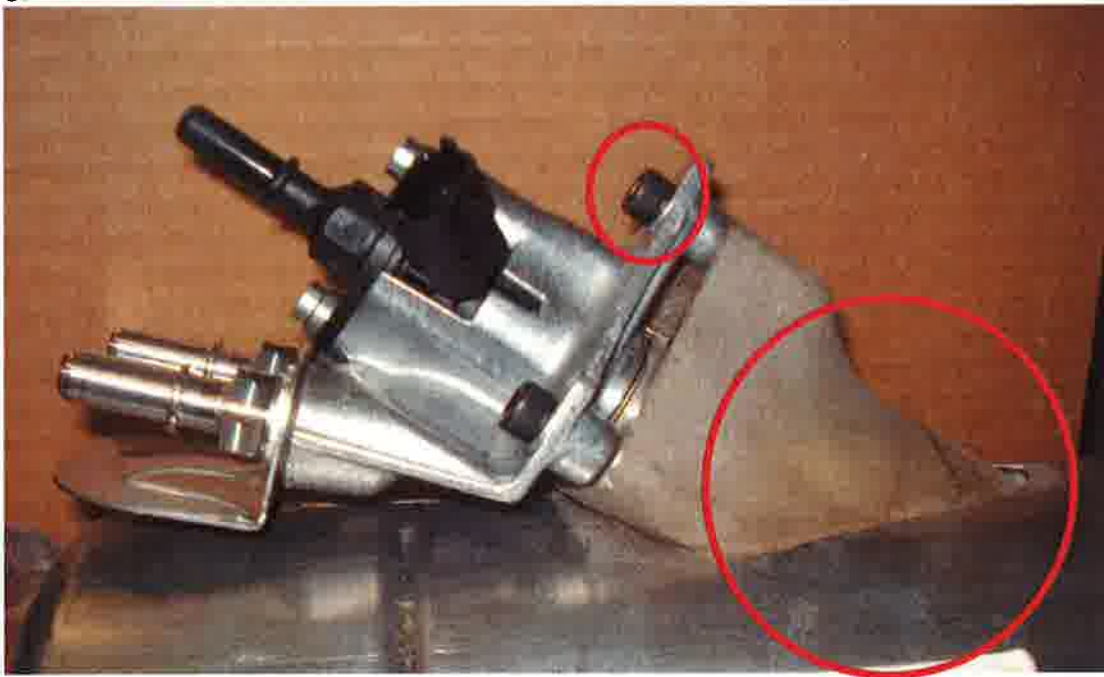
3.

Figure (3) depicts a non-conical aftertreatment decomposition tube design and needs to be replaced. Focus on the aftertreatment DEF dosing valve mounting area base and notice there is no heat shield covering it. The aftertreatment DEF dosing valve capscrews do not have washers or spacers. Also notice that aftertreatment DEF dosing valve mounting area does not have additional screw holes aside from the 3 securing the aftertreatment DEF dosing valve.

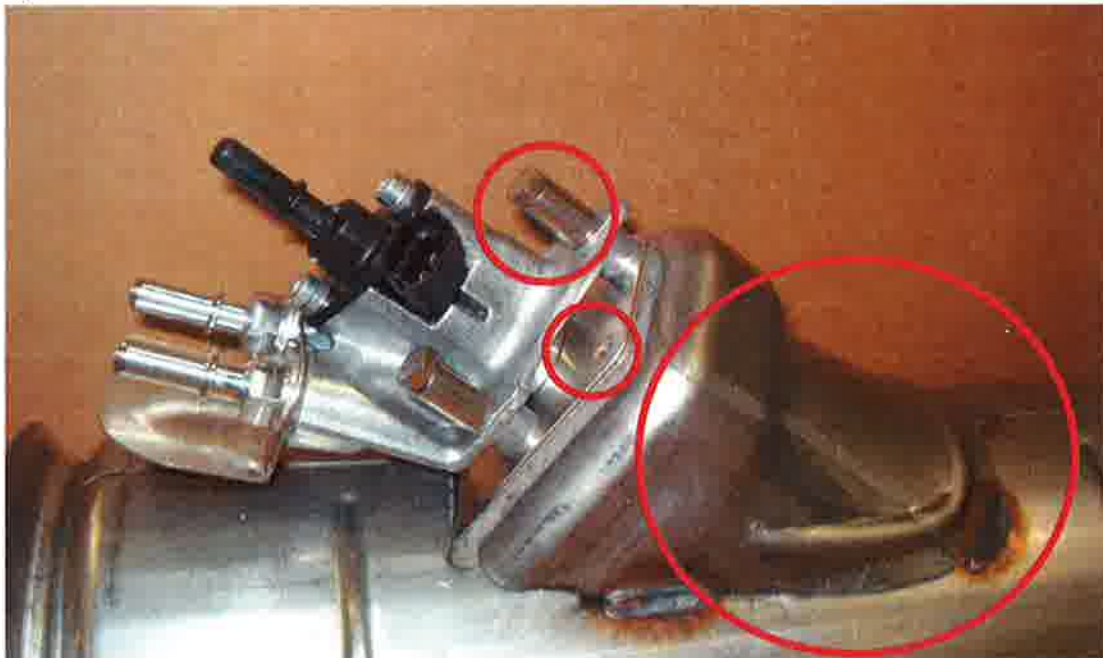
4.

Figure (4) is the new conical design aftertreatment decomposition tube and does NOT require replacement. Notice that the aftertreatment DEF dosing valve mounting area base has a heat shield. The capscrews securing the aftertreatment DEF dosing valve are longer and require spacers. The new conical aftertreatment decomposition tube will have 2 extra screw holes in the aftertreatment DEF dosing valve mounting area where an aftertreatment DEF dosing valve guard may be secured.
