TECHNICAL SERVICE BULLETIN

| DATE ISSUED | MODEL YEAR(S) AFFECTED | MODEL(S) AFFECTED | TSB # |
|--|---|---|---|
| 02/21/2013 | 2013-2014 | Essex, King Aire | 402 |

CSB13-290-001A

SUBJECT: Spartan Motors Chassis, Inc. has determined a defect relating to coolant leaks may exist in certain incomplete motorhomes and bus chassis.

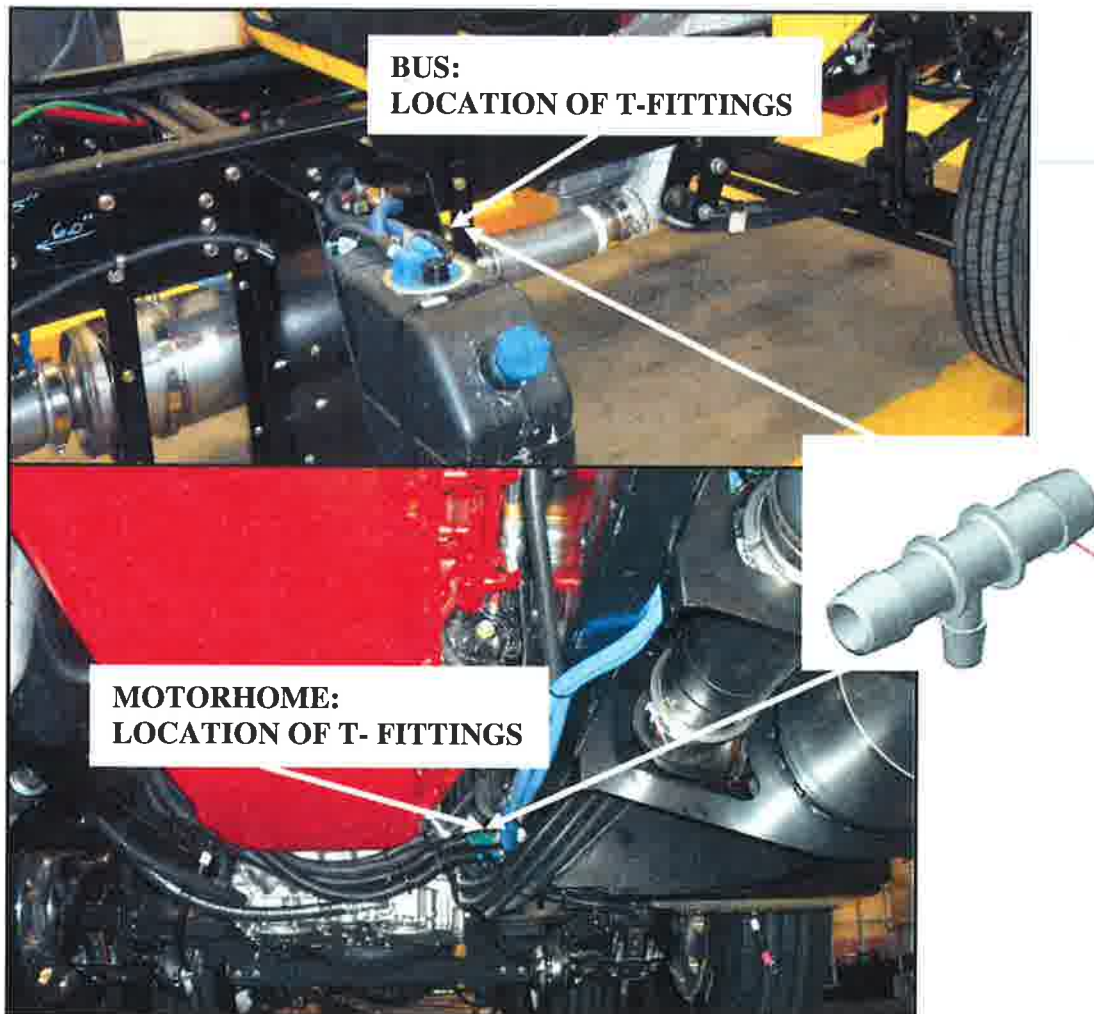
FIG. 2-1

CONDITION: Coolant leaks may exist at the T-fitting connections in coolant circuit for DEF system.

1. Locate and inspect T-fittings on the passenger side of vehicle behind the DEF tank and under the frame rail. If the fitting material is brass no actions are required. If the fittings are made of plastic, proceed with the remaining steps of the bulletin. Refer to FIG. 2-1.

CORRECTION: Replace two (2) plastic T-fittings with brass T-fitting assemblies.
