NEWMAR CORPORATION

TECHNICAL SERVICE BULLETIN							
DATE ISSUED		MODEL YEAR(S) AFFECTED		MODEL(S) AFFECTED		TSB #	
10/11/2013		2013 & 2014		King Aire, Essex & Mountain Aire		407	
BRAND						TYPE	
All	<input type="checkbox"/>	American Star	<input type="checkbox"/>	Mountain Aire	<input checked="" type="checkbox"/>	All	<input type="checkbox"/>
Cypress	<input type="checkbox"/>	Dutch Star	<input type="checkbox"/>	Kountry Aire	<input type="checkbox"/>	T T	<input type="checkbox"/>
Northern Star	<input type="checkbox"/>	Kountry Star	<input type="checkbox"/>	Essex	<input checked="" type="checkbox"/>	F W	<input type="checkbox"/>
Scottsdale	<input type="checkbox"/>	King Aire	<input checked="" type="checkbox"/>	London Aire	<input type="checkbox"/>	C A	<input type="checkbox"/>
All Star ME	<input type="checkbox"/>	Ventana	<input type="checkbox"/>	Bay Star	<input type="checkbox"/>	D P	<input checked="" type="checkbox"/>
<div style="display: flex; justify-content: space-between;"> <div> <input type="checkbox"/> Air Conditioning & Heating <input type="checkbox"/> Appliances & Accessories <input type="checkbox"/> Cabinets & Furniture <input type="checkbox"/> Chassis Components <input type="checkbo

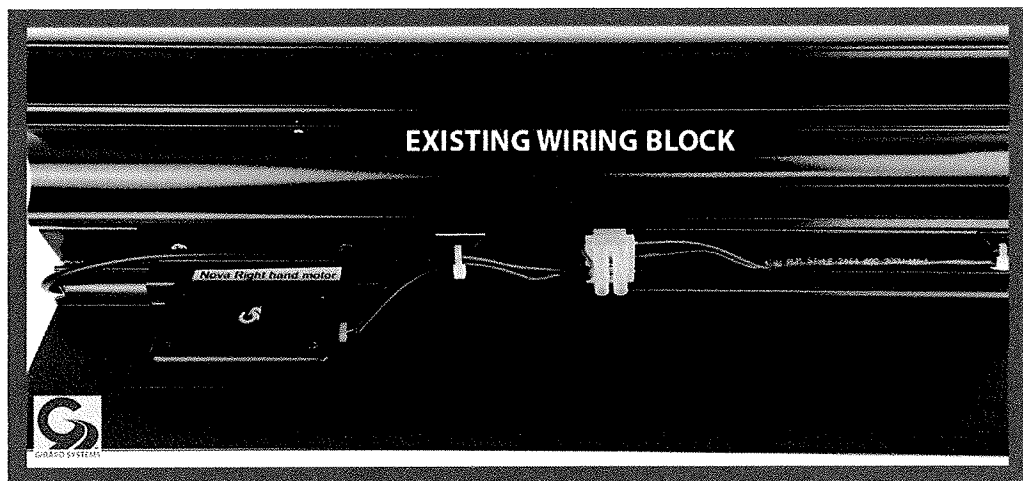
Figure 1

- A. Locate the wiring block that is supplying the motion sensor and led lighting system 12V power (if present). This should be located on the far right or far left side of the awnings' Lead Rail. (Figure 1)
- B. Make sure the 12V power has been shut off.
- C. Cut cable ties and remove wires from the existing wiring block making sure not to damage or cut any wires. Remove screws retaining the wiring block, and make sure to discard screws and old wiring block.

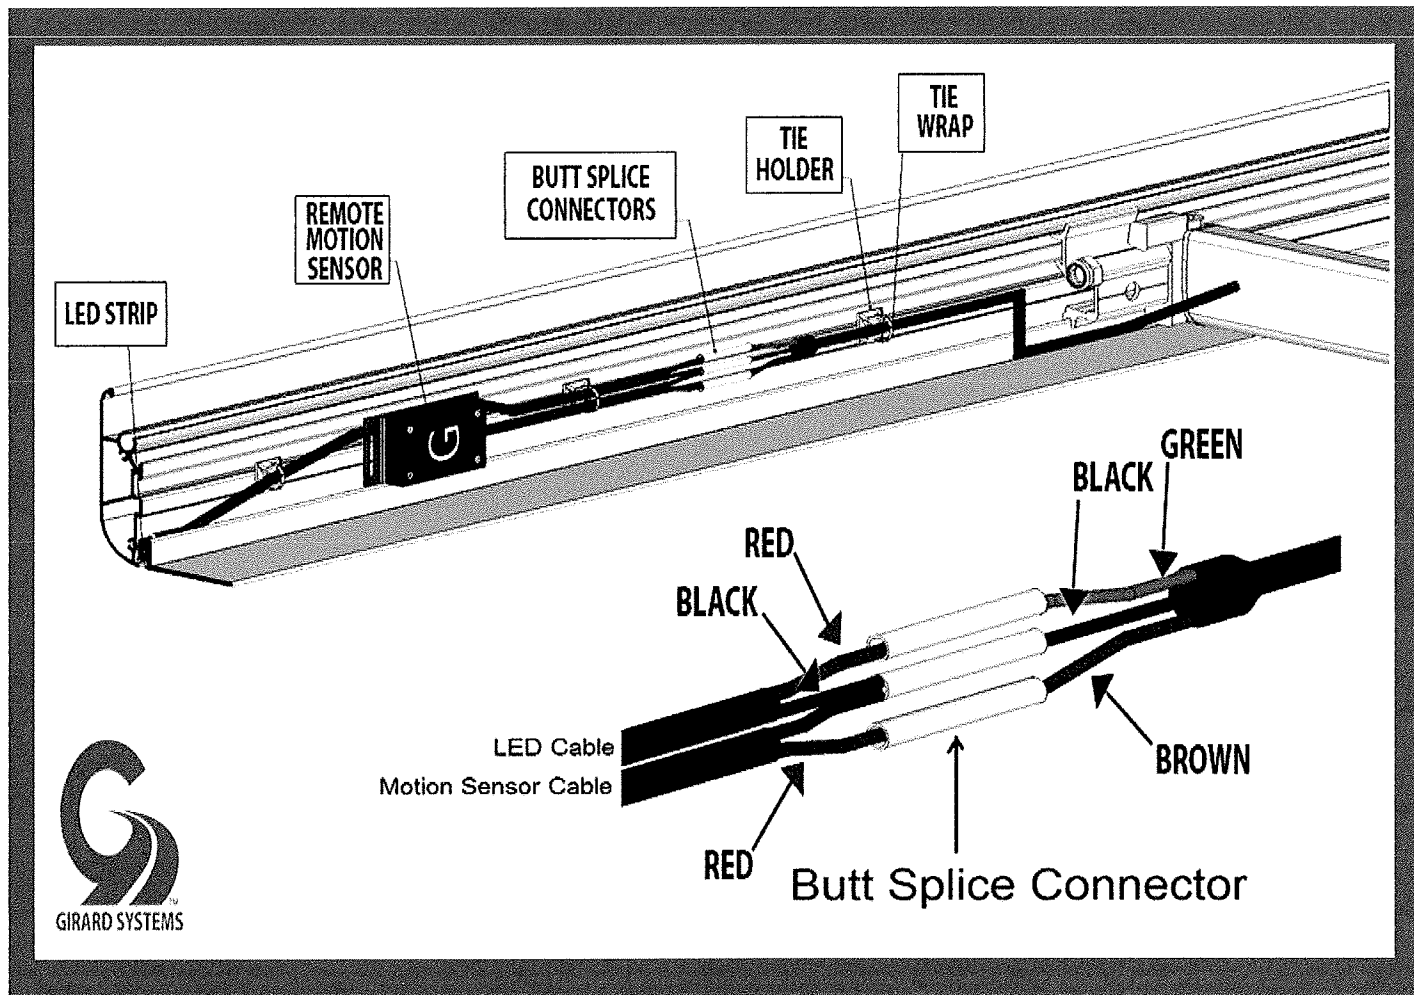
Figure 2

- L. Continue to the Motion Sensor and LED Lights wiring (if present). Make connections according to Figure 2. Ensure all connections are secure and tight.
- M. Return the 12V Power to the coach and test the Motion Sensor by shaking the Lead Rail of the awning; the awning should retract. Test the LED LIGHTS (if present).
- N. Once all connections have been made and tested, remove the 12V Power. Apply a heat source to the connectors to activate the thermal ends. The material should snug around the wire creating a waterproof seal.

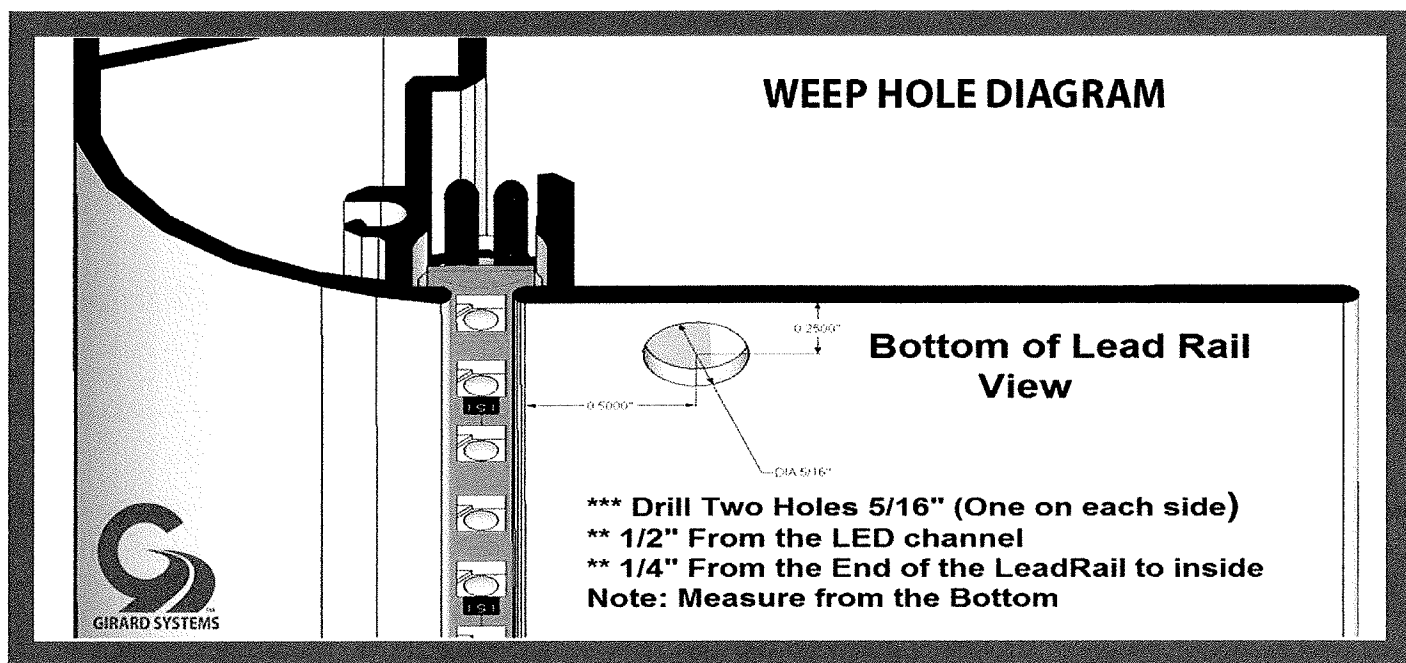
Figure 3

B. Drill 5/16" hole on each end of the NOVA Awnings' Lead Rail. Drill from the bottom side of the Lead Rail. Ensure that a sharp drill bit is used.
