TECHNICAL SERVICE BULLETIN						
DATE ISSUED	MODEL YEAR(S) AFFECTED		CTED	TSB #		
11/04/2014	2014-2015 Essex			Recall 14V-620 TSB 411		
BRAND						
Bay Star Sport 🛛 🗖	Ventana		Essex	x X		
Bay Star 🛛	Dutch Star		King	Aire 🛛		
Canyon Star	Mountain Aire		Other	r 🗖		
Ventana LE 🛛 🗖	London Aire					
DESCRIPTION						
Newmar Corporation has decided that a defect which relates to motor vehicle safety exists in certain 2014-2015 Essex motorhomes. The affected motorhomes were equipped with a jack mounting bracket that may be attached too close to the rear airbag. These motor homes require immediate service. Continued use poses a potential safety hazard.						
RECOMMENDED ACTION						
On certain Newmar 2014-2015 Essex motorhomes built on Freightliner chassis, the rear axle jack mounting bracket may have been attached too close to the rear suspension airbag. This could damage the suspension airbag over time, potentially resulting in an air leak and suspension collapse. This could affect vehicle handling, increasing the risk of a crash causing injury and/or damage to property. For the correction, dealers will reposition the bracket. Newmar Corporation will provide owners of all affected motor

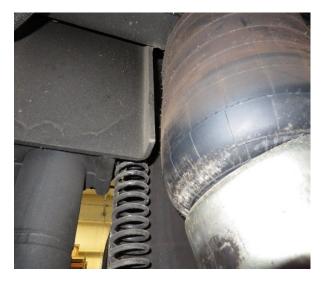
• Inspect both rear jacks "U" channel clearance to the airbag. There needs to be a minimum of 3/4 inch clearance showing from top to bottom.

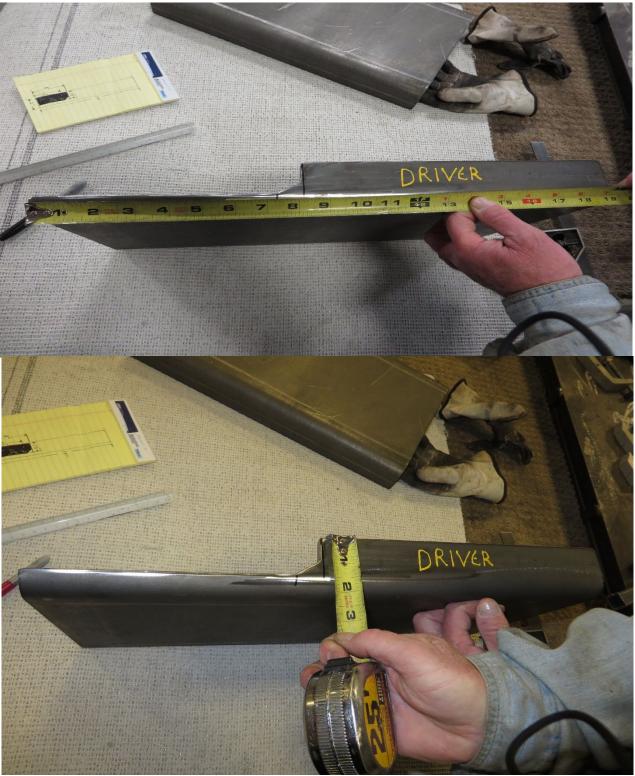
• The radius piece removed from bracket.
