# NEWMAR CORPORATION WARRANTY DEPARTMENT

## TECHNICAL SERVICE BULLETIN

Newmar Corporation has determined a defect relating to vehicle safety may exist in certain 2013 and 2014 King Aire coaches, as well as in certain 2014 Essex units. Recall 15v-067 and TC# 2015-049.

## SERVICE BULLETIN

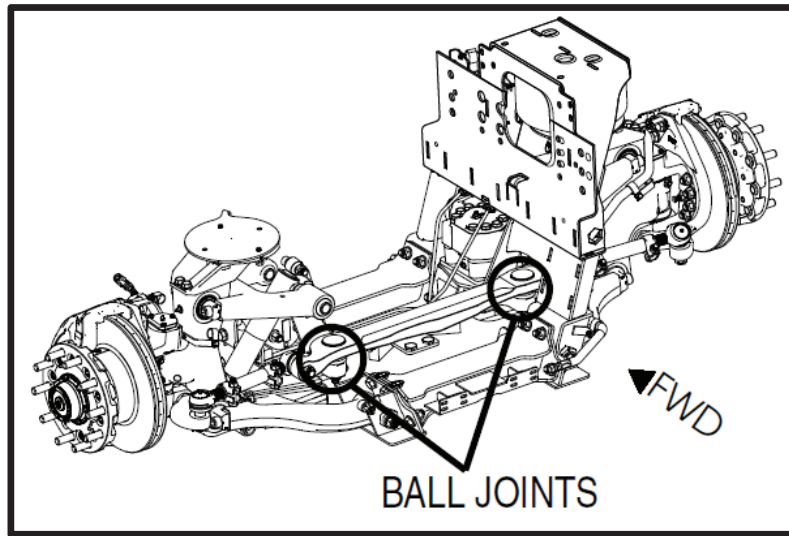
**FIG. 2-1**

1. Follow normal maintenance and safety procedures to gain access to the pitman arm ball joints. Refer to FIG. 2-1.

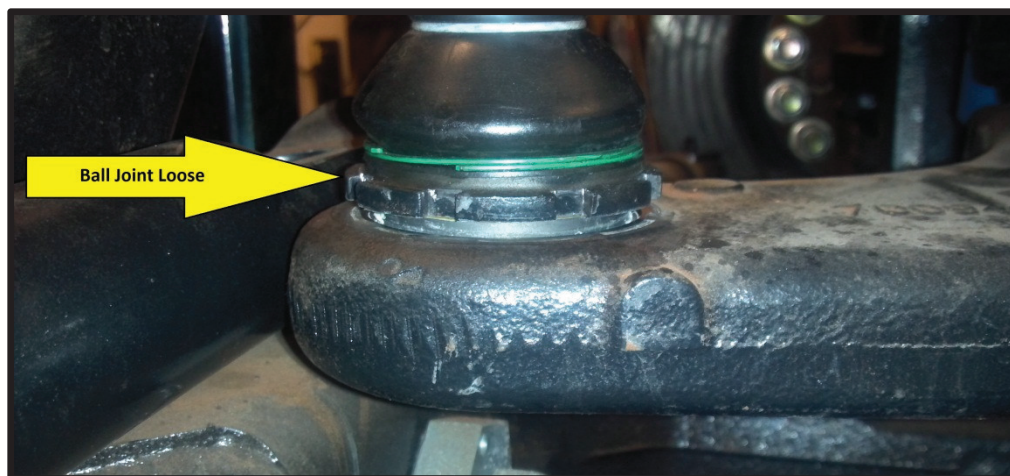
**FIG. 2-2**

2. Visually inspect the ball joints located in pitman arms, the ball joints will be seated in both pitman arms off of the steering gears. The ball joint shall be fully engaged with the notched flange in contact with the surface of the pitman arms. If it is not, please proceed to the repair procedure. Refer to FIG. 2-2 and 3-1 (pictures may not represent suspension you are working on).

3. If the ball joint appears to be seated, using a 0.001 inch feeler gauges to check under the notched flange. If the feeler gauge slides under the flange, please proceed to the step by step instructions.
4. With a punch and hammer use moderate force in an effort to tighten the ball joint in place. If it moves proceed to the step by step instructions. If it is tight this will finish the inspection and vehicle can be returned to service.
