# Newmar Corporation

### Technical Service Bulletin

Date Issued	Model Year(s) Affected	TSB #
11/12/2015	2007, 2008	432

## Recall Service Bulletin

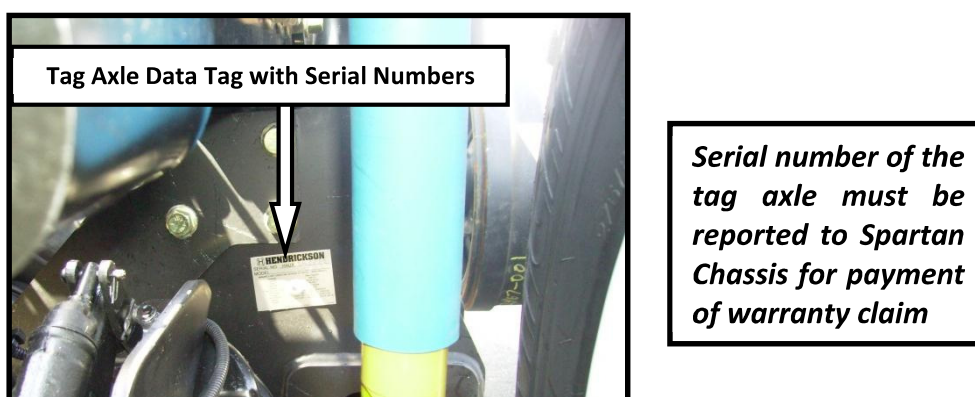
**FIG. 2-1**

**TAG AXLE DATA TAG LOCATION**

**NOTE: Refer to FIG. 2-1. To be paid for claim you must report tag axle number to Spartan Motors USA, Inc. Customer and Product Support.**
