NEWMAR CORPORATION WARRANTY DEPARTMENT

RECALL SERVICE BULLETIN

DATE ISSUED	MODEL YEAR(S) AFFECTED	RSB #
12/09/2016	2017	470

How to Correct the Orientation of the OnGuard™ System

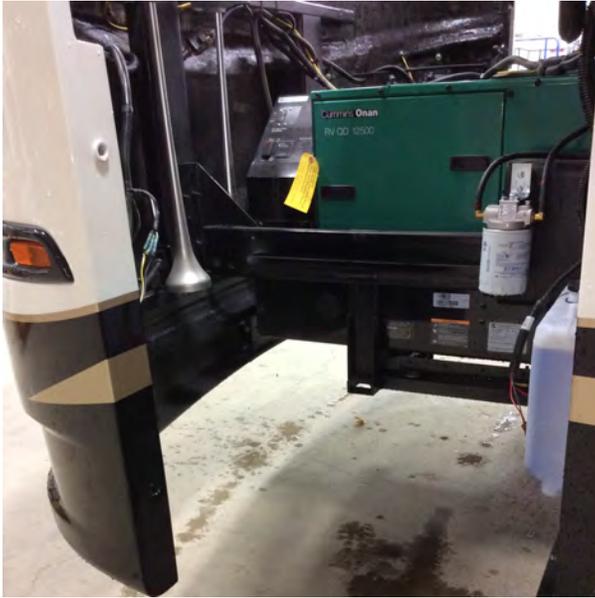
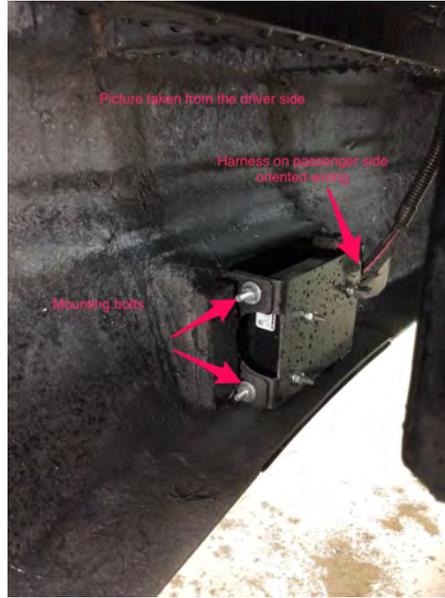
Checking the Orientation

1. Open the lower section of the front cap.
2. From the backside of the cap (near the front of the generator), locate the OnGuard radar in the middle lower section.
3. Check to see if the wire harness is plugged into the radar on either the driver or passenger side.
4. If the harness is plugged into the driver side of the radar, the orientation of the radar is correct. Proceed to the section entitled "Checking for backer."

5. If the harness is plugged into the passenger side of the radar, the radar will need to be unbolted (four bolts total, two on each side) and rotated 180 degrees such that the connector is now oriented to the driver side.
6. Do not remount the radar yet. Proceed to the next step.

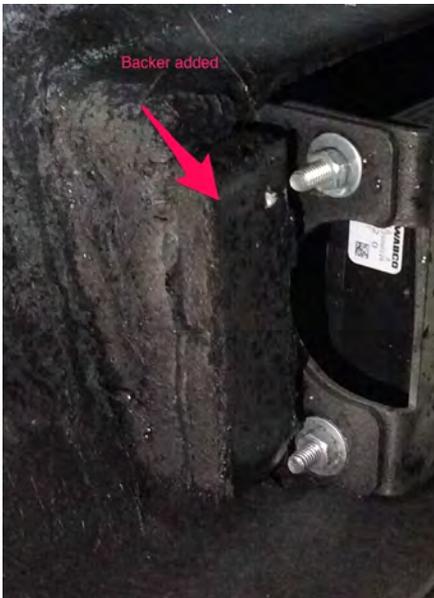
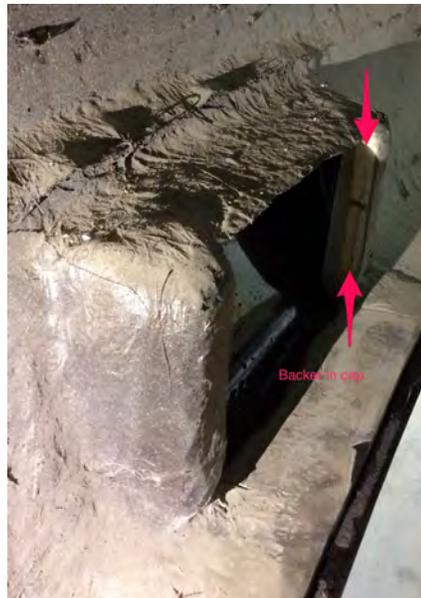
Checking for a Backer

7. While the radar is still unbolted, check the cap for a backer that looks like either of the two photos. You may not be able to clearly see the backer as pictured, but the cap will be over 1/2" thick. If there is no backer present in the cap or added behind the brackets, you will need to add a backer.
8. If the backer is in place, proceed to the section about remounting the radar. However if the technician went to this section from # 4 that the radar should not be remounted as it should not have been disconnected in the first place.

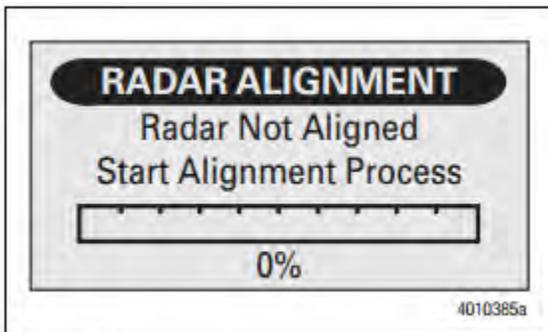
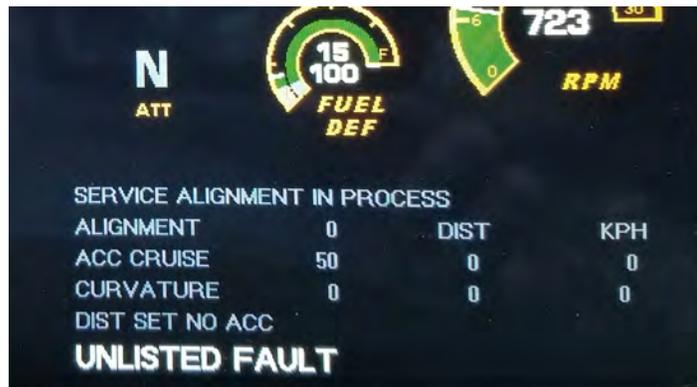
Figure 2.19

If a Radar Sensor Service Alignment is required, the Radar Not Aligned Screen may be displayed as shown in Figure 2.19.

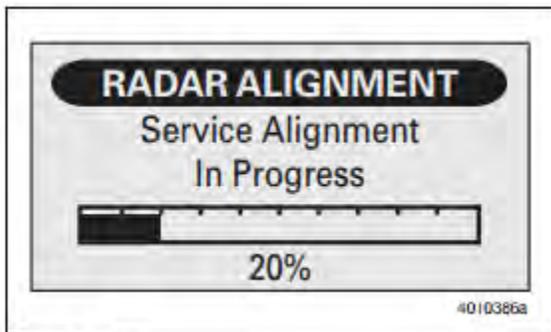
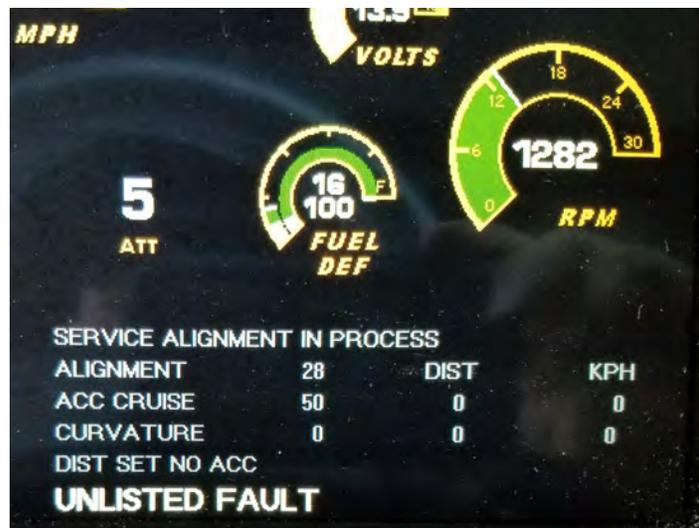
Figure 2.20

3. Verify the radar sensor is level both vertically (plumb) and horizontally.
4. Using TOOLBOX™ Software, send a command to the OnGuard™ system to begin Service Alignment mode. While in this mode, the OnGuard™ display will show the progress of the alignment process as shown in Figure 2.20.

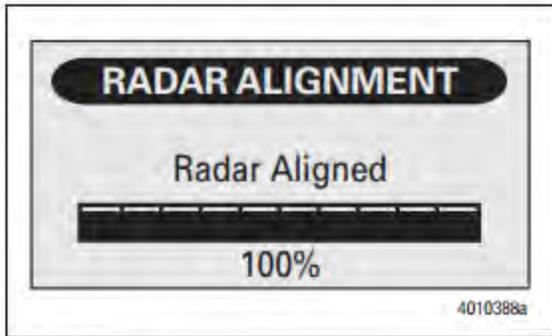
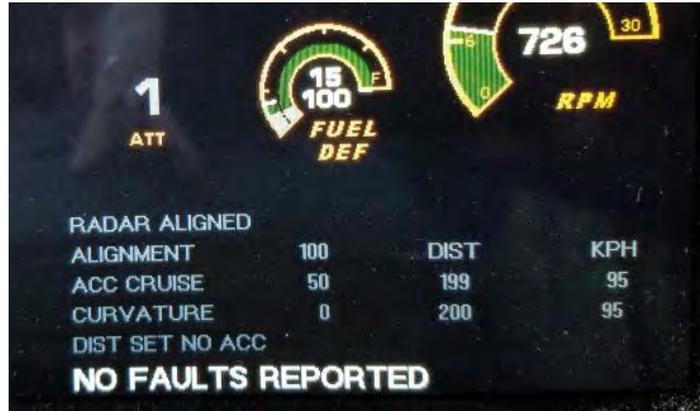
6. Drive until the Radar Aligned screen in Figure 2.21 appears in the OnGuard™ display. This typically takes 10 to 30 minutes of driving time to complete.
7. After completing the OnGuard Service Alignment procedure, the system returns to one of the normal operating screens.
