NEWMAR CORPORATION WARRANTY DEPARTMENT

RECALL SERVICE BULLETIN

DATE ISSUED	MODEL YEAR(S) AFFECTED	RSB #
12/15/2016	2017	473

How to Replace the Accent Light Module

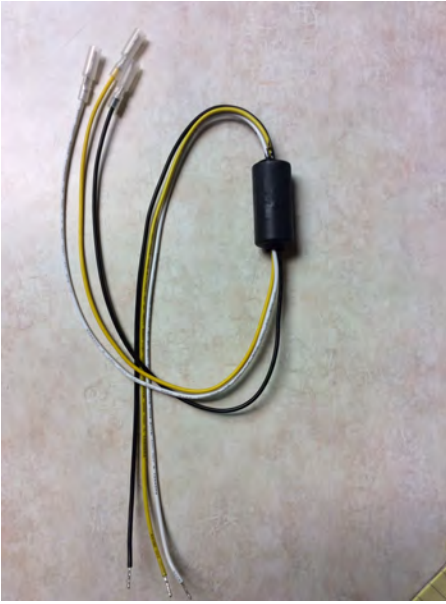
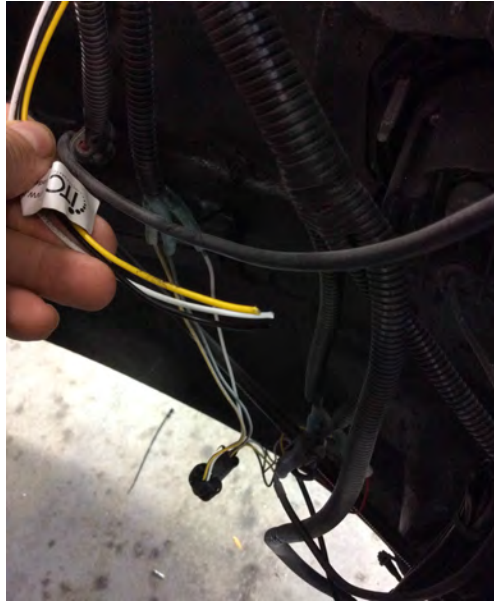
Inspecting the New Module

The new sealed light module will have stripped wire leads on one side, which will connect to the coach wiring. The other side will have connectors on them. It is important to correctly install the module due to a diode that was added.

1. Locate the three wires connecting the accent light to the light module.
2. Cut the connection from the light module, and strip the three wires back.
3. On the new module, find the side with terminals. This will hook up to the light, so do not reverse them.

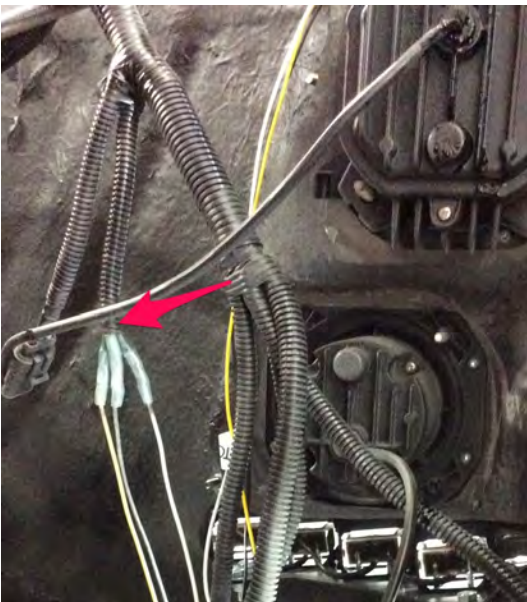
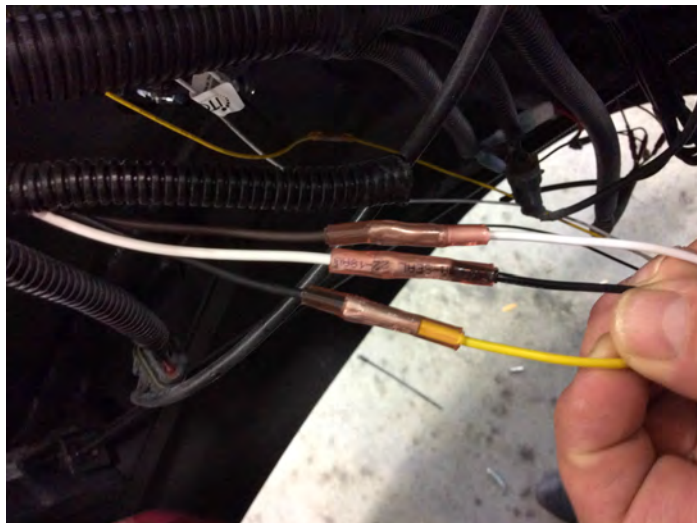
Connecting the New Module to the Coach Harness

The wire colors do not match up.

7. From the harness side of the module, cut off the old connectors.
8. Pull back the black wire loom if necessary.
9. Strip back the wires.
10. Hook up the wires as shown.

- Harness black = Module yellow
 - Harness white = Module black
 - Harness brown = Module white
11. Heat and seal the butt connectors.
