NEWMAR CORPORATION WARRANTY DEPARTMENT

RECALL SERVICE BULLETIN

DATE ISSUED	MODEL YEAR(S) AFFECTED	RSB #
4/21/2017	2017	476

How to Inspect the Headlight Harness

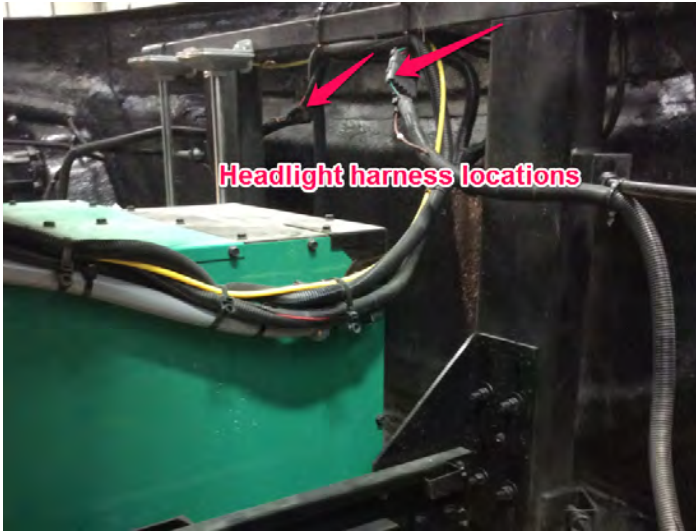
1. Turn the ignition key on.
2. Open the front driver side electric compartment
3. Extend the front lower cap via the HWH switch.
4. Locate the two connectors.

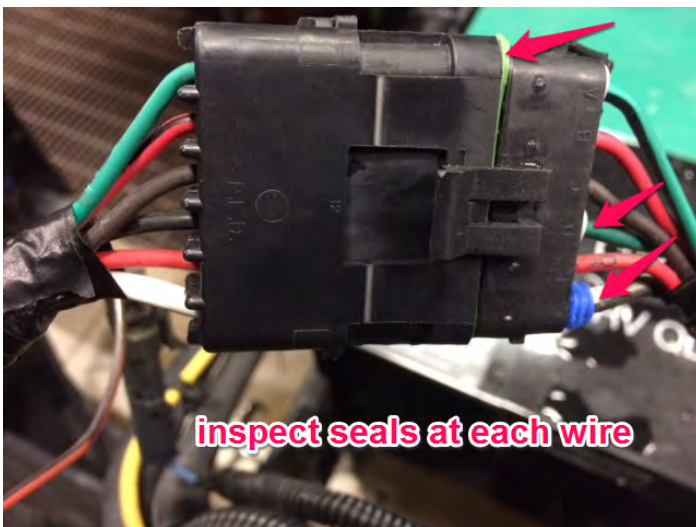
5. Cut the wire ties if needed to open both of the connectors.
6. Inspect for water intrusion and/or corrosion.

7. Inspect both sides of each connector,.
8. Inspect the seals around the wires and at the connector for unseated seals.
9. If necessary, release the clip holding the wires in place. Reposition the seal(s) into the connector and reconnect.
10. If the tape on the harness is forcing too much pressure on the wire seals, it may need to be removed and re-taped.
11. Strap the wires back in place with wire ties if necessary.
