NEWMAR CORPORATION

PRODUCT INFORMATION BULLETIN

DATE ISSUED	MODEL YEAR(S) AFFECTED	PIB #
9/28/2017	Coaches with HWH Leveling System (built before 8/31/2017)	494

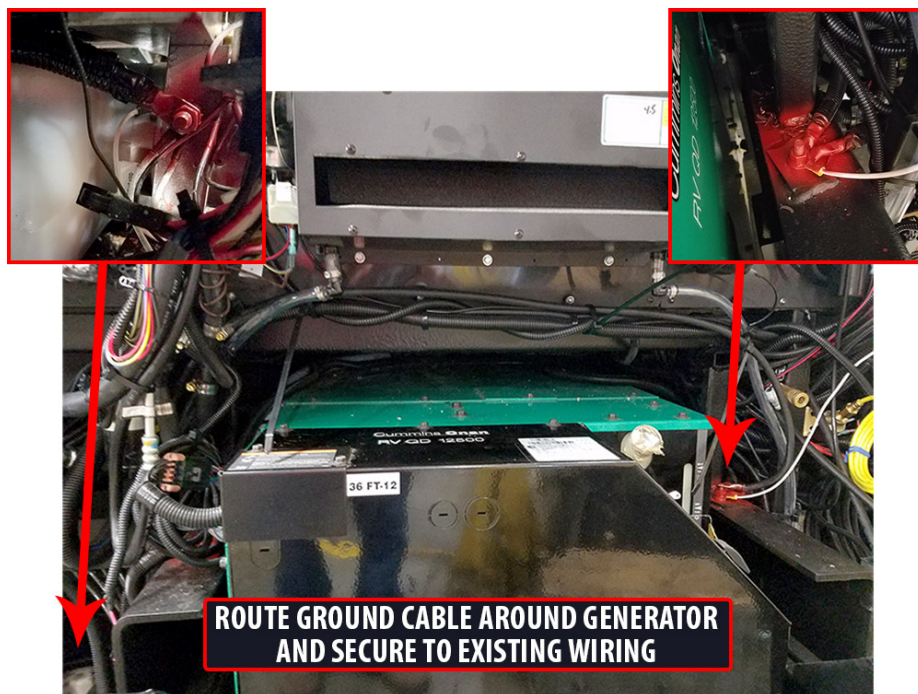
If the coach's HWH leveling system has intermittent issues when operating, check for corrosion or loose mounting bolts. Torque the mounting bolts (if needed) to 30 ft. pounds. A ground cable may also be installed to improve the overall grounding of the HWH pump assembly.

Install the ground cable from the ground stud on the frame at the front driver's side frame rail.

Route and secure the cable up and around the generator compartment and to the ground stud of the HWH pump assembly.

Spray the ground connections with battery terminal sealer.
