# NEWMAR CORPORATION

# TECHNICAL SERVICE BULLETIN

DATE ISSUED	MODEL YEAR(S) AFFECTED	TSB #
10/19/2017	2018	497

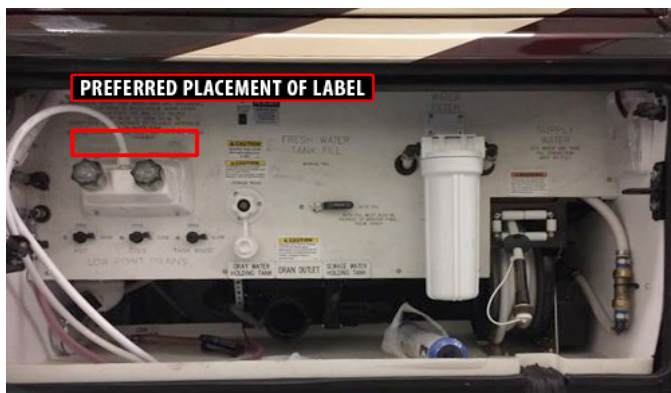
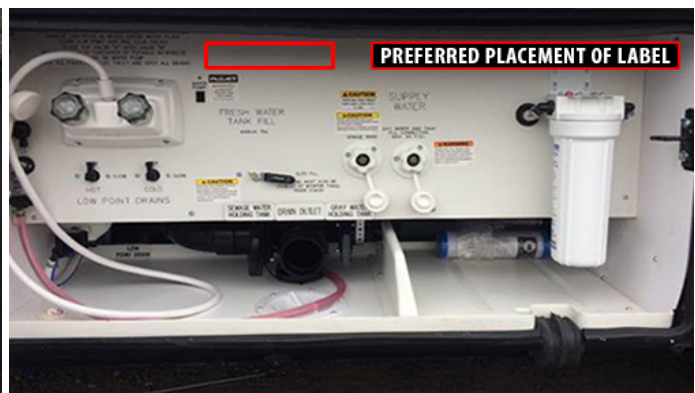
Newmar has determined that certain 2018 Dutch Star and Ventana coaches were shipped without a notice label regarding the ShowerMiser.

Issue: The customer or servicing technician may not place the ShowerMiser valve in the correct position when pumping antifreeze into the water lines during the winterization process. This may allow antifreeze to be pumped into the fresh water tank.

Order the notice label (part # 139030) from the Newmar Parts Department. Once you have label, wipe the water works panel clean. Place the label and adhere it above, below, or beside the winterizing text on the water works panel. Below are some examples:
