NEWMAR CORPORATION

PRODUCT INFORMATION BULLETIN

DATE ISSUED	MODEL YEAR(S) AFFECTED	PIB #
12/27/17	2018	499 Amended

Step-by-step instructions for replacing the Cargo Door Controller (MCDLA-1B).

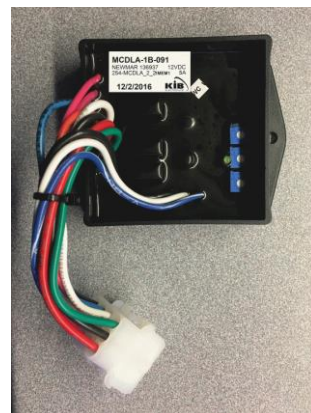
Fig.1

- Pick one of the two cargo doors with the issue.
- Locate the MCDLA-1B (Newmar Part#136937)
- Each cargo door has its own controller located behind that cargo door, usually mounted to upper subfloor.

- Unplug the 12-position connector.
- Unscrew MCDLA-1B from upper subfloor.
- Replace with new MCDLA-1B.
- Plug in the 12-position connector.
