NEWMAR CORPORATION

PRODUCT INFORMATION BULLETIN

DATE ISSUED	MODEL YEAR(S) AFFECTED	PIB #
4/12/2018	2018	511

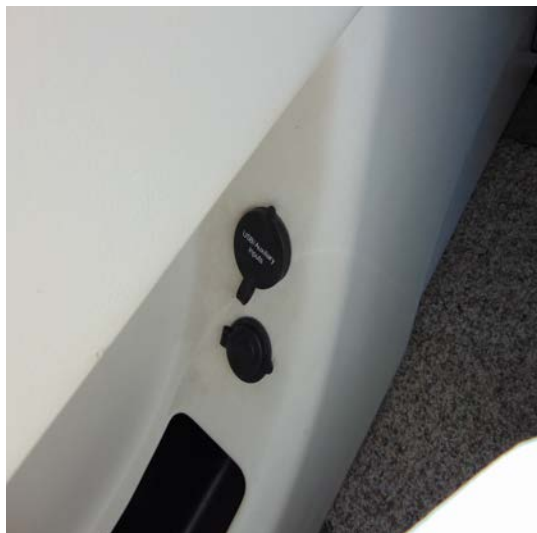
Certain Dash Xite Radio USB Inputs may have been spliced without the shield of the cable properly attached. If affected, the USB ports may not be active as the USB input to the Xite Infotainment center. The affected USB input is normally located on the driver side console

USB Typical Location on Driver Side

Non-working USB cables may be replaced with unmodified cables (Newmar part# 110664) to fix the issue.
