# NEWMAR CORPORATION

### TECHNICAL SERVICE BULLETIN

RE: Notice of Campaign Service Bulletin: **CSB18-560-001**

Attached is a copy of Campaign Service Bulletin **CSB18-560-001** regarding the digital dash and data collector module.

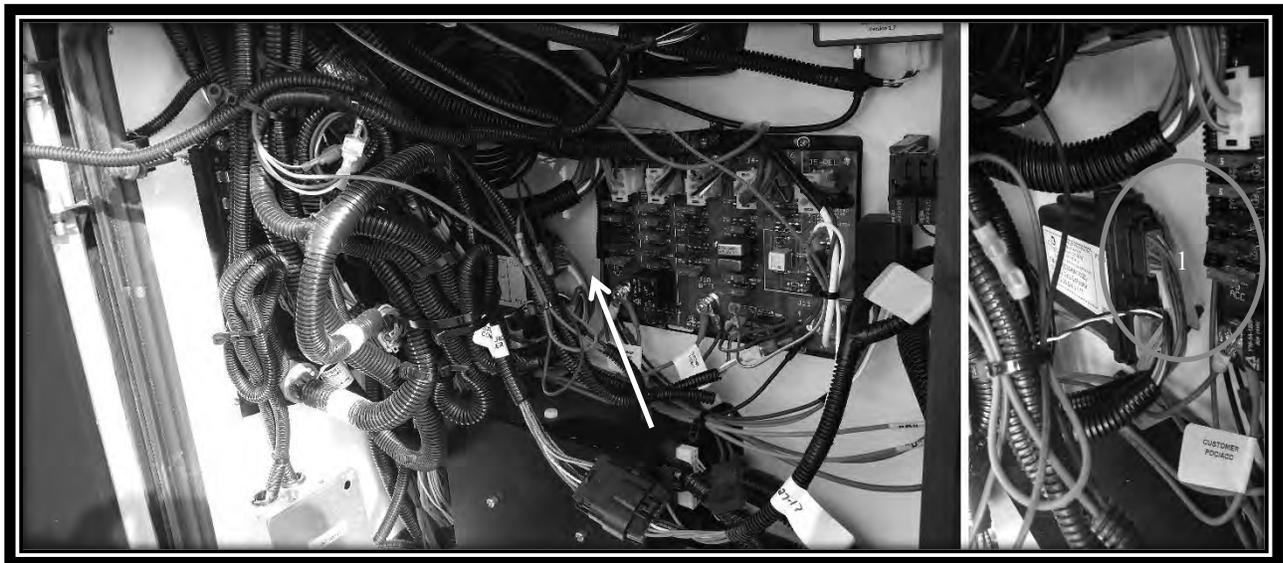
**FIG. 2-1**

1. Locate TM120, which is located on wall of front electrical compartment. Refer to FIG. 2-1.

2. Unplug TM120 module from harness.
3. Remove TM120 module from vehicle, retain all mounting hardware for reuse. (TM120 must be Returned to Spartan).

4. Install new TM120 module using retained mounting hardware.
5. Connect harness back up to new module.

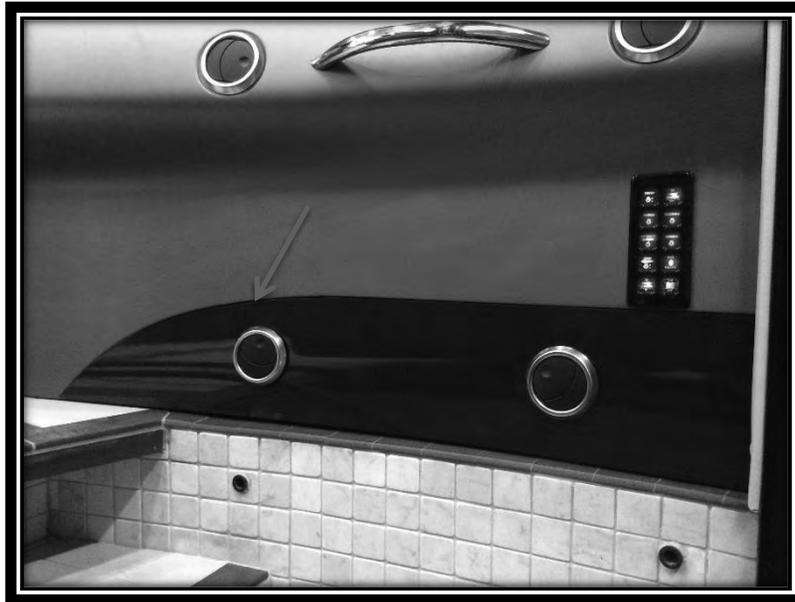
**FIG 3-1**

1. Remove black panel, which will be affixed with Velcro, located on dash console directly above stairs. Refer to FIG. 3-1.

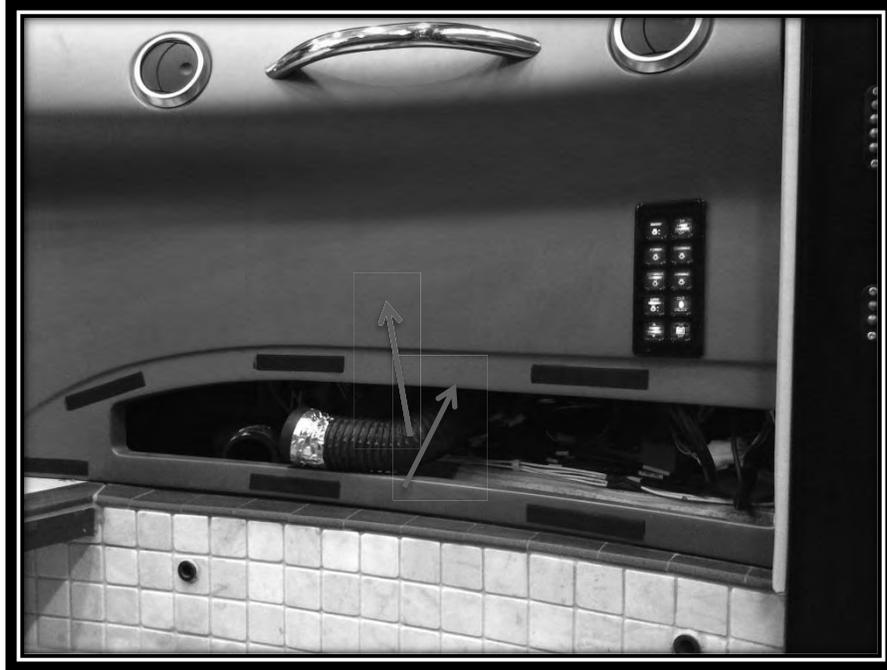
**FIG. 4-1**

2. Remove HVAC vents from removed panel. Refer to FIG. 4-1.
3. Locate TM120 module, located against back wall inside dash. Connectors are oriented up. Refer to FIG. 4-2.
