NEWMAR CORPORATION WARRANTY

RECALL SERVICE BULLETIN							
DATE ISSUED	MODEL YEAR(S) AFFECTED			RSB#			
8/3/2018	2018, 2019			522			
MODEL							
Bay Star Sport	Ventana		Essex	X			
Bay Star	Dutch Star		King Aire	X			
Canyon Star	Mountain Aire	X	New Aire				
Ventana LE	London Aire	X	Other				
	DESCI	RIPTION					
Newmar Corporation has dec NHTSA 18V 387 TC 2018-3		g to motor veh	icle safety exis	ts in specifi	ic motorhomes.		
Issue: On certain motorhomes, the windshield wiper arms may have been manufactured incorrectly. This may reduce the driver's visibility under certain conditions and increase the risk of a crash and/or property damage.							
<u>Correction</u> : Dealers will replace the wiper arms.							
This recall applies only to specific 2018 and 2019 coaches. Please refer to the attached population list for production numbers and VINs of the affected coaches.							
RECOMMENDED ACTION							
Follow the attached instruction to obtain authorization. The particular of the state of the stat		-			_

Subject:Recall Campaign No.: 18V 387

H.D. WIPER ARM REMOVAL AND INSTALLATION

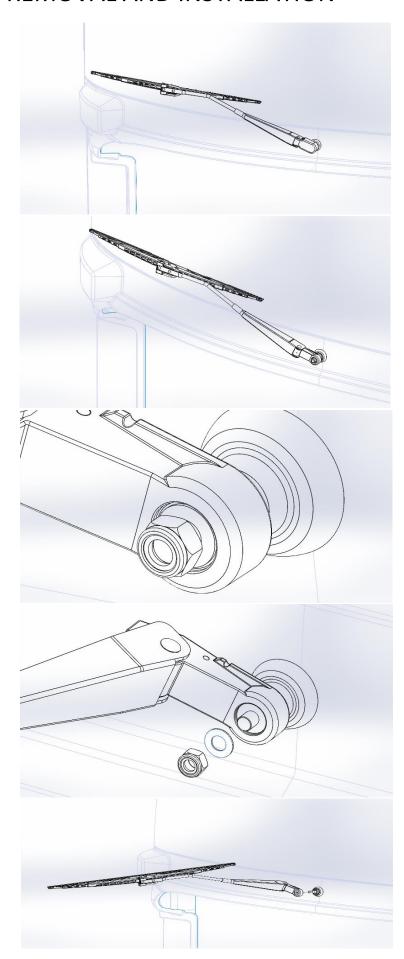
On certain motorhomes, the windshield wiper arms may have been manufactured incorrectly. This could reduce the driver's visibility under certain conditions and increase the risk of a crash and/or property damage. Correction: Dealers will replace the wiper arms.

- 5. Remove the Wiper Arm Assembly from the Pivot shaft and Uninstall the Wiper Blade from the Wiper Arm. Discard the Old Wiper Arm.
- Inspect the splines on the Pivot Shaft to insure the splines are free of any debris of the Wiper Arm Head. Clean splines if necessary.

- 7. Install Wiper Blade onto the New Wiper Arm. Make sure the Wiper Blade rotates freely when secured to the Wiper Arm saddle.
- 8. Position the Wiper Arm into the Lock-Back Position.
- 9. Install the Wiper Arm onto the Pivot Shaft.
