NEWMAR CORPORATION

PRODUCT INFORMATION BULLETIN

DATE ISSUED	MODEL YEAR(S) AFFECTED	PIB #
8/14/2018	2016-2019	529

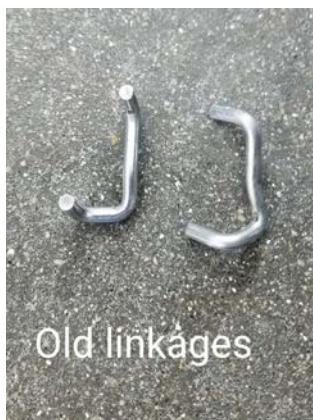
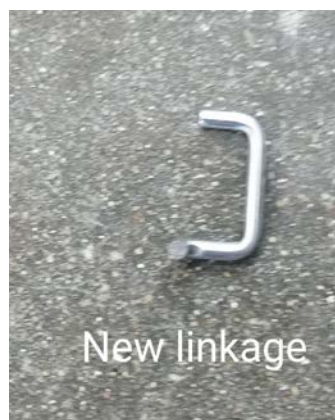
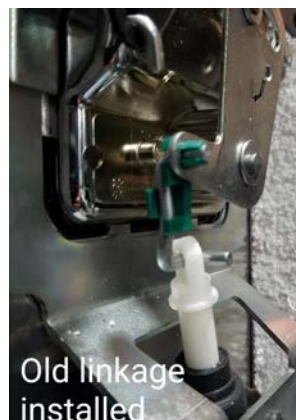
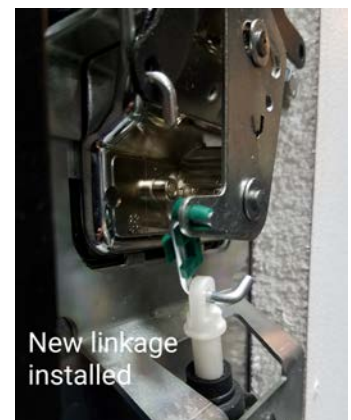
This bulletin was created to inform dealers and techs that an updated linkage is available that provides a remedy for binding linkages to the power actuator. This issue often creates difficulty when locking or unlocking the compartment door using the key and is only relevant on 2016 to early 2019 model year coaches equipped with power baggage locks.

The new replacement linkage (Newmar part #132391A) will replace the old left or right-handed linkages. Complete the following steps to replace the linkages.

1. Remove the cover to expose the latch and linkage assembly.
2. Release the retainer clip.
3. Remove the old linkage.
4. Install the new linkage.
5. Engage the retainer clip on the new linkage.
6. Reinstall the removed cover(s).
