Newmar Corporation

TSB 544
June 04, 2019

TECHNICAL SERVICE BULLETIN

Shade and Valance Replacement for 2019 Bay Star 3628 (Select Coaches Only)

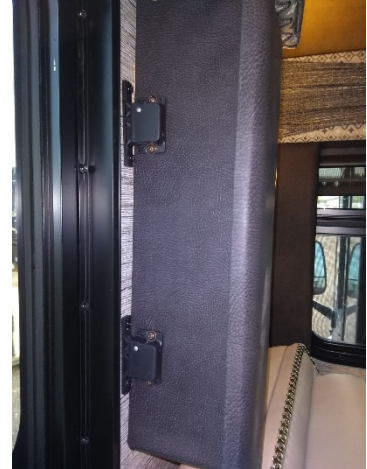
The valance is now fastened by four friction catches and can be pulled off if an emergency exit is necessary.

- Put the valance in place, and secure them to the other side of the Friction Catches using 8x½” screws (part #136072).

Do not use additional fasteners in the wall or cabinets.
