Newmar Corporation

TSB 548 Aug. 22, 2019

TECHNICAL SERVICE BULLETIN

Replacing the HWH Step Miom

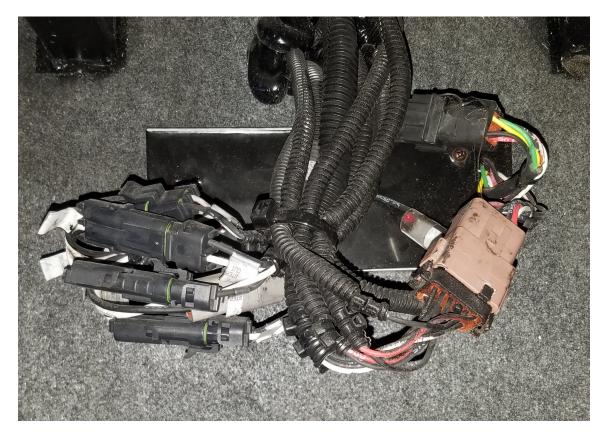
The Newmar Engineering Department discovered that HWH changed the step programming for 2020 coaches, causing the curb sensor not to function as originally designed.

- 1. Remove the two mounting screws.
- 2. Unplug the wire harness connectors.
- 3. Mount the new Miom.
- 4. Reconnect each wire harness connector to the new Miom. Make sure to match the harness connectors to the matching label on the Miom.
