Newmar Corporation

TSB 549
Aug. 22, 2019

TECHNICAL SERVICE BULLETIN

How to Seal the Hole on Early-Production 2020 New Aire Coaches

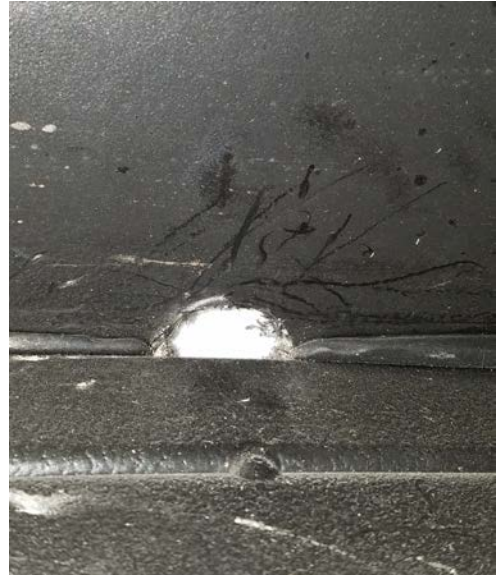
1. Air up the coach, and turn the wheels to the right.
2. Check in the wheel well for the hole (it will look similar to picture).
