Newmar Corporation

RSB 559 Nov 6, 2020 NHTSA #20V 594

RECALL SERVICE BULLETIN

Work Instructions for Front Jack Inspection and Repair

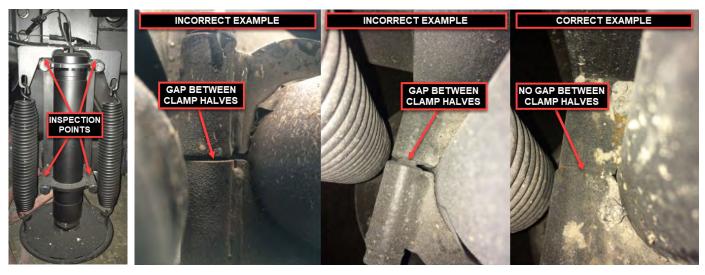
Inspect the front jacks to determine if any gaps are present at the clamps, which hold the jacks in place. There are four clamp halves on each jack, as well as bolts that go through them creating an inspection point. This is where the clamp halves come together at both sides of the jack: one near the top and near the bottom of the cylinder. A total of eight joints must be inspected (four on the passenger side and four on the driver side).

If all four clamp joints on the jack are tight with no gaps, move to the opposite front jack and inspect. If all four of its clamp joints are also tight with no gaps, no repair will need to be performed. If all eight clamp joints are tight with no gaps, obtain authorization for inspection only.

If one or more clamped joints are gapped, both jacks will need to be removed and inspected, then have the clamp placement corrected.

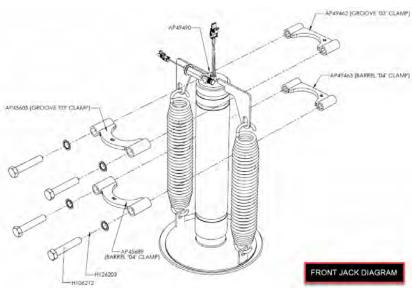
- Clamps labeled "03" are intended to be used in the groove of the cylinder.
- Clamps labeled "04" are intended to be used on the barrel of the cylinder.

The clamp halves must match for the intended position. Both upper clamps that fit in the groove must be 03 clamps, and both lower clamps that fit around the jack without the groove must both be 04 clamps.

If the welded half of the clamp is correct, then just the outer half brackets can be reoriented (mated) and reassembled.

The clamp half that is welded to the bracket could be wrong. If so, it will need to be cut off the bracket and a new, correct clamp welded back in its place. It is suggested to use a plasma cutter (if available) and grind smooth; otherwise, use another quality cutting device, and grind smooth in preparation of welding on new bracket(s).
