# Newmar Corporation

RSB 597  
April 28, 2023

## RECALL SERVICE BULLETIN

# GLOBAL ENTRY DOOR LATCH INSPECTION/ REPLACEMENT INSTRUCTIONS \*MOTORIZED UNITS ONLY

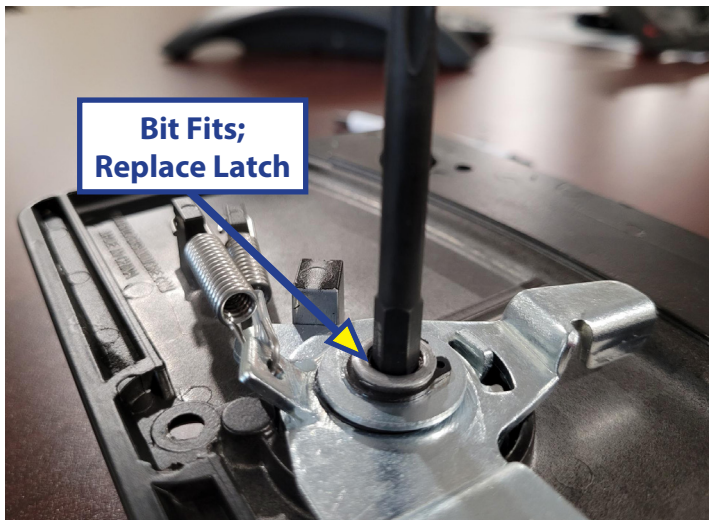
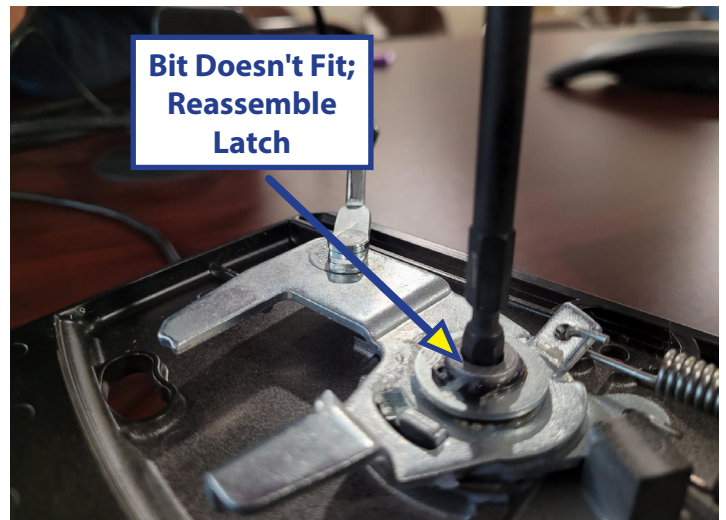
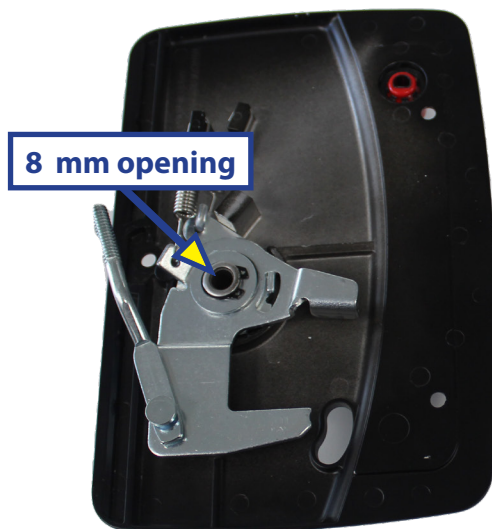
**Fig. 5**

- Using a 1/4" screwgun bit, try to insert the bit into the spun rivet of the inside latch assembly (Fig. 5).
- If bit fits into rivet opening there are two options:
  - Replace the complete latch assembly, including both inside and outside latch assemblies.
  - Replace just the inside latch assembly to be combined with current outside latch assembly.
- If the bit does not fit, no action is required. Proceed to latch reassembly instructions.

**New Inside Latch Assembly Needed**

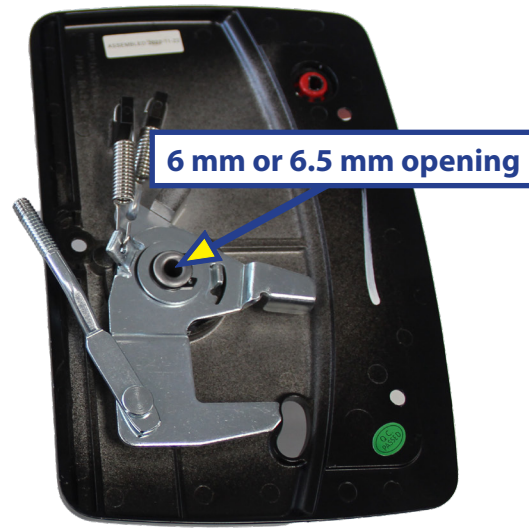
**Replacement Not Needed**

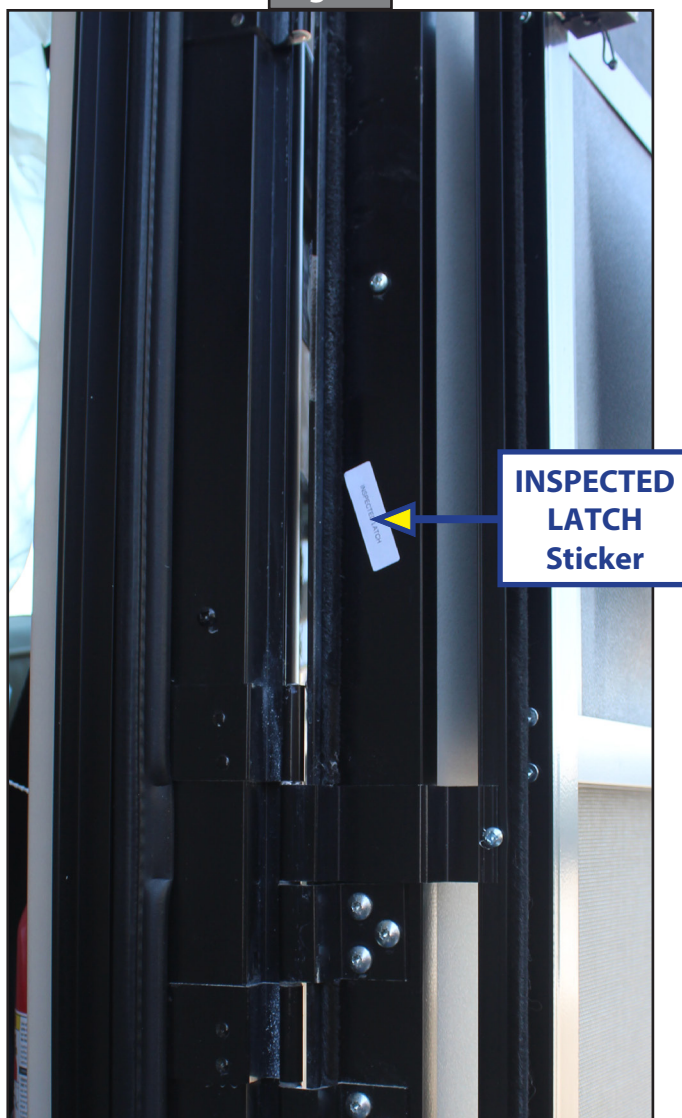
**Fig. 12**

**NOTE:** Check first for an "INSPECTED LATCH" sticker on the inside of the door frame between the hinges (Fig. 12). If it is present, report back to the OEM that the VIN has already been addressed.

6. Replace adhesive patch over nut access port (Fig. 11).
7. Place an "INSPECTED LATCH" sticker indicating the assembly has been replaced on the inside of the door frame between the hinges (Fig. 12).
