NEWMAR CORPORATION

TECHNICAL SERVICE BULLETIN

TSB #
193

TSB #991111-01

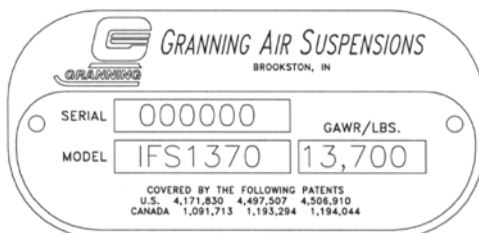
Figure 1: Suspension Identification

The suspension model and serial number are stamped on an aluminum tag (See Figure 1) that is riveted to the driver side steering arm mount on the subframe assembly (See Figure 2).

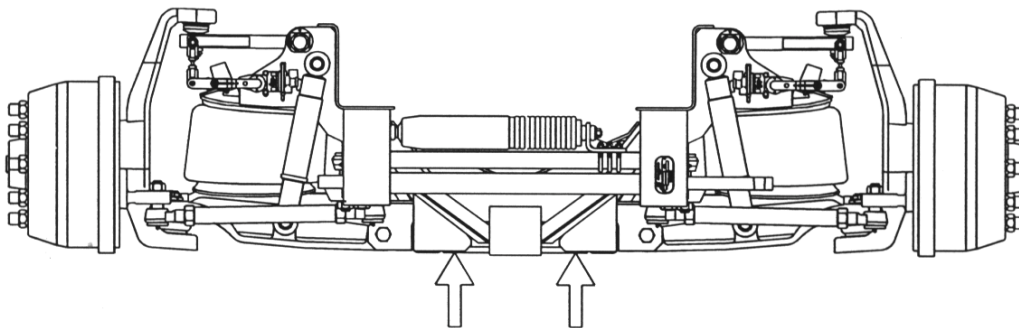
Figure 3: Jack Point Locations

The recommended jack point locations are shown in Figure 3. The jack must have sufficient return stroke to lower the chassis below the suspension ride height to actuate the HCV to inflate the air springs. Placing a jack under the lower control arm or the steering knuckle can result in an unstable condition.
