NEWMAR CORPORATION

TECHNICAL SERVICE BULLETIN

TSB #
194

SUBJECTS: 1) Gussets on Cradle for the Bell Crank and Idler Crossmember

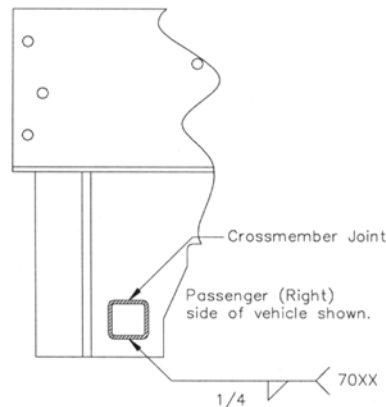
1. Clean and remove all dirt, oil, undercoating and road tar from the weld area where the crossmember is connected to the steering component brackets.
2. While turning the wheels from left to right, check weld joints (both sides) for cracking. If no cracks are observed, proceed with the installation of the gussets.

3. If a crack is suspected but not readily visible, use a dye penetrant for crack indication. If dye penetrant is not available, back grind the weld and repair per item 5. If no cracks are observed, proceed with the installation of the gussets.

5. If the weld is cracked but not all the way around such the end of the crossmember is not separated for the steering brackets, repair the weld as follows:

- a) Remove the cracked weld material by grinding.

- b) Repair the joint by welding the crossmember to the steering bracket using AWS 70,000 tensile weld wire (gas shielded) or electrode (flux shielded). Remove weld spatter and slag as required.
