# NEWMAR CORPORATION WARRANTY DEPARTMENT

TECHNICAL SERVICE BULLETIN																			
DATE ISSUED		MODEL YEAR(S) AFFECTED		MODEL(S) AFFECTED		TSB #													
March 31, 2004		1999 – 2004		DP as noted below		247													
BRAND						TYPE													
All	<input type="checkbox"/>	American Star	<input type="checkbox"/>	Mountain Aire	<input checked="" type="checkbox"/>	All	<input type="checkbox"/>	T T	<input type="checkbox"/>										
		Dutch Star	<input checked="" type="checkbox"/>	Kountry Aire	<input type="checkbox"/>	F W	<input type="checkbox"/>	C A	<input type="checkbox"/>										
		Kountry Star	<input checked="" type="checkbox"/>	Essex	<input type="checkbox"/>	D P	<input checked="" type="checkbox"/>	D B	<input type="checkbox"/>										
Scottsdale	<input type="checkbox"/>	Northern Star	<input checked="" type="checkbox"/>	London Aire	<input type="checkbox"/>

# Technical Service Information

**Issue:** When raised to full extension, power step well cover sags under a load.

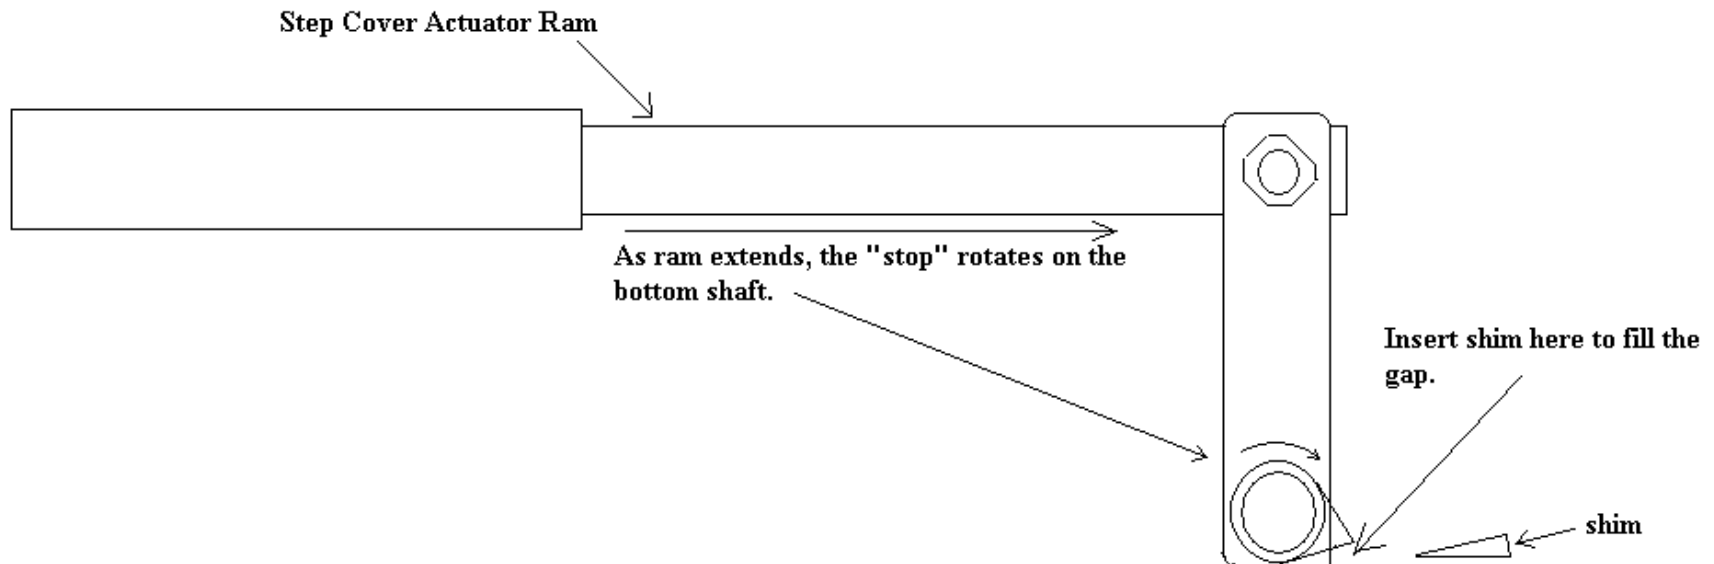
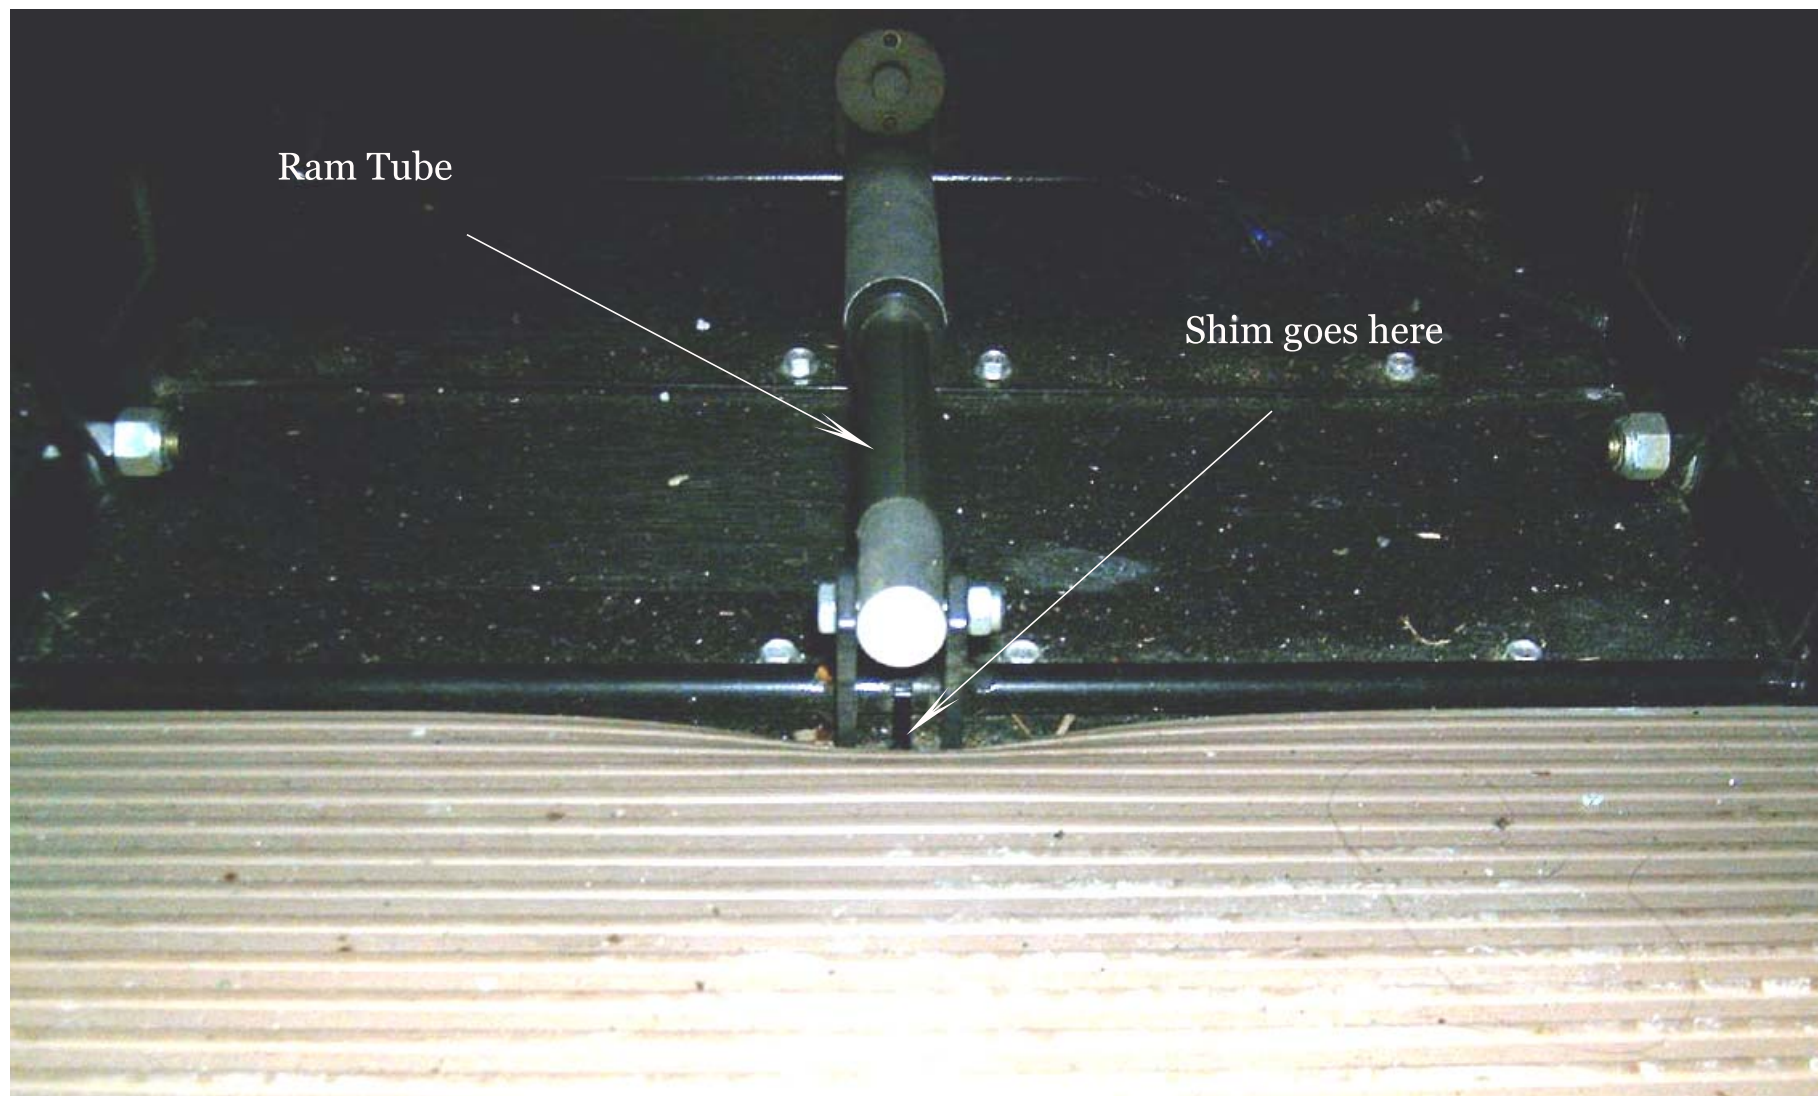
## Power Step Cover TSB Illustration

**Cause:** Limited “Ram” extension. When extending, the ram shaft pushes an arm on the shaft that rotates to lift the steps into place as a platform. If the ram stops short of the point where the “stop” piece that rotates with the shaft presses against the base of the assembly, the rotating shaft will not have adequate support. This causes the rotating shaft to bend under weight. The flex in the shaft allows the step well cover to sag when weight is placed on it.

At full ram extension, the "Stop" must be in physical contact with the base of the step cover assembly. If it is not, shim the opening so there is a hard rest for the "stop" to press against.

**Cure:** Shim the mechanism to provide support at full extension.

- 1) Raise the steps to full extension. Inspect the rotating “stop” piece as noted in the attached photo to see if it is physically touching the base of the mechanism. If it is, there is no repair required.
- 2) If there is a gap, determine the size of shim to be installed (usually a 1/8<sup>th</sup> or 1/16<sup>th</sup> inch shim), and fabricate one to fit.
- 3) Retract the step cover approximately an inch to allow insertion of the shim. Once in place, extend the step cover to full extension to be sure the rotating “stop” is resting firmly on the shim. This supplies physical support for the rotating “stop” piece on the shaft when the ram is at full extension, eliminating the sag and helping the rotating shaft maintain it's position and torque load.
