NEWMAR CORPORATION WARRANTY DEPARTMENT

TECHNICAL SERVICE BULLETIN							
DATE ISSUED		Model Year(s) Affected		Model(s) Affected		TSB #	
12/20/04						250	
	BRAND					Түре	
All		American Star		Mountain Aire		All 🗖	ТТ 🗖
		Dutch Star		Kountry Aire		FW□	САП
		Kountry Star		Essex		D P 🔳	D B 🗖
Scottsdale		Northern Star		London Aire			
Air Conditioning & Heating Electrical Components							
□ Appliances & Accessories				Exterior Components			
Cabinets & Furniture				□ Interior Components			
Chassis Components				Plumbing & Bath Components			
Construction Components				□ Windows, Awnings, Vents, & Doors			
DESCRIPTION OF PROBLEM

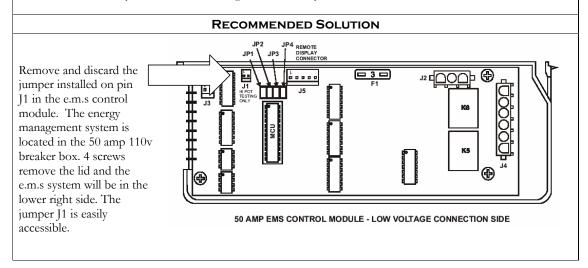
Inability of the optional EMS (Energy Management System) system to shed loads for low amperage connections. This would result in all controlled appliances to be kept "on-line" despite incoming amperage. This can result in overload and tripping of the main breaker "at the post" when connected to external 110 VAC power while camping. This is caused by a "jumper" connector located on the e.m.s circuit board that was not removed at the factory after "Hi-Pot" testing the electrical system.

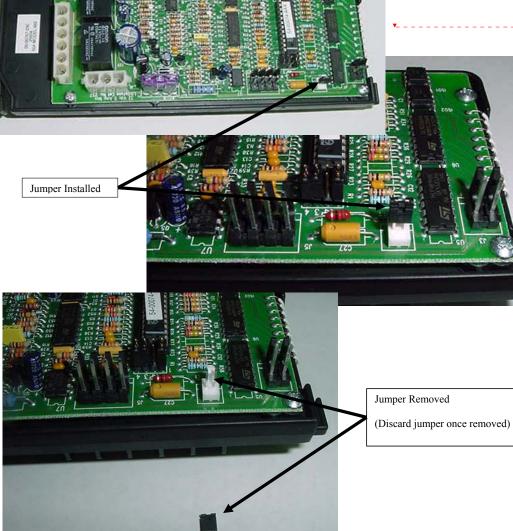
Jumper Installed 20 Jumper Removed (Discard jumper once removed)
