NEWMAR CORPORATION WARRANTY DEPARTMENT

TECHNICAL SERVICE BULLETIN								
DATE ISSUED		MODEL YEAR(S) AFFECTED		MODEL(S) AFFECTED		TSB#		
4/19/05		2004-2005		Essex / MADP		251		
		BRAND	BRAND				Түре	
All		American Star		Mountain Aire		All \square	ТТП	
		Dutch Star		Kountry Aire		FW 🗖	САП	
		Kountry Star		Essex		D₽■	DB□	
Sco	ttsdale	Northern Star		London Aire				
☐ Air Conditioning & Heating ☐ Electrical Components								
☐ Appliances & Accessories ☐ Exterior Components								
☐ Cabinets & Furniture ☐ Interior Components					nents			
	Chassis Components □ Plumbing & Bath Components							
	Construction Components Windows, Awnings, Vents, & Doors				8			
DESCRIPTION OF PROBLEM								
Water migrating through the engine compartment may get into the Spartan Electronics package mounted on the rear wall. Water settling into the electronics can damage them.								
RECOMMENDED SOLUTION								
Install a water resistant ABS plastic box with clear cover (p/n 76512P) over the Spartan Electronics Package. This minimizes the risk of moisture damage to the electronics. 1) Locate the Spartan Electronics Package on the right rear wall of the engine compartment (picture 1). 2) Cut wire passage

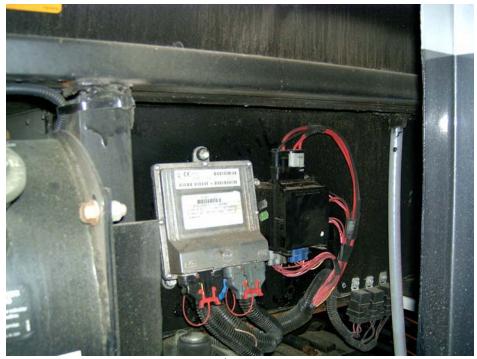
Picture 1 Locating the Spartan Electronics Package on the Engine Compartment Rear Wall
