Technical Service Bulletin

DATE ISSUED	MODEL YEAR(S) AFFECTED	MODEL(S) AFFECTED	TSB #
May 6, 2005	2004-2006	Essex / MADP	252

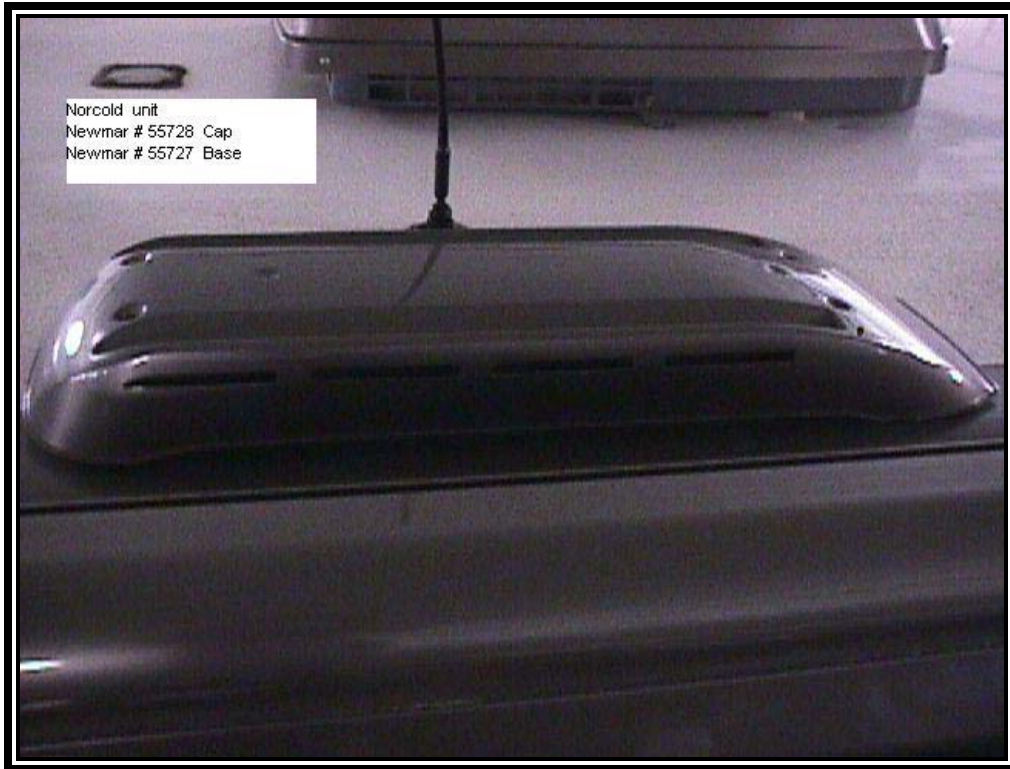
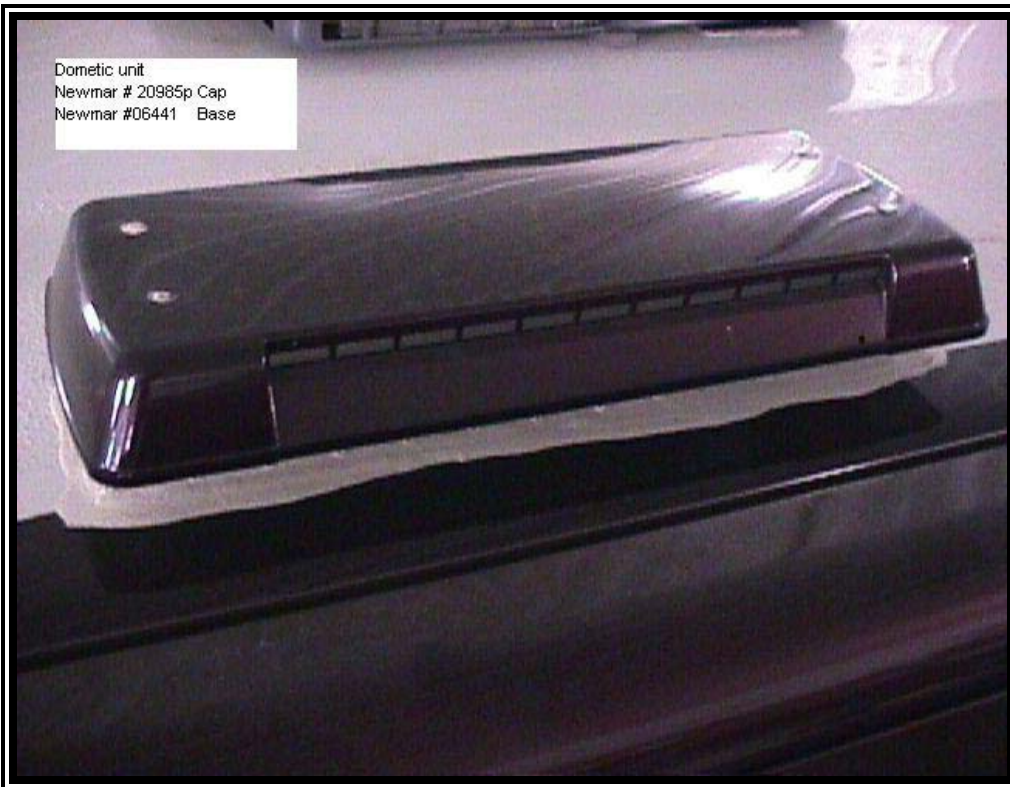
Poor refrigerator performance on certain units with Dometic refrigerator. Performance decreased by poor air flow across refer cooling unit because of restricted air movement by roof mounted vent. Norcold vent cover was installed on some models with Dometic refrigerators. Norcold vent does not allow for sufficient air movement to allow adequate ventilation of the cooling unit on the back of the refrigerator.

On units equipped with Dometic refrigerator and Norcold roof mounted refer vent, change to less restrictive Dometic roof mounted refer vent. See attached photos for identification purposes, and order as necessary. Prior authorization required.

Dometic Refer Vent: Cap:20985p
Base: 06441
