# Newmar Corporation Warranty Department

| <b>Technical Service Bulletin</b> | | | | | | | |
| <b>10/19/2006</b> | <b>3/24/05 – 2/17/06</b> | <b>All Spartan Chassis</b> | | | <b>266</b> | | |

**SUBJECT:** Current Distribution – Brake Light Circuit

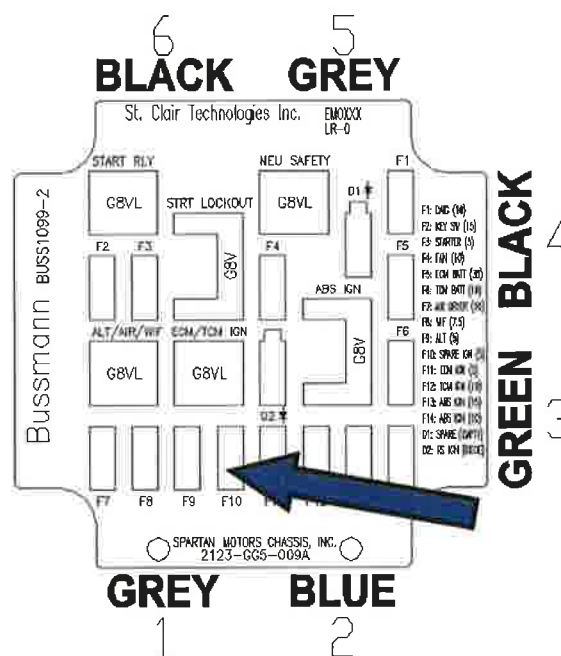
**Note:** There may be a 7.5A fuse in this location. If so, remove and replace it with a 5A fuse or 5A circuit breaker (determined by the kit being used).

10. Verify and/or replace the F10 fuse/circuit breaker in the rear Power Distribution Center (PDC) with the appropriate component.

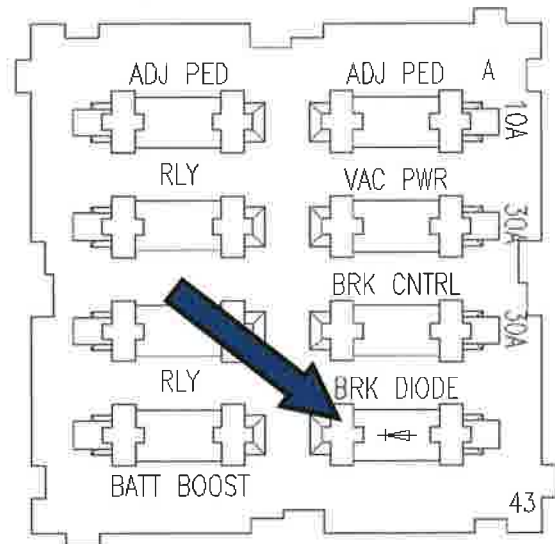
**Note:** Although the diode may still function and have no apparent defects, it may have internal damage.

**Note:** Diode must be keyed correctly as shown.

12. REPLACE the BRK DIODE. This diode is located in approximately the center of the front PDC.
