# Newmar Corporation Warranty Department

| <b>Technical Service Bulletin</b> | | | | | | | |
| <b>10/23/2006</b> | <b>2004 2005 2006</b> | <b>Workhorse 8.1 L<br/>gasoline engines</b> | | | <b>304</b> | | |

**SUBJECT: 8.1 L Engine Fuel Rail Damper Retainer Clip**

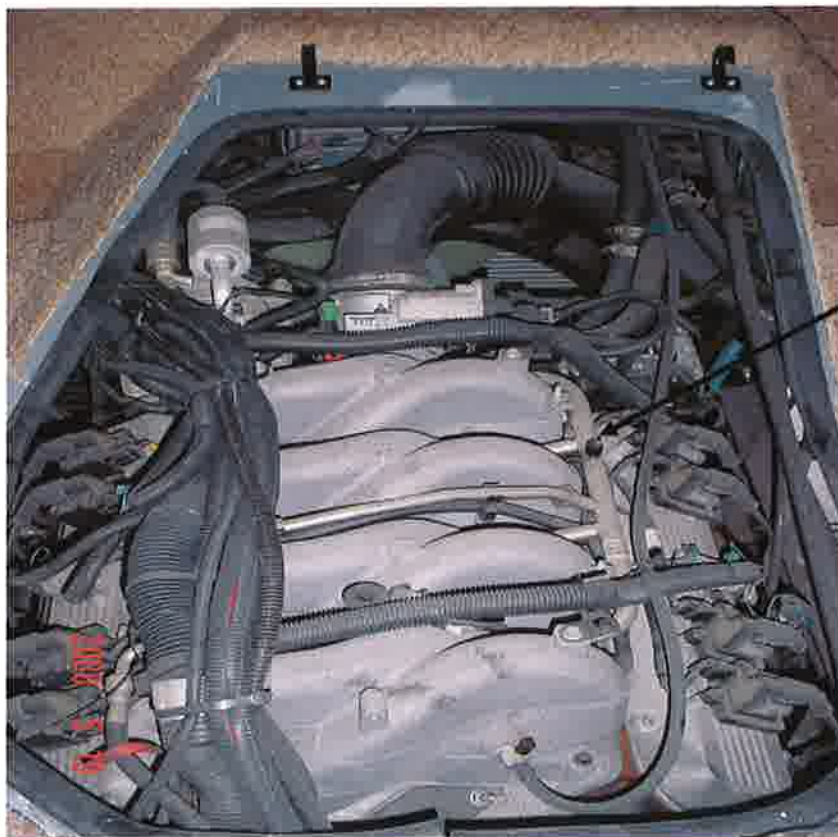
**Photo 1 Black cap on pressure valve on fuel rail on top RH side of Engine**

4. Loosen the fuel filler cap in order to relieve the tank vapor pressure.
5. Relieve any residual fuel pressure through the fuel pressure connection valve shown by photo 1 using a fuel pressure gage, or equivalent, and an approved fuel container. Wrap a shop towel around the fitting while connecting the gage in order to avoid spillage.

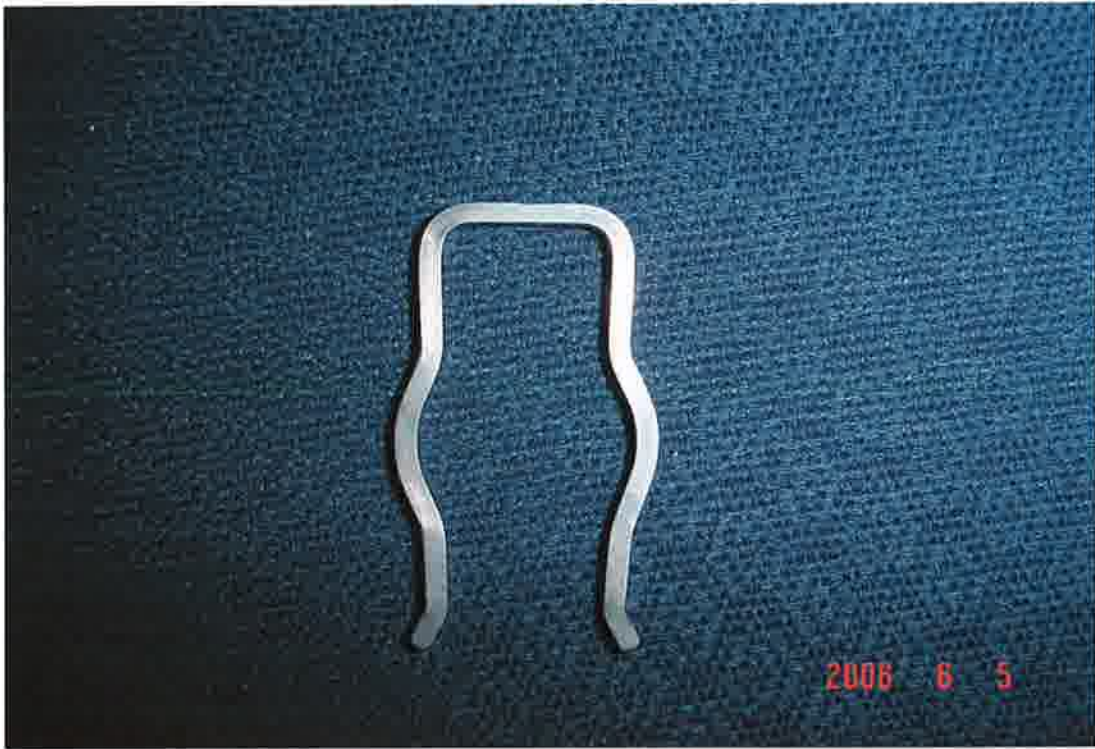
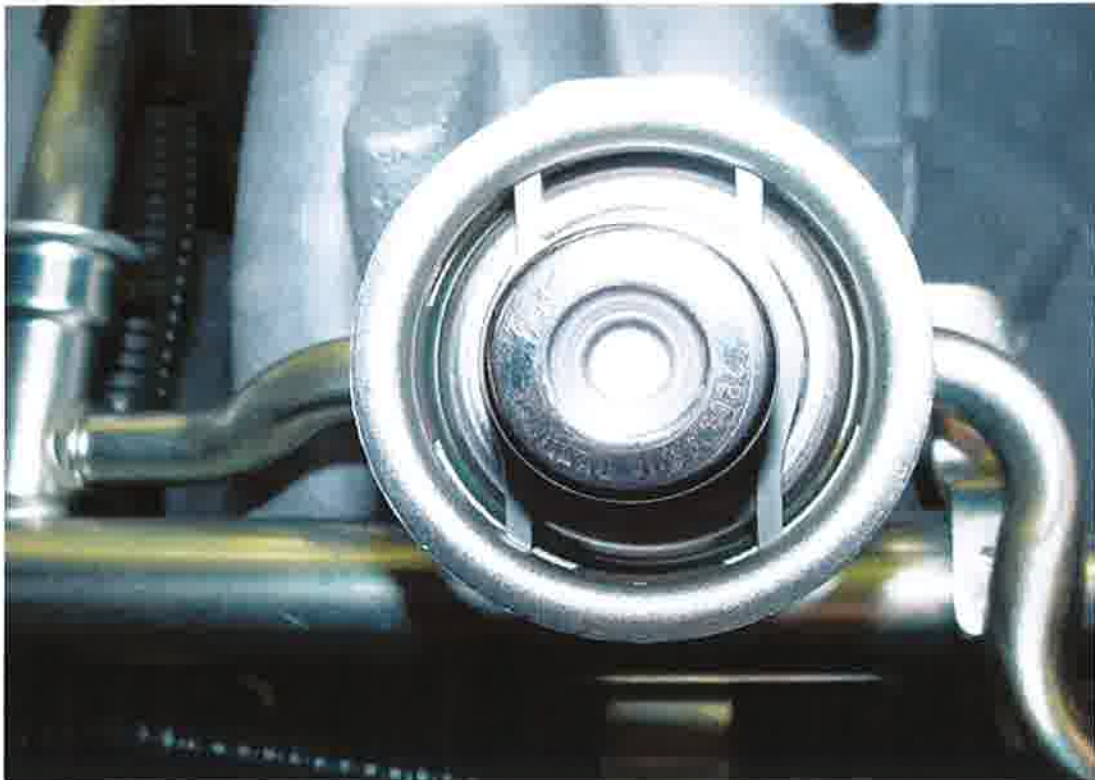
The defect involves the possible installation of an improperly heat treated fuel rail damper retainer clip. An improperly heat treated clip may break resulting in a gasoline fuel leak at the fuel rail damper. A vehicle fire can result if the leaking fuel is ignited by a spark, or flame.

**Photo 2 and 3 retaining clip and damper held by the clip**

6. Push down on the fuel damper while using a flat screw driver to remove the existing clip. (See photos 2 and 3)
7. Do not remove the fuel damper from the fuel rail. If the damper is removed the fuel damper o-ring must be replaced at the technician's/dealer's expense.

8. While holding down the damper, install the new clip in same position as removed clip.
9. Reconnect the negative battery cable.
10. Tighten the fuel filler cap.
