Newmar Corporation

Technical Service Bulletin							
Date Issued		Model Year(s) Affected		Model(s) Affected		TSB #	
12/20/2006		All		Workhorse Chassis		309	
Brand						Type	
All	<input type="checkbox"/>	American Star	<input type="checkbox"/>	Mountain Aire	<input checked="" type="checkbox"/>	All	<input type="checkbox"/> T T <input type="checkbox"/>
		Dutch Star	<input type="checkbox"/>	Kountry Aire	<input type="checkbox"/>	F W	<input type="checkbox"/> C A <input checked="" type="checkbox"/>
Canyon Star	<input checked="" type="checkbox"/>	Kountry Star	<input checked="" type="checkbox"/>	Essex	<input type="checkbox"/>	D P	<input type="checkbox"/> D B <input type="checkbox"/>
Scottsdale	<input checked="" type="checkbox"/>	Northern Star	<input type="checkbox"/>	London Aire	<input type="checkbox"/>		
<div style="display: flex; justify-content: space-between;"> <div> <input type="checkbox"/> Air Conditioning & Heating <input type="checkbox"/> Appliances & Accessories <input type="checkbox"/> Cabinets & Furniture <input checked="" type="checkbox"/> Chassis Components <input type="checkbox"/> Construction Components </div> <div> <input type="checkbox"/> Electrical Components <input type="c

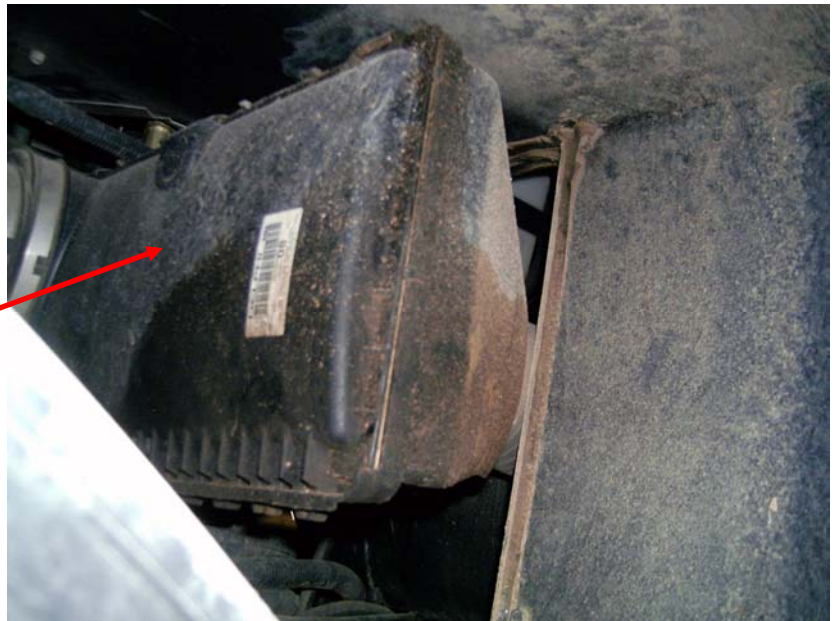
(Workhorse Air Filter Housing)

Description of Problem							
Possible water infiltration into the Workhorse factory installed plastic intake plenum and air filter box.							
Recommended Solution							
<p>See attached Technical Service information and illustrations for repair procedures for this condition. Contact your Newmar Warranty Service Representative if you have further questions.</p> <p style="text-align: center;">Flat Rate Code: 4904 Time allowed: 1.2 Newmar Part Number: 41281</p>

1) Locate Workhorse engine air filter housing in RF (passenger side) wheel well. Disconnect intake and exit air hoses from housing, and remove the housing from the RV.
