Technical	Serv	ice Bulletin			
Date Issued Model Year(s) Affected		ted	Model(s) Affected		1	TSB #	
	1/3/2007 12/2/2005 - 5/9/2006		2006	All Star		311	
		Brand				Туре	
All	C	American Star		Mountain Aire		All 🗖	ТТП
		Dutch Star		Kountry Aire		FW 🗖	САП
All	Star	Kountry Star		Essex		D P 🗖	DB□
Sco	ttsdale 🛛	Northern Star		London Aire		D1 –	
□ Air Conditioning & Heating			Electrical Components				
	Appliances & Acc	ressories	[Exterior Components			
□ Cabinets & Furniture □			Interior Components				
■ Chassis Components □ I			Plumbing & Bath Components				
Construction Components			[□ Windows, Awnings, Vents, & Doors			
		Descri	iption of I	Problem			
Pote	ential for Driveline	Vibration.					
		Recom	mended	Solution			
-		the rear engine mounts, and nufacturer directly for addit		-		's attached	l repair

Re: Notice of Campaign Service Bulletin: CSB06-170-002

CAMPAIGN SERVICE BULLETIN

<u>SUBJECT</u>: Engine -Mounts

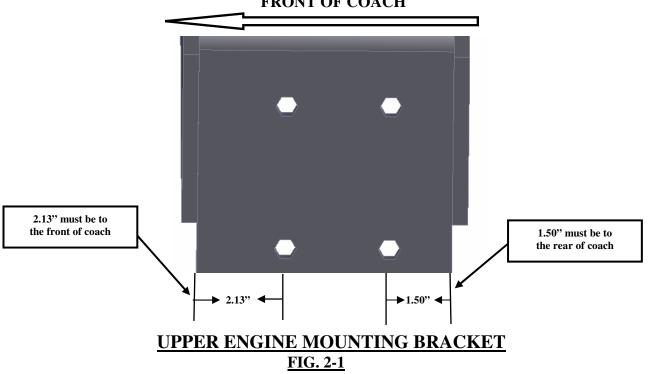
2. Refer to FIG. 2-1. Measure the bolt hole location on the vertical surface of each rear upper engine mounting bracket.

NOTE: The hole location must be measured for EACH of the rear upper engine mounting brackets.

- 2a) From the rear vertical edge of the bracket, measure to the centerline of the first hole. If the dimension is 1.50" the mount is installed properly and no further work is necessary.
- 2b) If the measurement is not 1.50" proceed to step #3.

NOTE: The measurement should be the same for both brackets. If the measurement is not the same, contact Spartan Chassis, Inc.
