NEWMAR CORPORATION WARRANTY DEPARTMENT

TECHNICAL SERVICE BULLETIN							
DATE ISSUED		MODEL YEAR(S) AFFECTED		MODEL(S) AFFECTED		TSB #	
3/31/08		2008		BS/CS/GS		326	
BRAND						TYPE	
All Star	<input type="checkbox"/>	American Star	<input type="checkbox"/>	Mountain Aire	<input type="checkbox"/>	All	<input type="checkbox"/>
Bay Star	<input checked="" type="checkbox"/>	Dutch Star	<input type="checkbox"/>	Kountry Aire	<input type="checkbox"/>	T T	<input type="checkbox"/>
Canyon Star	<input checked="" type="checkbox"/>	Kountry Star	<input type="checkbox"/>	Essex	<input type="checkbox"/>	F W	<input type="checkbox"/>
Grand Star	<input checked="" type="checkbox"/>	Northern Star	<input type="checkbox"/>	Ventana	<input type="checkbox"/>	C A	<input checked="" type="checkbox"/>
						D P	<input type="checkbox"/>
<input type="checkbox"/> Air Conditioning & Heating		<input type="checkbox"/> Electrical Components					
<input checked="" type="checkbox"/> Appliances & Accessories		<input checked="" type="checkbox"/> Exterior Components

TSB 326 Atwood Wiring Harness Repair Procedure

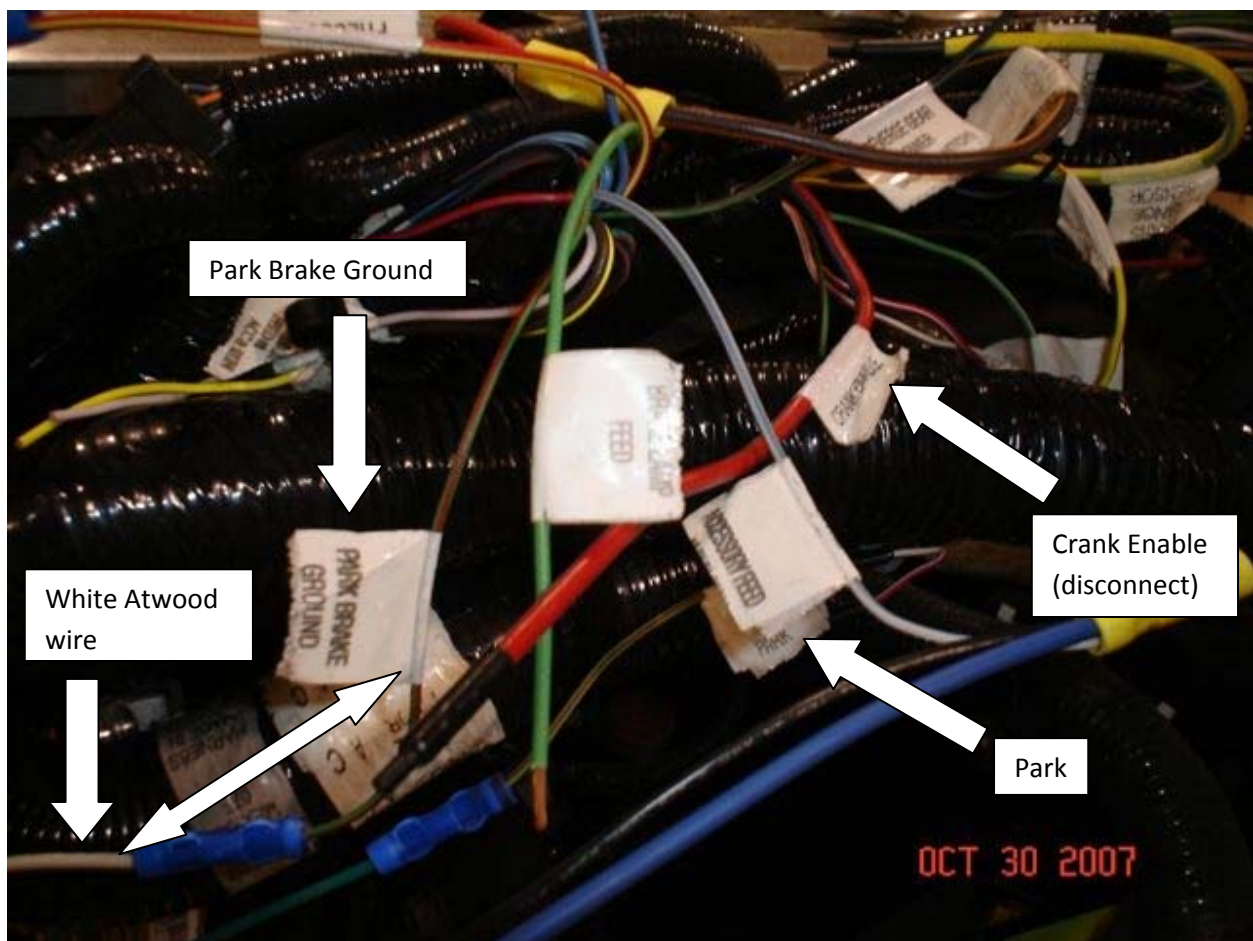
Disconnect red "Crank Enable" lead and tape off to insulate against shorts. Connect green w/red "Park Brake Ground" wire to the white Atwood harness lead.

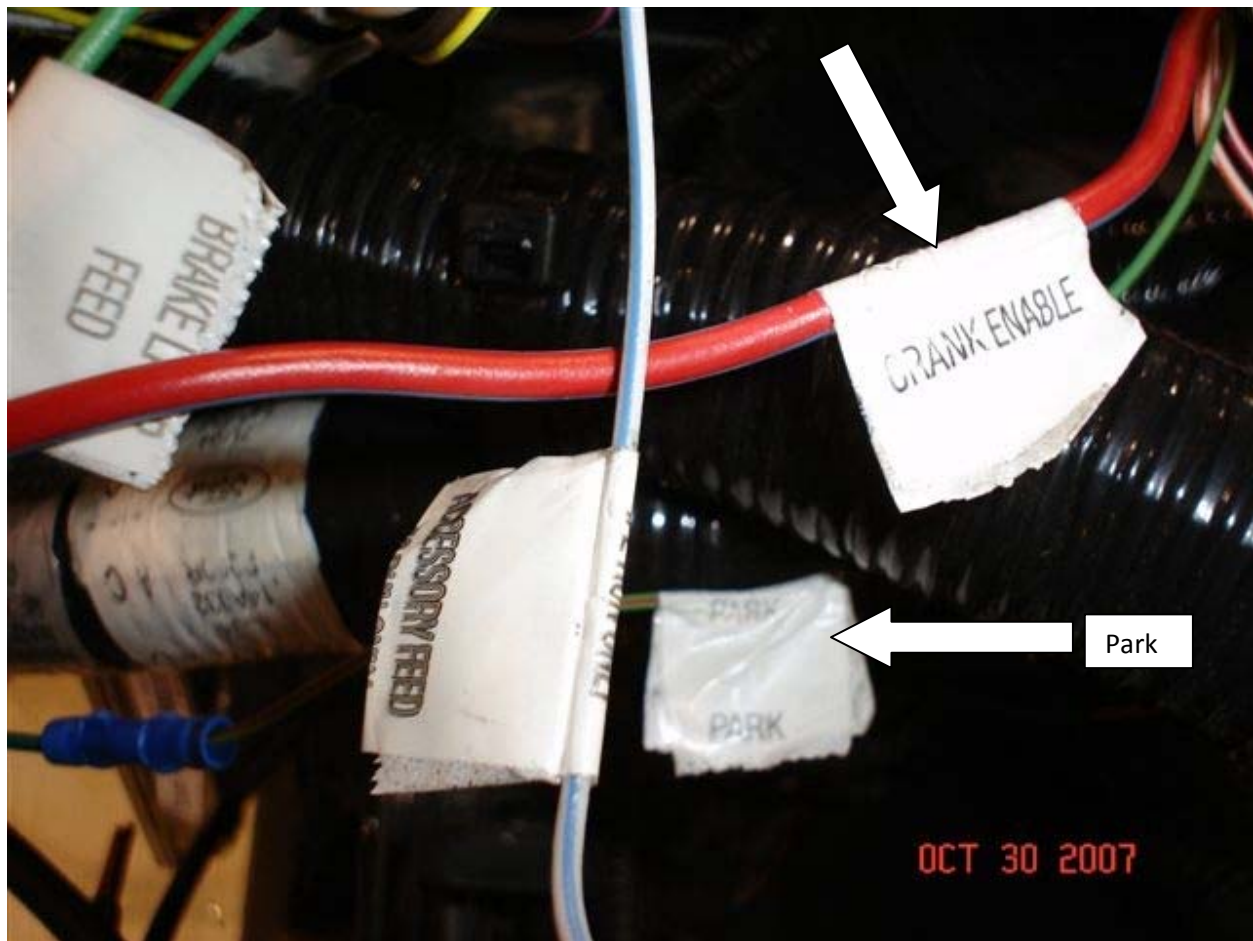
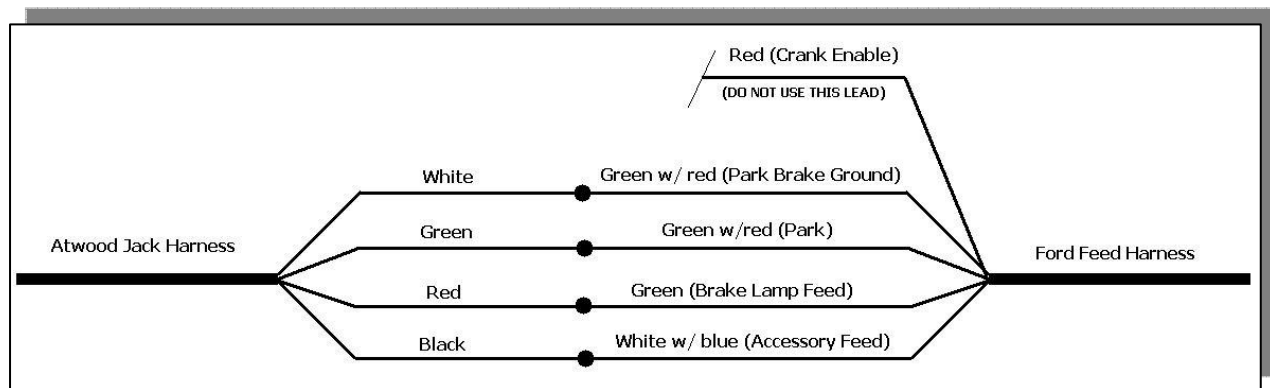
IMPORTANT: There are two “Green w/red” wires in the Ford harness. It is important that they be connected correctly; be certain the “Green w/red” one labeled “Park Brake Ground” is connected to the White wire in the Atwood harness, and the “Green w/red” wire labeled “Park” is connected to the Green wire in the Atwood harness.
