# NEWMAR CORPORATION WARRANTY DEPARTMENT

TECHNICAL SERVICE BULLETIN																			
DATE ISSUED		MODEL YEAR(S) AFFECTED		MODEL(S) AFFECTED		TSB #													
8/20/08		2002-2008		All DP on Freightliner Chassis		329													
BRAND						TYPE													
All	<input type="checkbox"/>	American Star	<input type="checkbox"/>	Mountain Aire	<input type="checkbox"/>	All	<input type="checkbox"/>	T T	<input type="checkbox"/>										
Cypress	<input type="checkbox"/>	Dutch Star	<input checked="" type="checkbox"/>	Kountry Aire	<input type="checkbox"/>	F W	<input type="checkbox"/>	C A	<input type="checkbox"/>										
Northern Star	<input checked="" type="checkbox"/>	Kountry Star	<input checked="" type="checkbox"/>	Essex	<input type="checkbox"/>	D P	<input checked="" type="checkbox"/>	D B	<input type="checkbox"/>										
Scottsdale	<input type="checkbox"/>	King Aire	<input type="checkbox"/>	London Aire	<input type="checkbox"/>														
All Star ME	<input type="checkbox"/>	Ventana	<input checked="" type="checkbox"/>

# Recall Campaign

### Subject: ZF Lenksysteme 8018 Steering Gears

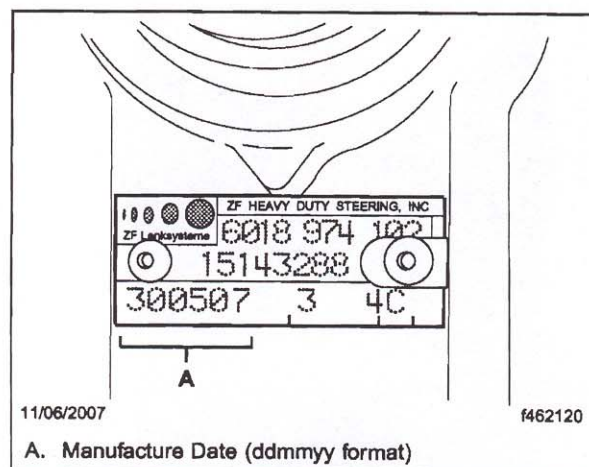
Fig. 1, Data Plate Identification

1. Check the base label (Form WAR259) for a completion sticker for FL509 (Form WAR260) indicating this work has been done. The base label is usually located on the front wall under the dash in motorhomes. If a sticker for FL509 is present, nothing further needs to be done. If a sticker is not present, go to the next step.
2. Shut down the engine, set the parking brake, and chock the tires.
3. Check the date code on the data plate of the steering gear. See Fig. 1.
  - 3.1 If the date code is 250407 or more, nothing further needs to be done. Go to step 4.
  - 3.2 If the date code is less than 250407 go to "Steering Gear Replacement."
4. Clean a spot on the base label, write the Recall number, FL509, on a blank completion sticker, and attach it to the base label.
5. Remove the chocks from tires.
