## NEWMAR CORPORATION WARRANTY DEPARTMENT

## **TSB 332 Wire Procedure**

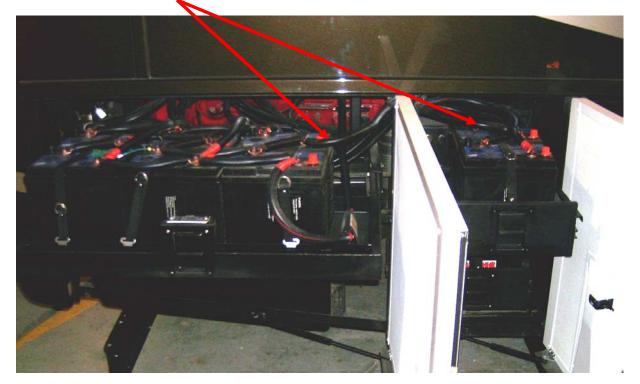
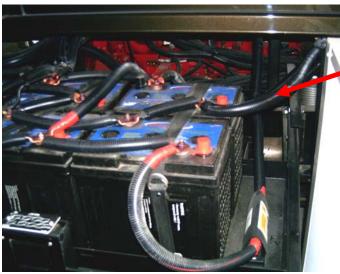
On a 2008 "All Electric" Essex, open both battery compartments and extend the trays completely for inspection. Confirm the cable linking the 6VDC side of the two battery banks together was installed.

The cable in question is installed between the right rear battery in the main bank and the rear battery in the second bank of batteries. Secure it with tie straps so it does not drop onto exhaust components.

If this cable is missing, install the following:

- Approximately 4' of 3/0 cable (Newmar part # 51829)
- 2) Approximately 4' of black conduit to cover the cable (Newmar part # 35270)
- 3) 2 Crimp on terminal end rings (Newmar part # 22404)
