1	DATE ISSUED		TECHNICAL S Model Year(s) Aff						TSB #
3/24/08			2006-2007			MODEL(S) AFFECTED All Newmar DP on Spartan MM Chassis		335	
Brand					•		7	Гүре	
All			American Star			Mountain Aire		All 🗖	ТТП
Сург	ess		Dutch Star			Kountry Aire		FW□	САП
Northern Star			Kountry Star		Essex				
Scot	Scottsdale		King Aire			London Aire		D P 🗖	D B □
All S	tar ME		Ventana						
Air Conditioning & Heating Electrical Components									
	0 0				Exterior Components				
	11				Interior Components				
	_				Plumbing & Bath Components				
 Construction Components 				Windows, Awnings, Vents, & Doors					
Description of Problem									
Spartan RSB07-500-002 / NHTSA Recall # 07V-363. Possible chassis electrical failure due to bad jumper connection inside the "Bussman Box" in the chassis electrical system. Electrical failure can mean shut down of engine, transmission, and numerous other chassis electrical components or systems.

NHTSA # 07V-363 RSB07-500-002 January, 2008

RECALL SERVICE BULLETIN

SUBJECT: Power Distribution – Bussmann® (DVEC) Dual Vehicle Electrical Center.

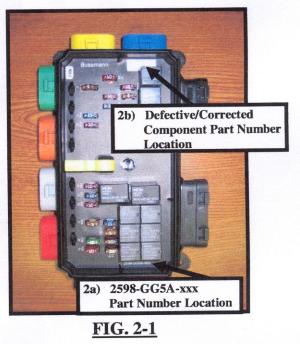
FIG. 2-2

- 1. Observe all industry safety standards, disconnect any necessary power source and secure vehicle to allow for replacement of the Bussmann® DVEC at the rear PDC (Power Distribution Center).
- 2. Locate the rear PDC near the engine, generally on the passenger side between the rear wheels and the rear of the vehicle.
 - 2a. Refer to FIG. 2-1. Identify the DVEC having a part number beginning with 2598-GG5A. The part number is located on the inside cover and on the lower right inside face of the box.
 - 2b. Refer to FIG. 2-1, 2-2 & 3-1. The DVEC having a part number in the top right corner of the box ending in a -1 is defective and must be replaced with a box where this number ends in -2 as shown in FIG. 3-1.

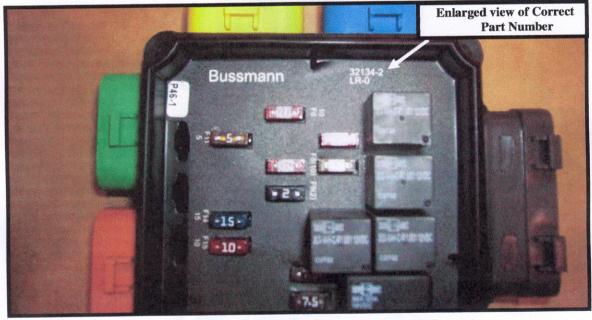
CORRECT BUSSMANN® DVEC SHOWN FIG. 3-1

- 4. Attach the DVEC to the mounting surface using the fasteners removed in step #3.
- 5. Connect electrical connectors to the new DVEC.
- 6. Reconnect any power source previously disconnected.
