# NEWMAR CORPORATION WARRANTY DEPARTMENT

**TSB08-570-001**February, 2008
Page 1 of 2

**SUBJECT**: Communication Systems – Engine Programming

APPLIES TO: Certain Spartan Motorhomes equipped with a 2007 emissions

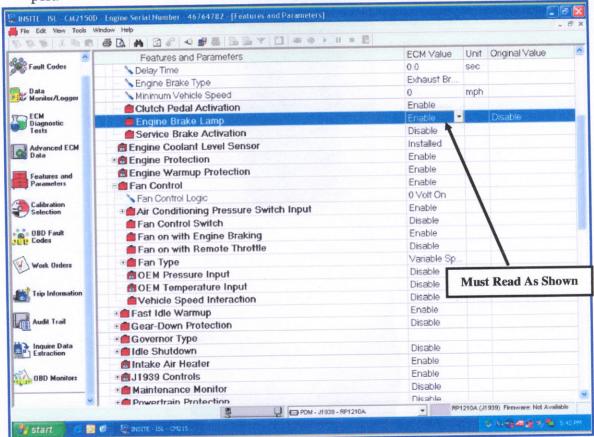
#### ENGINE BRAKE LAMP PARAMETER <u>FIG. 2-1</u>

**CONDITION:** Engine brake light function was programmed "disable" in engine

programming parameters.

- 1. Observe all industry safety standards, disconnect any necessary power source and secure vehicle for engine parameters update.
- 2. Connect PC (with Insite<sup>TM</sup>) to the engine diagnostic port.
- 3. Refer to FIG. 2-1. Locate **Features and Parameters** and Expand the **Engine Brake Control** folder.

- 4. Refer to FIG. 2-1. Locate the Engine Brake Lamp feature and change the ECM Value to read "Enable".
- Send change to engine and follow appropriate procedures to disconnect from the diagnostic port.
