SPARTAN CHASSIS, INC.

TSB08-250-001

TECHNICAL SERVICE BULLETIN

SUBJECT: Front Suspension –Independent Front Suspension (IFS)

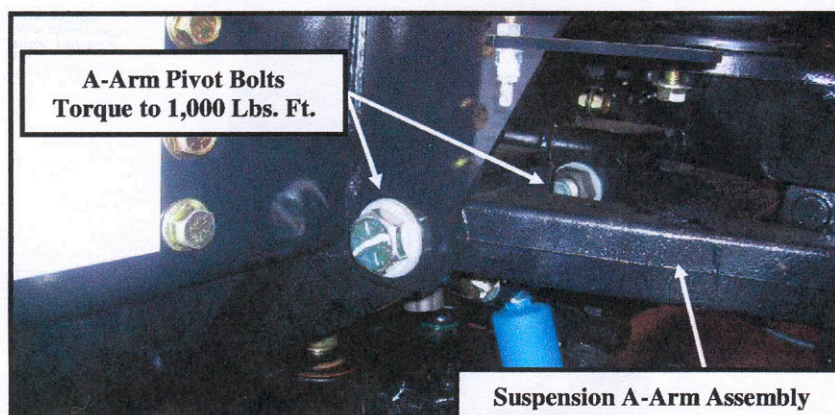
FIG. 2-1

DRIVER SIDE A-ARM ASSEMBLY SHOWN

1. Observe all industry safety standards, disconnect any necessary power source and secure vehicle for inspection/ replacement of upper A-arm pivot bolts.
2. Remove front wheel dressing and retain for reuse.
3. Jack up vehicle using the proper safety devices to support the vehicle.
4. Refer to FIG. 2-1. Remove front wheel assembly to gain access to the upper A-arm pivot bolts. Retain all hardware and wheel assembly for reuse.
5. Refer to FIG. 2-1. Using a torque wrench set to 1,000 lbs. ft. inspect to ensure both upper A-arm pivot bolts are at the proper torque value. If either (2) of the A-arm pivot bolts are found to be below the 1,000 lbs. ft. retorque bolts.

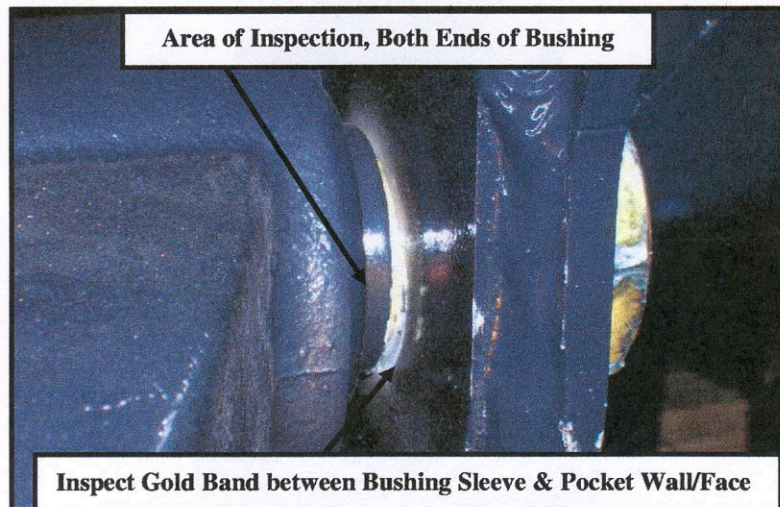
FIG. 3-1

INSPECT BUSHING

12. Refer to FIG. 3-1. Inspect forward bushing and rearward bushing.
13. Check for gold band in between bushing sleeve and pocket wall on both sides of bushing in question.

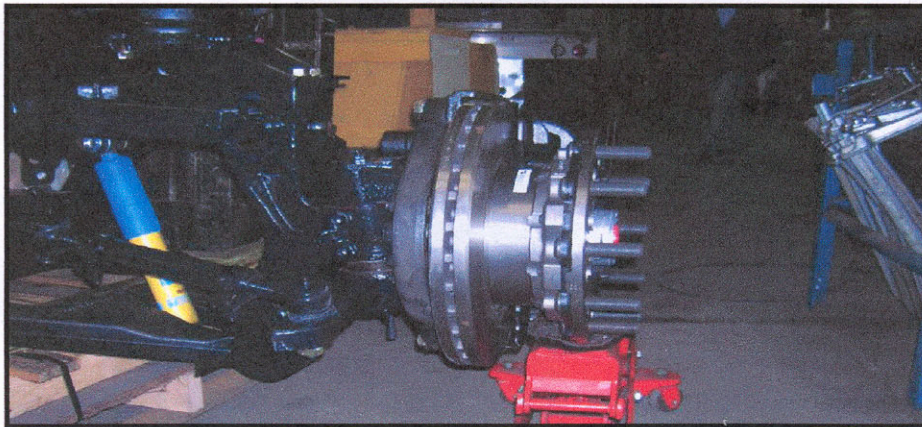
WHEEL END SHOWN SUPPORTED

17. Refer to FIG. 5-1. Support wheel end with floor jack with hubs steered straight ahead. Using impact with 1-11/16" socket and 1-11/16" wrench, loosen and remove (2) pivot bolts, being careful not to let A-arm fall down. **Do not** reuse pivot bolts.

18. Let bushing end of A-arm rest on shock mount.
19. Refer to FIG. 5-1 & 6-1. To gain access for inspection and possible resurfacing, remove the two bolts connecting bottom of air spring, support A-arm and slowly lower the wheel end. Then gently let A-arm down.
20. Refer to FIG. 6-1. Raise or lower A-arm to move the A-arm out of cradle pockets for inspection.
21. Refer to FIG. 6-2. Inspect the surface of the bushing mating area and inside of bushing pocket for wear. Wear deeper than 1/16" will require contacting Spartan Chassis Customer Service.

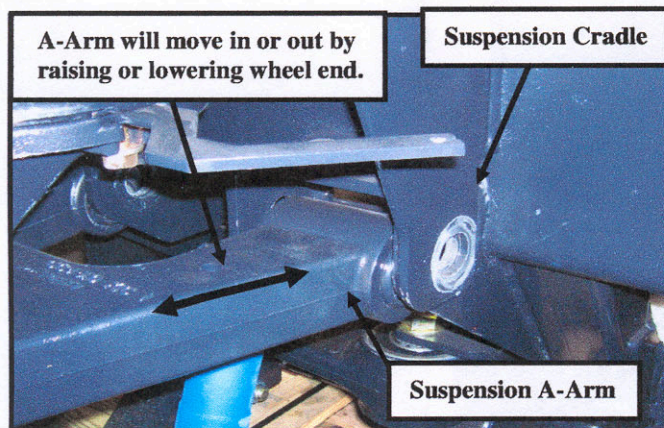
**A-ARM WITH PIVOT
BOLTS REMOVED
FIG. 6-1**

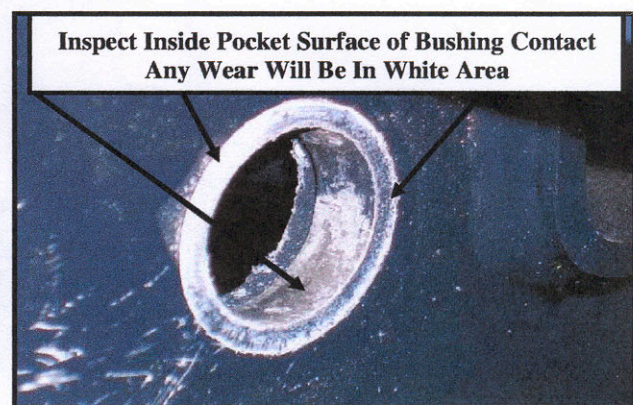
**INSPECT CRADLE FOR WEAR
AS SHOWN
FIG. 6-2**

22. Refer to FIG. 6-2. Inspect bushing for wear. Min. length is 4.874", Max. ID, measured horizontally is 1.189". Wear beyond these dimensions will require replacement of A-arm assembly. If A-arm replacement is necessary remove the two bolts attaching A-arm to steering knuckle carrier and remove A-arm. Retain bolts for reuse. When installing new A-arm (kit S-1939-002) attach the arm to the steering knuckle carrier with the original bolts. Torque to 365-385 lbs. ft.

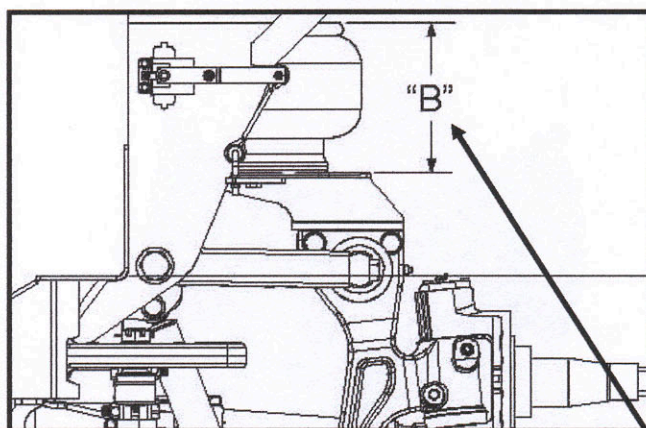
FIG. 7-1

**Measure from Bottom of Air Spring Base to Top of Air Spring
1460 IFS Ride Height Set to 9.00" 1660 IFS Ride Height Set to 9-1/4"**

26. Refer to FIG. 7-1. With new fasteners installed, use jack under wheel end to bring air spring height to **9" for 1460 IFS model or 9-1/4" for 1660 IFS model.**
