NEWMAR CORPORATION WARRANTY DEPARTMENT

TECHNICAL SERVICE BULLETIN							
DATE ISSUED		MODEL YEAR(S) AFFECTED		MODEL(S) AFFECTED		TSB #	
6/12/08		2008		All Class A on Ford Chassis		345	
BRAND						TYPE	
All	<input type="checkbox"/>	Canyon Star	<input checked="" type="checkbox"/>	Mountain Aire	<input type="checkbox"/>	All	<input type="checkbox"/>
Cypress	<input type="checkbox"/>	Dutch Star	<input type="checkbox"/>	Kountry Aire	<input type="checkbox"/>	T T	<input type="checkbox"/>
Northern Star	<input type="checkbox"/>	Kountry Star	<input type="checkbox"/>	Essex	<input type="checkbox"/>	F W	<input type="checkbox"/>
Grand Star	<input checked="" type="checkbox"/>	King Aire	<input type="checkbox"/>	London Aire	<input type="checkbox"/>	C A	<input checked="" type="checkbox"/>
All Star ME	<input type="checkbox"/>	Ventana	<input type="checkbox"/>	Bay Star	<input checked="" type="checkbox"/>	D P	<input type="checkbox"/>
<input checked="" type="checkbox"/> Air Conditioning & Heating		<input type="checkbox"/> Electrical Components

SUBJECT: Water leaks in passenger area

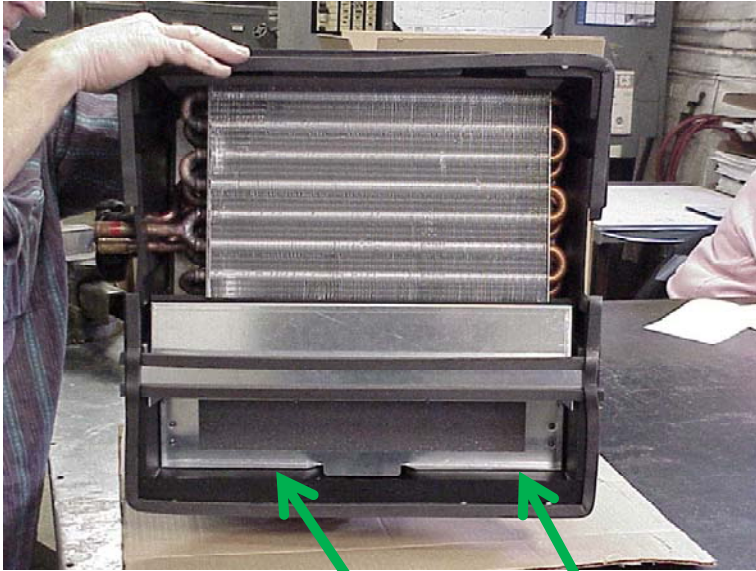
This is a view of the back side of a typical RV Base Unit. This is the side of the unit mounted to the firewall. See the view below which indicates the area where sealing may be required.

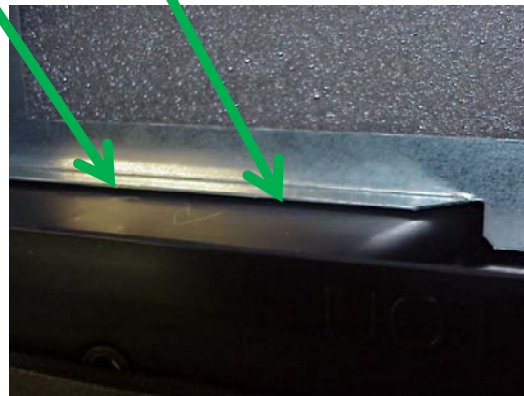
We have received sporadic reports of water coming in through the return air grill on certain Class A Motorhomes, misting the carpet and passengers' feet/leg area. We have determined that this may be the result of an increased amount of ram air due to a more open front cap re-design pushing condensation through the base heater a/c unit when the fresh air door is open and the vehicle is moving. This does not occur in "Max A/C" mode as fresh air is not used and the fresh air door is closed.

In order to eliminate this problem, it is necessary to apply a bead of waterproof sealant to a small gap at the bottom of the firewall mounted heater a/c unit. You will need to access this from inside the coach, through the recirculation opening near the passenger's feet. Remove the plastic grille covering the opening and remember to replace it when the fix is complete. Do not remove the heater a/c unit from the firewall.

This view shows the area that may require sealing to prevent water from being drawn to the interior of the coach. To access this area, you will need to remove the return air grill under the dash. We recommend a bead of waterproof caulk between the metal and the plastic on each side of the drain opening. You will only need to seal the horizontal gap to the right and left of the drain opening. The vertical surfaces on the sides already provide a sufficient seal.
