# NEWMAR CORPORATION WARRANTY DEPARTMENT

### CSB08-500-003

# **CAMPAIGN SERVICE BULLETIN**

**<u>SUBJECT</u>**: Low Voltage Power Distribution – Spartan Control Module (SCM)

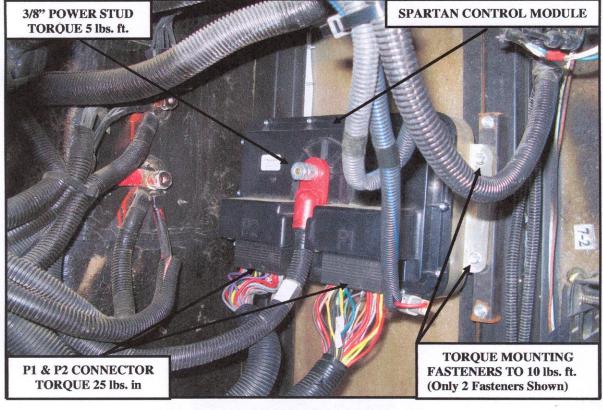
## SPARTAN CONTROL MODULE FIG. 2-1

**<u>CONDITION</u>**: Irregular flash rate in turn signals

- 1. Observe all industry safety standards, disconnect any necessary power source and secure vehicle for replacement of Spartan Control Module (SCM).
- 2. Locate main disconnect switch, normally installed on rear bulkhead in engine compartment, switch to the "off" position.
- 3. Refer to FIG. 2-1. Locate SCM in driver side front compartment or under front hood.

- 4. Refer to FIG. 2-1. Remove main power lug from 3/8" stud on SCM, retain nut for reuse.
- 5. Refer to FIG. 2-1. Remove two (2) connectors labeled P1 & P2 from SCM.
- 6. Refer to FIG. 2-1. Remove SCM from mounting location, retain mounting hardware for reuse. Properly dispose of control module.
- 7. Install new SCM (Rev.E) from kit, using hardware retained from previous steps. Torque to 10 lbs. ft.
- 8. Refer to FIG. 2-1. Reinstall both connectors (P1 & P2). Torque to 25 lbs. in.
- 9. Refer to FIG. 2-1. Reinstall main power cable to 3/8" power stud. Torque to 5 lbs. ft.
- 10. Reconnect any power source previously disconnected.
- 11. Return main power switch to the "on" position.
