NEWMAR CORPORATION WARRANTY DEPARTMENT

RSB08-940-002

Recall SERVICE BULLETIN

SUBJECT: Fasteners – 5/8" X 1.50" Grade 8 Yellow Flange Head Bolts

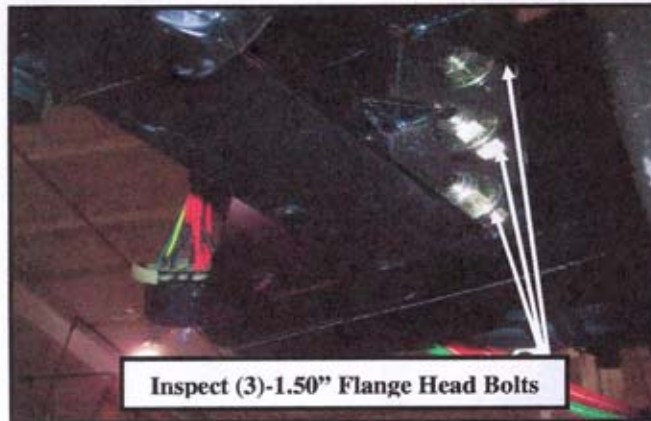
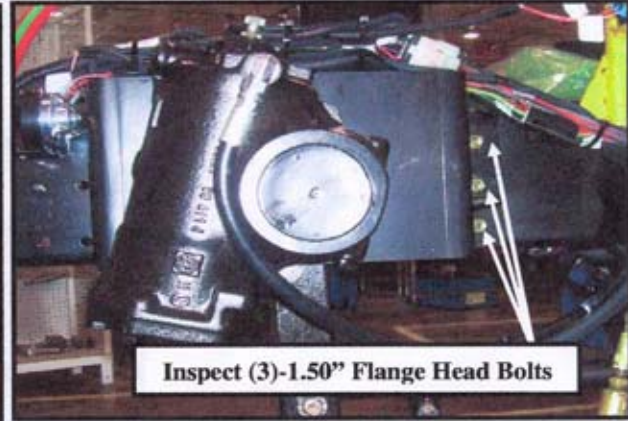
FIG. 2-1

STEERING GEAR SUPPORT MOUNTING LOCATION

2. Refer to FIG. 2-1. Visually inspect the six bolts attaching the steering gear support to the frame. If all of the bolts appear to be intact proceed to step 3. If any bolts are missing proceed to step 4.

3. Using a torque wrench set at 50 lbs. ft. attempt to rotate each bolt from which ever side is most accessible. If a bolt or nut rotates it must be replaced. If it does not rotate do not replace. Torque the new bolt and nut to 148 lbs. ft. from the nut, or 185 lbs. ft. from the bolt head.

4. Replace the missing bolts and nuts and torque them to 148 lbs. ft. from the nut or 185 lbs. ft. from the bolt head. Perform step 3 to the bolts that are not missing.

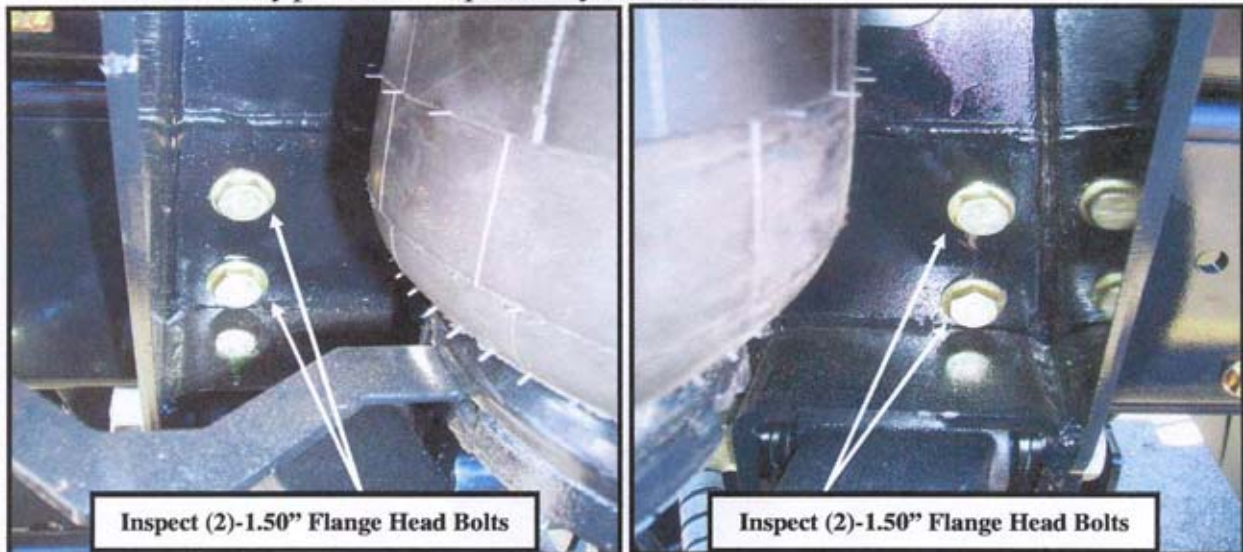
5. Refer to FIG. 3-1 & FIG. 3-2. Visually inspect the bolts attaching the IFS cradle to each frame rail. If all of the bolts appear to be intact proceed to step 6. If any bolts are missing proceed to step 7.

**TUTHIL/GRANNING IFS CRADLE MOUNTING LOCATION
(BEHIND AIRSPRING)**

6. Using a torque wrench set at 50 lbs. ft. attempt to rotate each bolt from which ever side is most accessible. If a bolt or nut rotates it must be replaced. If it does not rotate do not replace. Torque the new bolt and nut to 148 lbs. ft. from the nut, or 185 lbs. ft. from the bolt head.

7. Replace the missing bolts and nuts and torque them to 148 lbs. ft. from the nut or 185 lbs. ft. from the bolt head. Perform step 6 to the bolts that are not missing.

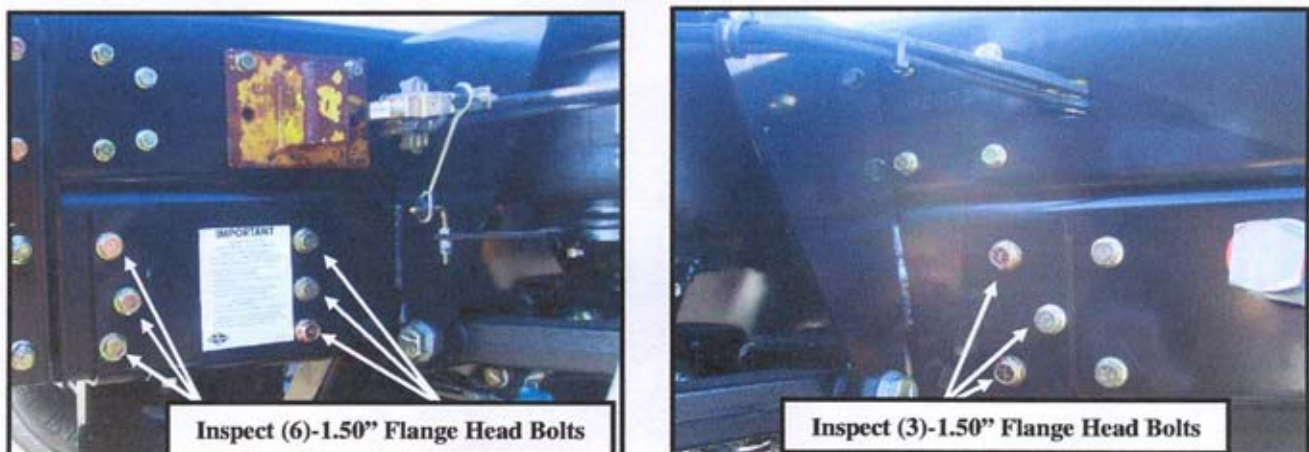
FIG. 3-2

TUTHIL/GRANNING IFS CRADLE MOUNTING LOCATION

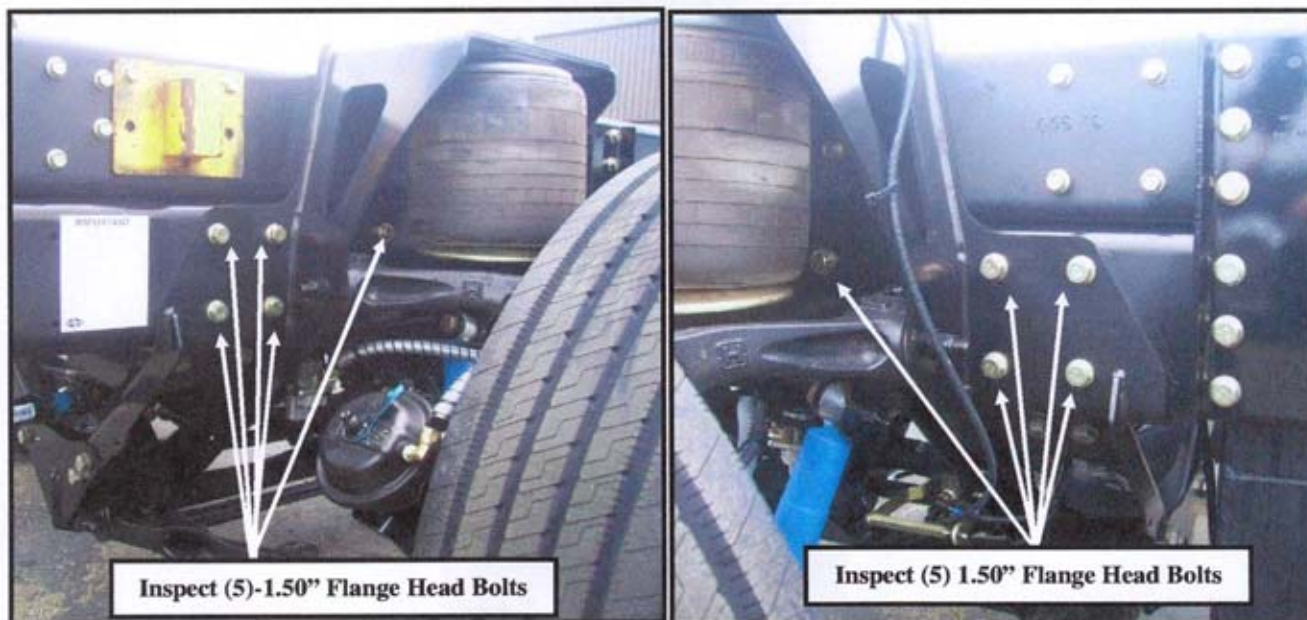
FIG. 4-1

HENDRICKSON IFS CRADLE MOUNTING LOCATION

1. Refer to FIG. 4-1. Visually inspect the bolts attaching the IFS cradle to each frame rail. If all of the bolts appear to be intact proceed to step 2. If any bolts are missing proceed to step 3.
2. Using a torque wrench set at 50 lbs. ft. attempt to rotate each bolt from which ever side is most accessible. If a bolt or nut rotates it must be replaced. If it does not rotate do not replace. Torque the new bolt and nut to 148 lbs. ft. from the nut, or 185 lbs. ft. from the bolt head.
3. Replace the missing bolts and nuts and torque them to 148 lbs. ft. from the nut or 185 lbs. ft. from the bolt head. Perform step 2 to the bolts that are not missing.
4. Reconnect any power source previously disconnected.

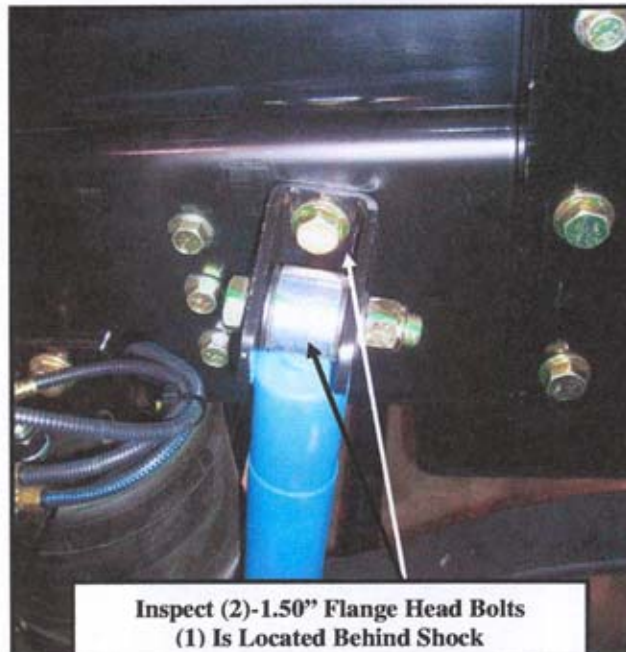
FIG. 5-1

HENDRICKSON AIRTEK SHOCK MOUNTING LOCATION

1. Refer to FIG. 5-1. Visually inspect the bolts attaching the front suspension shock absorber upper mounting brackets to each frame rail. If the bolts appear to be intact proceed to step 2. If any bolts are missing proceed to step 3.
2. Using a torque wrench set at 50 lbs. ft. attempt to rotate each bolt from which ever side is most accessible. If a bolt or nut rotates it must be replaced. If it does not rotate do not replace. Torque the new bolt and nut to 148 lbs. ft. from the nut, or 185 lbs. ft. from the bolt head.
3. Replace the missing bolts and nuts and torque them to 148 lbs. ft. from the nut or 185 lbs. ft. from the bolt head. Perform step 2 to the bolts that are not missing.
4. Reconnect any power source previously disconnected.
