# NEWMAR CORPORATION WARRANTY DEPARTMENT

TSB# 353

## Technical Service Bulletin

**Subject:** Potential lack of drainage in drivers side power window frame.

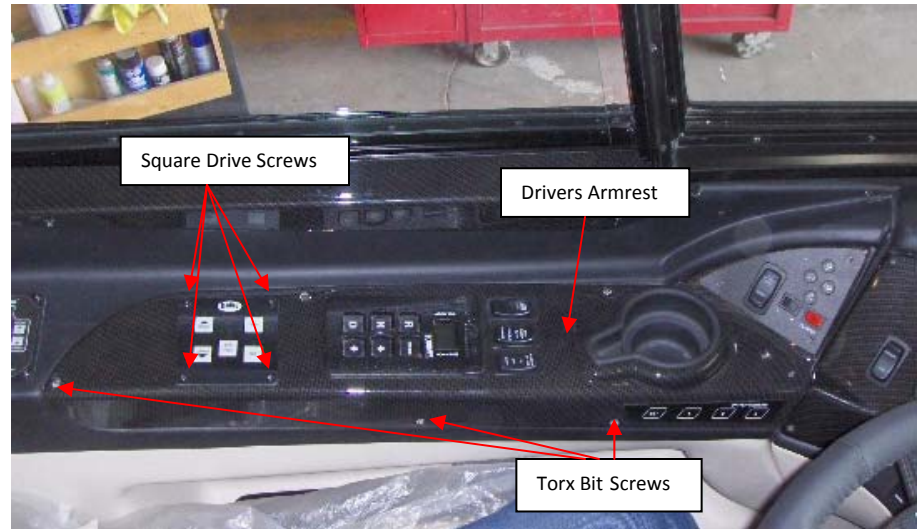
Figure 1: Drivers Side Armrest

**Diagnosis Inspection:** You will need to access the window tub & frame assembly for physical inspection. Begin by removing the driver's side armrest (figure 1). This will allow you to see down inside the window frame and tub to see if the hole is there. The armrest assembly is held in place around it's perimeter with screws. Note that there may be two different types of screws; decorative screws with a Torx fitting hold the armrest in place, while the Hadley Air Leveling pad and the Exterior Rear View Mirror pads are held in place by conventional square drive screws.

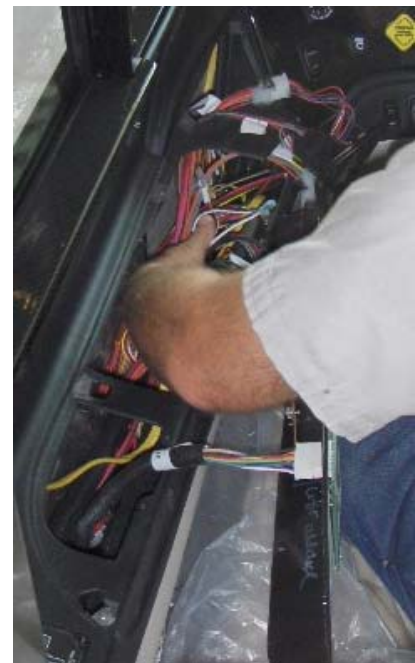
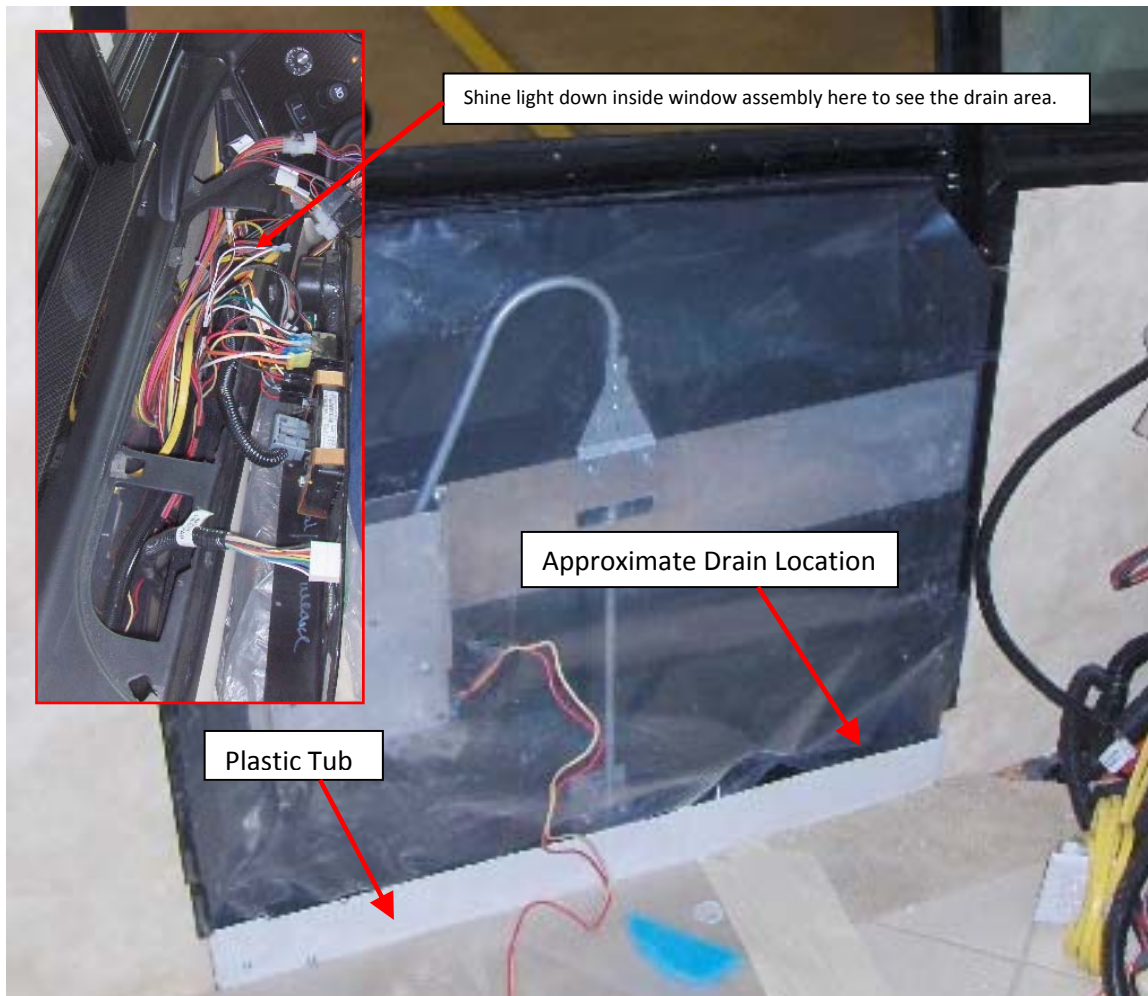
Figure 2: Drivers Power Window Assembly

This illustration shows the window frame assembly sitting in the plastic tub. The drain is located toward the front of the window frame assembly (see figure 3). Shine a flashlight down into the opening to see if the drain hole has been drilled. **If there is no drain hole in the black metal window frame, one will need to be added.**

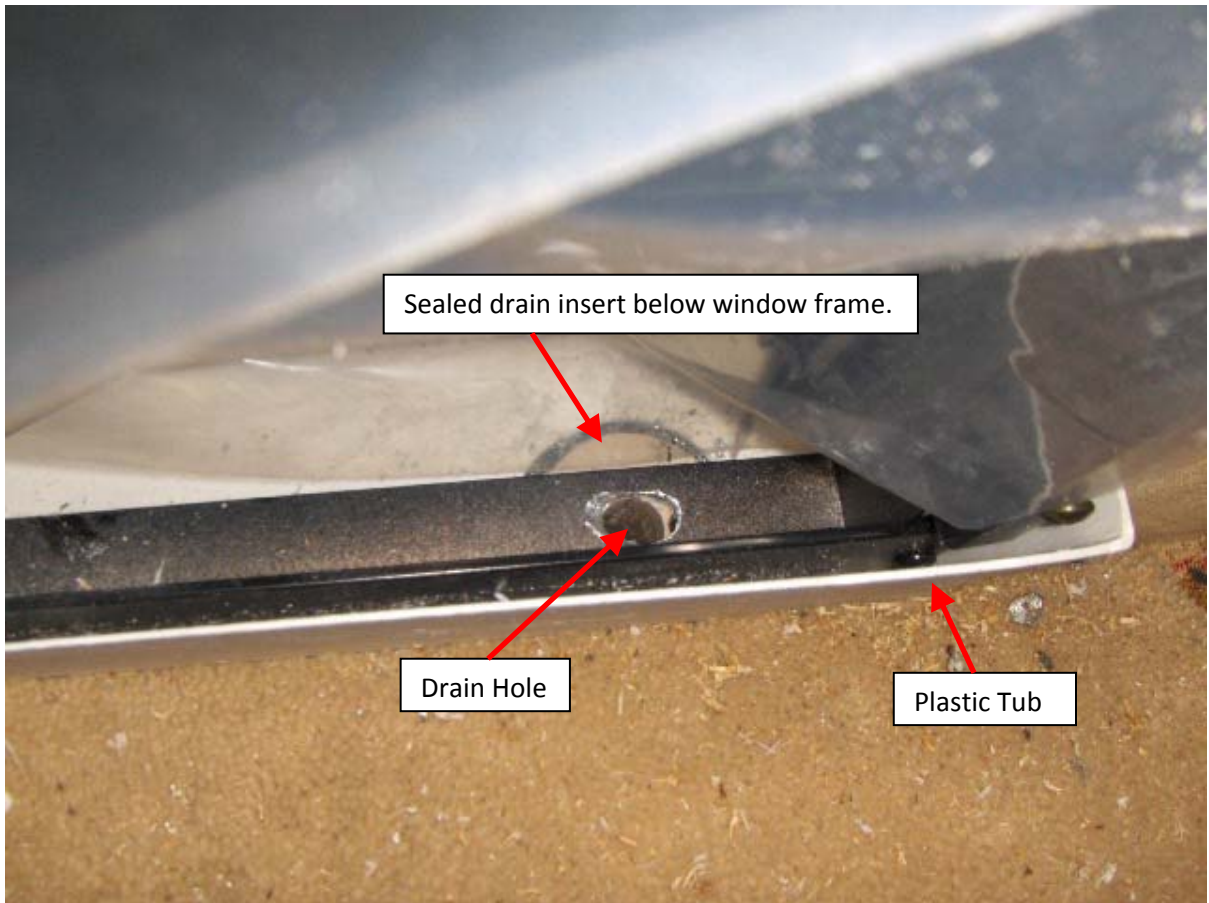
Figure 4: Drain Hole Detail

Figure 4 shows detail of where and how the drain hole is positioned. The plastic tub has a drain insert installed that runs through the floor structure to the front wheel well area. This is a sealed insert to channel the water out of the plastic tub without seepage onto the floor. If there is a drain hole drilled in the black metal frame, inspect it to be sure it is clear of any debris and re-install the driver's side armrest. No further action is required.

If no drain hole is located in the black metal frame here, visually locate the insert in the plastic tub below the window frame (see figure 4), and drill a 1/8" pilot hole visually centered over the insert. Once the pilot hole has been drilled, drill it out

to size using a 7/16" drill bit. Clear the hole of any debris or shavings that might plug it, or in any way restrict the flow of the drain.

**WARNING:** It is critical to make sure when drilling the drain hole that it be as centered as possible, and as straight vertically as possible. Great care must be taken not to fracture or otherwise damage the plastic drain insert in the plastic tub; replacement would require removal of the window frame assembly to replace the drain tube. It may be helpful to drill a pilot hole or make a drill guide out of wood to aid in proper positioning of the drill bit prior to drilling the actual drain hole.
