Re: Newmar Corporation – Motor Vehicle Recall Notification

Subject: Recall Campaign No.: 08V-443

TSB 355

**Subject:** Missing heat shielding for engine exhaust.

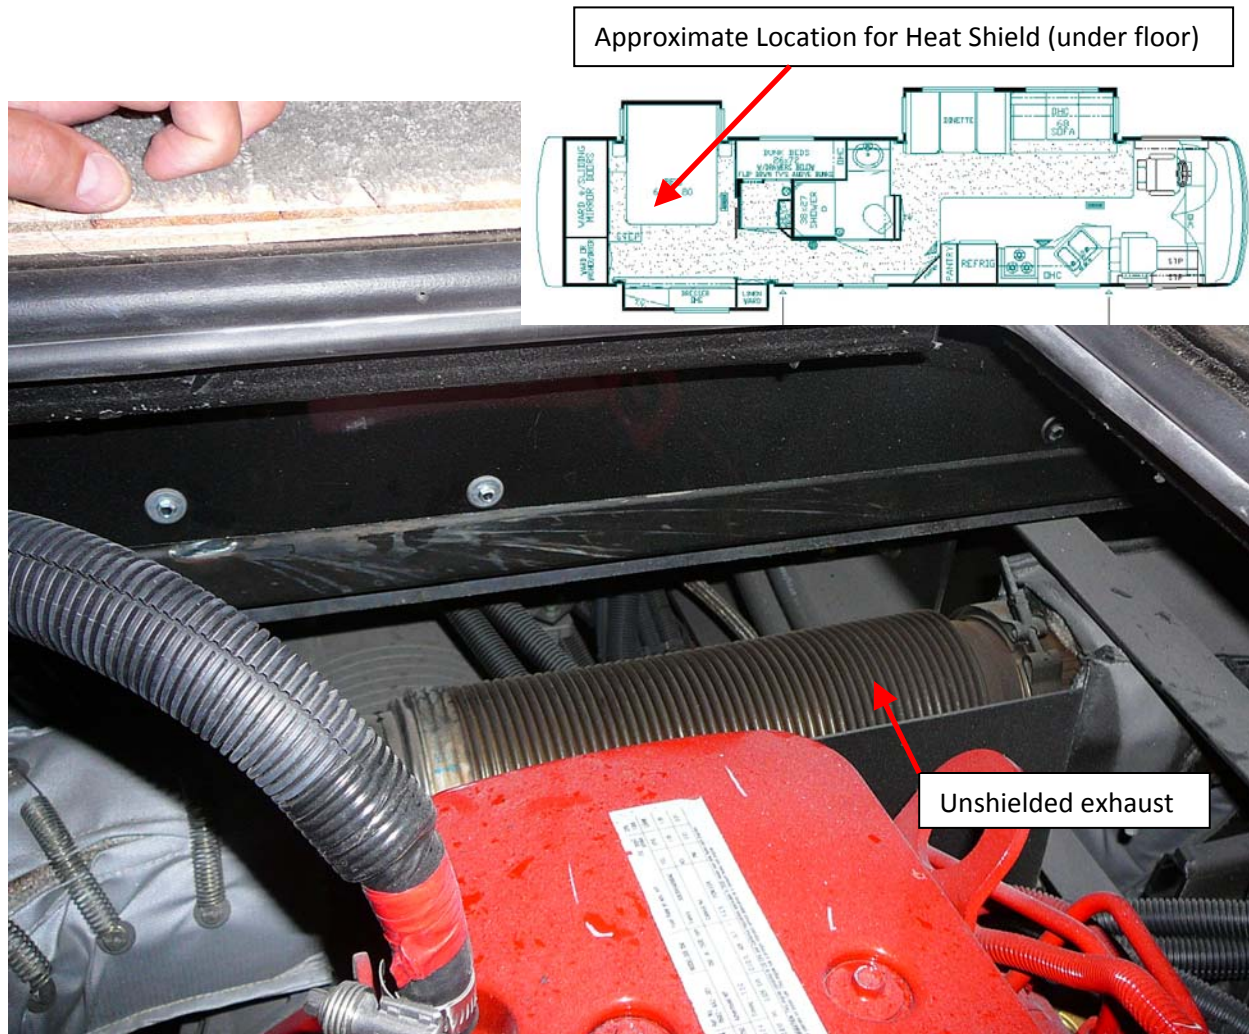
**Diagnosis Procedure:** Move any obstructions, and open the engine access located in the floor. Look forward toward the front end of the engine compartment. Look for the heat shield on the cross member that is located just below the engine access opening. This heat shield will be installed on the cross member. Figure 1 shows the unit without a heat shield, figure 2 shows the unit with a heat shield installed.

Figure 1: No heat shield installed

If a heat shield is not present you will need to install one to redirect the heat. Use **ONLY** the specified Heat Shield (Newmar part #112234) for this recall.

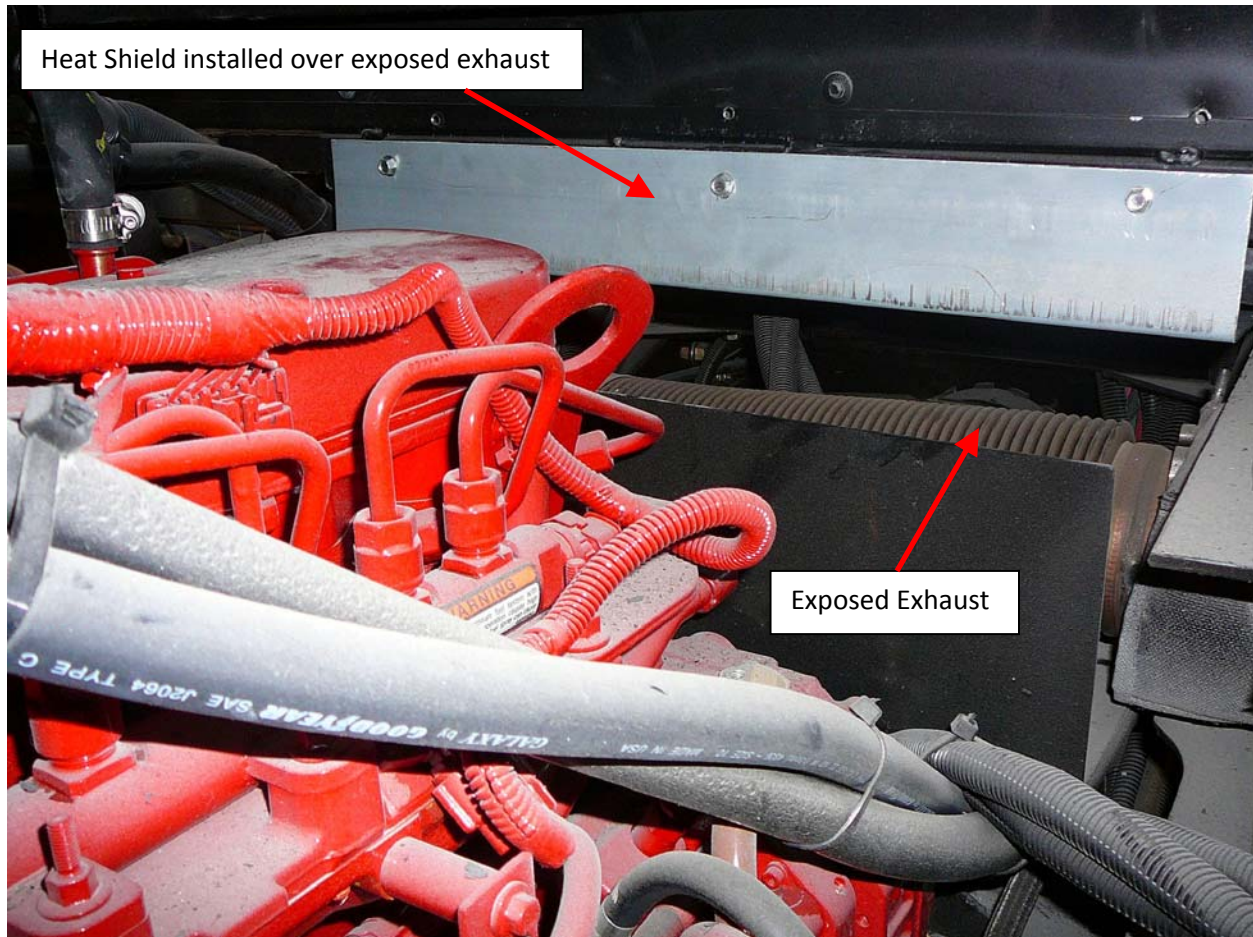
Figure 2: Heat Shield installed

If a heat shield is already installed, no further action is required.

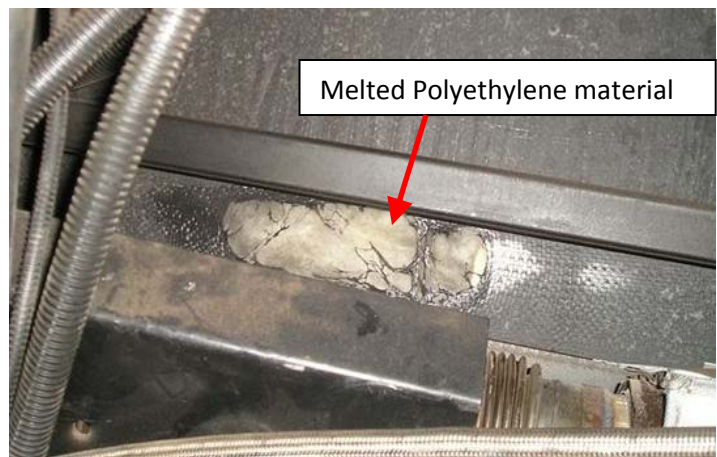
Figure 2A

Before installing the heat shield, inspect the polyethylene vapor barrier above the exhaust for signs of heat damage. If the vapor barrier has been heat damaged, it will need to be repaired prior to installing the heat shield (see figure 2A).

If a repair is required, Newmar recommends installing a piece of .030 aluminum or galvanized steel, cut to fit, and secured into place with screws and silicone as necessary. This patch may need to be 17-33 in. by 3-4 in. and must be fastened directly to the stringers between the structural cross-members forward of the engine compartment. Clean any dust, dirt, or road debris from the area to be repaired, then install the cover into place over the damaged section. Inspect the repair to be sure it is thoroughly covering the damaged area, and is properly secured to insure it will not fall off.

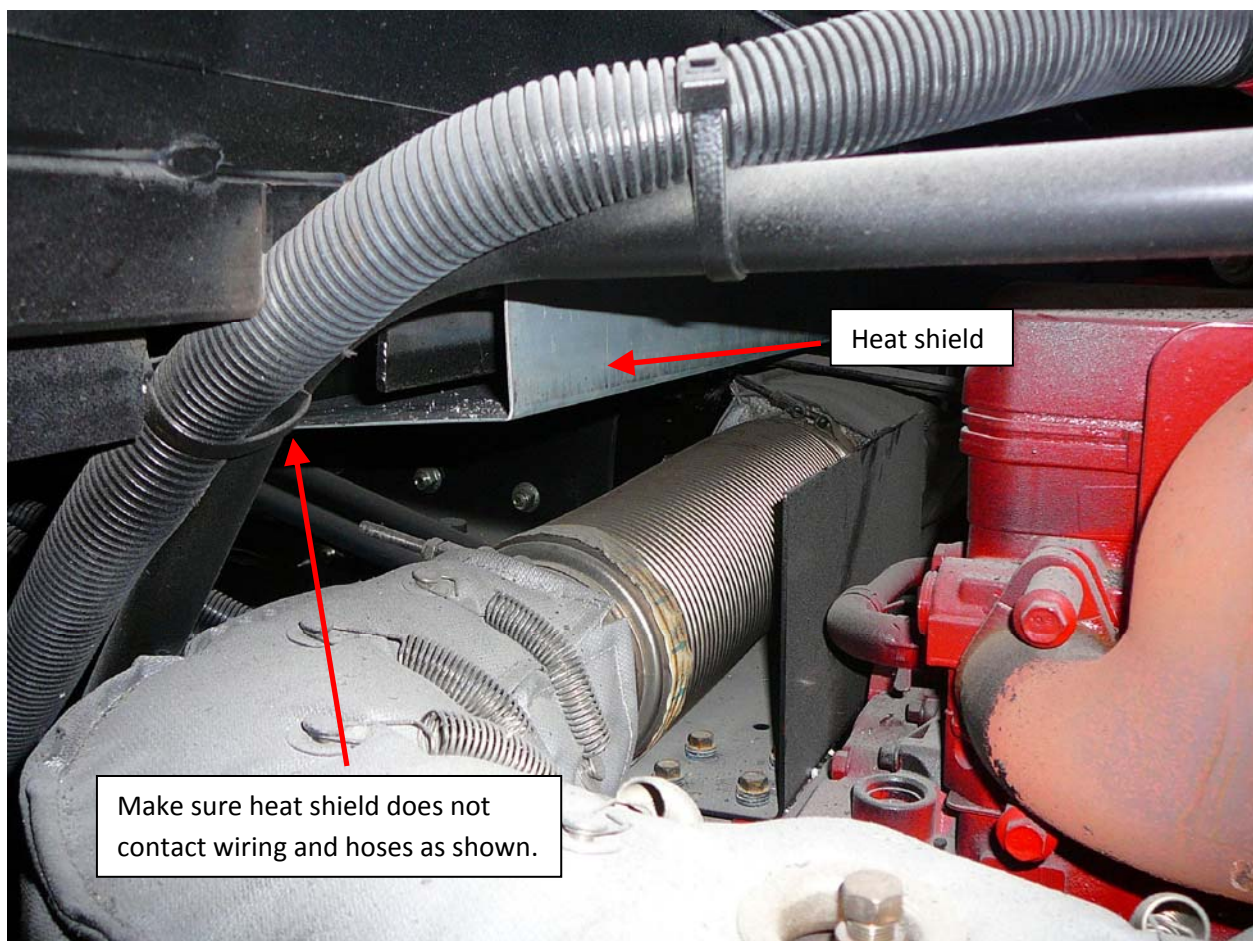
Figure 4: Check for contact / chaffing

**IMPORTANT:** Once installed, be certain the heat shield is not rubbing against or chaffing any surrounding wiring, hoses, or other items in the engine compartment (Figure 4). Contact with wiring, hoses, and other items will cause excessive wear and potential failures in those components. If the heat shield is properly positioned (over the exposed exhaust between the two existing heat blankets) and there is physical contact between the shield and any wiring or hoses in the engine compartment, reposition the wires or hoses and tie them back to prevent chaffing. Positioning the heat shield properly between the heat blankets and over the exposed exhaust is critical to this repair.
