# Newmar Corporation Warranty Department

Technical Service Bulletin			
Date Issued	Model Year(s) Affected	Model(s) Affected	TSB #
6/16/09	2008	Diesel Pusher w/Oasis heat systems.	361
Brand		Type	
All <input type="checkbox"/>	Bay Star <input type="checkbox"/>	Canyon Star <input type="checkbox"/>	Grand Star <input type="checkbox"/>
Ventana <input type="checkbox"/>	Dutch Star <input type="checkbox"/>	Dutch Aire <input checked="" type="checkbox"/>	Mountain Aire <input checked="" type="checkbox"/>
Essex <input checked="" type="checkbox"/>	King Aire <input checked="" type="checkbox"/>	London Aire <input type="checkbox"/>	
<input type="checkbox"/> Air Conditioning & Heating <input checked="" type="checkbox"/> Appliances & Accessories <input type="checkbox"/> Cabinets & Furniture <input type="checkbox"/> Chassis Components <input type="checkbox"/> Construction Components		<input type="checkbox"/> Electrical Components <input type="checkbox"/> Exterior Components <input type="checkbox"/> Interior Components <input type="checkbox"/> Plumbing & Bath Components <input type="checkbox"/> Windows, Awnings, Vents, & Doors

# TECHNICAL BULLETIN

**Description:** **Aquastat re-positioning**

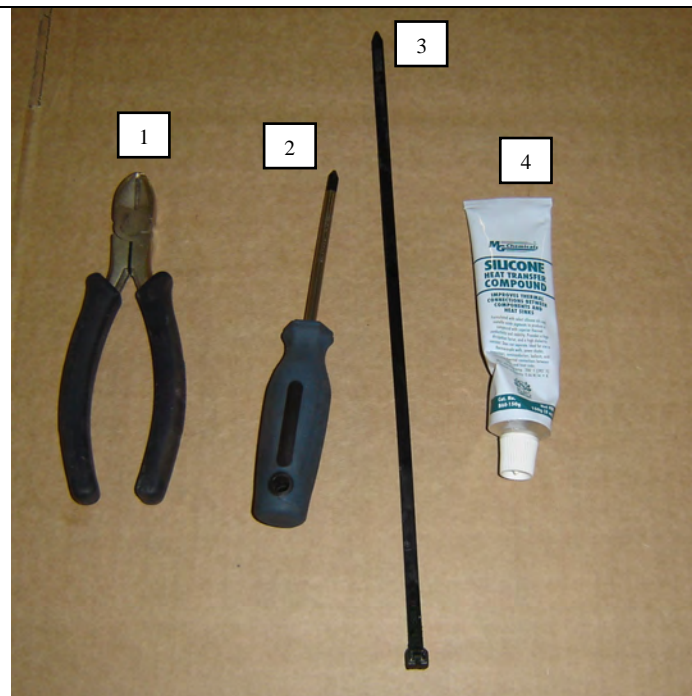
The current location of the domestic water aquastat can cause a cold dip in the initial hot water supply. Re-locating the aquastat closer to the cold water inlet will eliminate this cold dip.

## AQUASTAT CHANGE PROCEDURE
