# Newmar Corporation Warranty Department

## Technical Service Bulletin

TSB 363

**Subject:** Ground wire sizing for electric leveling jacks.

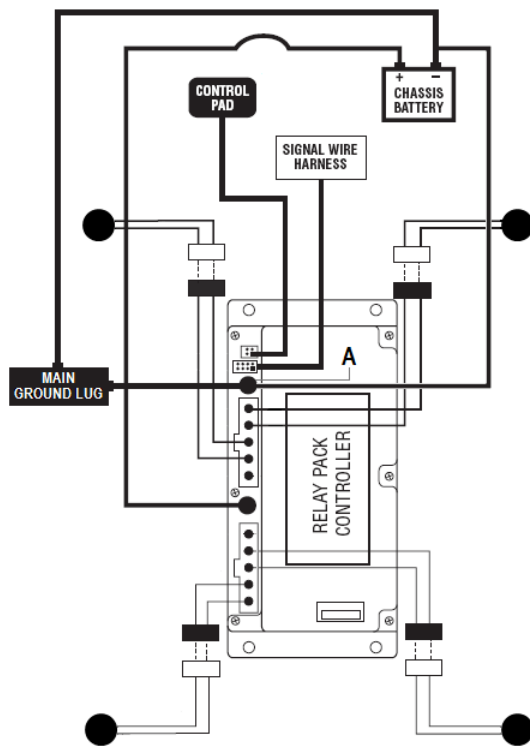
Figure 1

**Condition:** The ground wire for the electric leveling jack system is undersized. Undersized electrical conductors may result in conductor failure, creating a shock or fire hazard. Failure of the cable may occur without obvious preceding indicators.

- Measure length of 2 AWG cable required and cut to length. Strip cable ends and crimp ring terminals to cable.
- Attach small ring terminal of 2 AWG grounding cable to the ground post of the leveling jack controller (Figure 2) and large ring terminal to the main ground lug.
- Reset leveling jack controller per instructions in the owner's manual.
