NEWMAR CORPORATION

WARRANTY DEPARTMENT

TECHNICAL SERVICE BULLETIN							
DATE ISSUED		MODEL YEAR(S) AFFECTED		MODEL(S) AFFECTED		TSB #	
01/29/2010		2009 - Present		ALL		365	
BRAND						TYPE	
All	<input checked="" type="checkbox"/>	American Star	<input type="checkbox"/>	Mountain Aire	<input type="checkbox"/>	All	<input checked="" type="checkbox"/>
		Dutch Star	<input type="checkbox"/>	Kountry Aire	<input type="checkbox"/>	F W	<input type="checkbox"/>
		Kountry Star	<input type="checkbox"/>	Essex	<input type="checkbox"/>	D P	<input type="checkbox"/>
Scottsdale	<input type="checkbox"/>	Northern Star	<input type="checkbox"/>	London Aire	<input type="checkbox"/>		
<div style="display: flex; justify-content: space-between;"> <div> <input type="checkbox"/> Air Conditioning & Heating <input type="checkbox"/> Appliances & Accessories <input type="checkbox"/> Cabinets & Furniture <input type="checkbox"/> Chassis Components <input type="checkbox"/> Construction Components </div> <div> <input type="checkbox"/> Electrical Components <input checked="" type="checkbox"/> Exterior Components <input type="checkbox"/> Interior Components <input type="checkbox"/> Plumbing & Bath Components <input ty

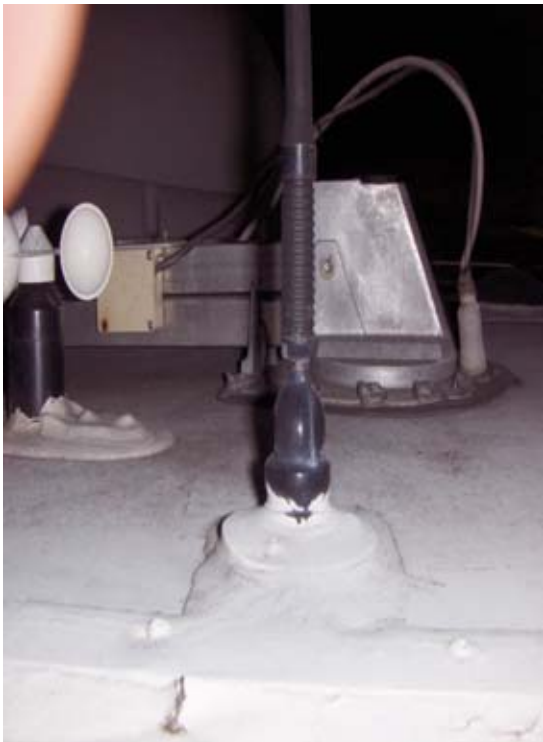
DESCRIPTION OF PROBLEM							
12" black rubber AM/FM radio antenna masts are being broke off at the base of the antenna mount.							
RECOMMENDED SOLUTION							
<p>When replacing a 12" AM/FM rubber radio antenna mast, Newmar Corporation recommends that the tip of the mast be pointed back towards the rear of the coach and positioned at approximately a 60 degree angle. This process is currently being performed during the production stage at Newmar on all current units.</p> <ul style="list-style-type: none"> The Newmar part number for the radio antenna mast is # 34782A. Warranty flat rate time allowed is .10 Flat rate code to be used is 0650

Figure 1 - This shows the roof mounting of a 12" black AM/FM radio antenna.
