# Newmar Corporation Warranty Department

Technical Service Bulletin							
Date Issued	Model Year(s) Affected		Model(s) Affected			TSB #	
<b>12/17/2010</b>	<b>2008-2010</b>		<b>Dutch Star, Dutch Aire, Mountain Aire</b>			<b>378</b>	
Brand						Type	
All <input type="checkbox"/>	<input type="checkbox"/>	American Star <input type="checkbox"/>	<input type="checkbox"/>	Mountain Aire <input type="checkbox"/>	<input type="checkbox"/>	All <input type="checkbox"/>	T T <input type="checkbox"/>
Cypress <input type="checkbox"/>	<input type="checkbox"/>	Dutch Star <input checked="" type="checkbox"/>	<input checked="" type="checkbox"/>	Kountry Aire <input type="checkbox"/>	<input type="checkbox"/>	F W <input type="checkbox"/>	C A <input type="checkbox"/>
Northern Star <input type="checkbox"/>	<input type="checkbox"/>	Kountry Star <input type="checkbox"/>	<input type="checkbox"/>	Essex <input type="checkbox"/>	<input type="checkbox"/>		
Scottsdale <input type="checkbox"/>	<input type="checkbox"/>	King Aire <input type="checkbox"/>	<input type="checkbox"/>	Dutch Aire <input checked="" type="checkbox"/>	<input checked="" type="checkbox"/>	D P <input checked="" type="checkbox"/>	D B <input type="c

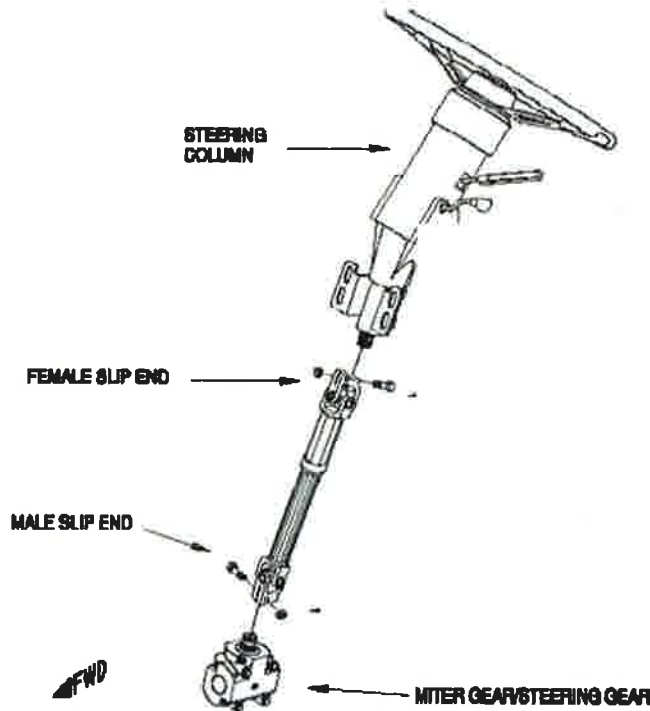
**FIG. 3-1**

### TYPICAL INTERMEDIATE SHAFT SHOWN

4. Center steering wheel prior to removing the steering slip shaft.
5. Remove clamp at the top of the steering column rubber boot located at the bottom of the steering column going to the floor to gain access to the pinch bolt located at the top of slip shaft. Retain clamp for reuse.
6. Refer to FIG. 3-1. Remove pinch bolt at steering column end of steering slip shaft. Properly discard hardware.
7. Refer to FIG. 3-1. Remove steering slip shaft from bottom of steering column.

8. Refer to FIG. 3-1. Remove pinch bolt at gear box and or miter box end of steering slip shaft. Properly discard hardware.
9. Refer to FIG. 3-1. Remove steering slip shaft and retain to ship back to Spartan Motors Chassis, Inc.

10. Refer to FIG. 3-1. Install new slip shaft in reverse order using new hardware. Torque bolts to proper values listed in service kit information on pages 1 and 2.
11. Reinstall rubber boot and clamp. Secure as needed.
12. If any power source was disconnected reconnect power source.
