NEWMAR CORPORATION WARRANTY DEPARTMENT

TECHNICAL SERVICE BULLETIN						
DATE ISSUED	MODEL YEAR(S) AFFECTED	MODEL(S) AFFECTED	TSB #			
7/21/94	1992-1993	ALL	100			
BRAND		TYPE				
All <input type="checkbox"/>	American Star <input type="checkbox"/>	Kountry Star <input checked="" type="checkbox"/>	Dutch Star <input type="checkbox"/>	All <input type="checkbox"/>	T T <input type="checkbox"/>	F W <input type="checkbox"/>
NewAire <input type="checkbox"/>	Mountain Aire <input type="checkbox"/>	Kountry Aire <input type="checkbox"/>	London Aire <input checked="" type="checkbox"/>	C A <input type="checkbox"/>	D P <input checked="" type="checkbox"/>	D B <input type="checkbox"/>
<input type="checkbox"/> Air Conditioning & Heating				<input type="checkbox"/> Electrical Components		
<input type="checkbox"/> Appliances & Accessories				<input type="checkbox"/> Exterior Components		
<input type="checkbox"/> Cabinets & Furniture				<input type="checkbox"/> Interior Components

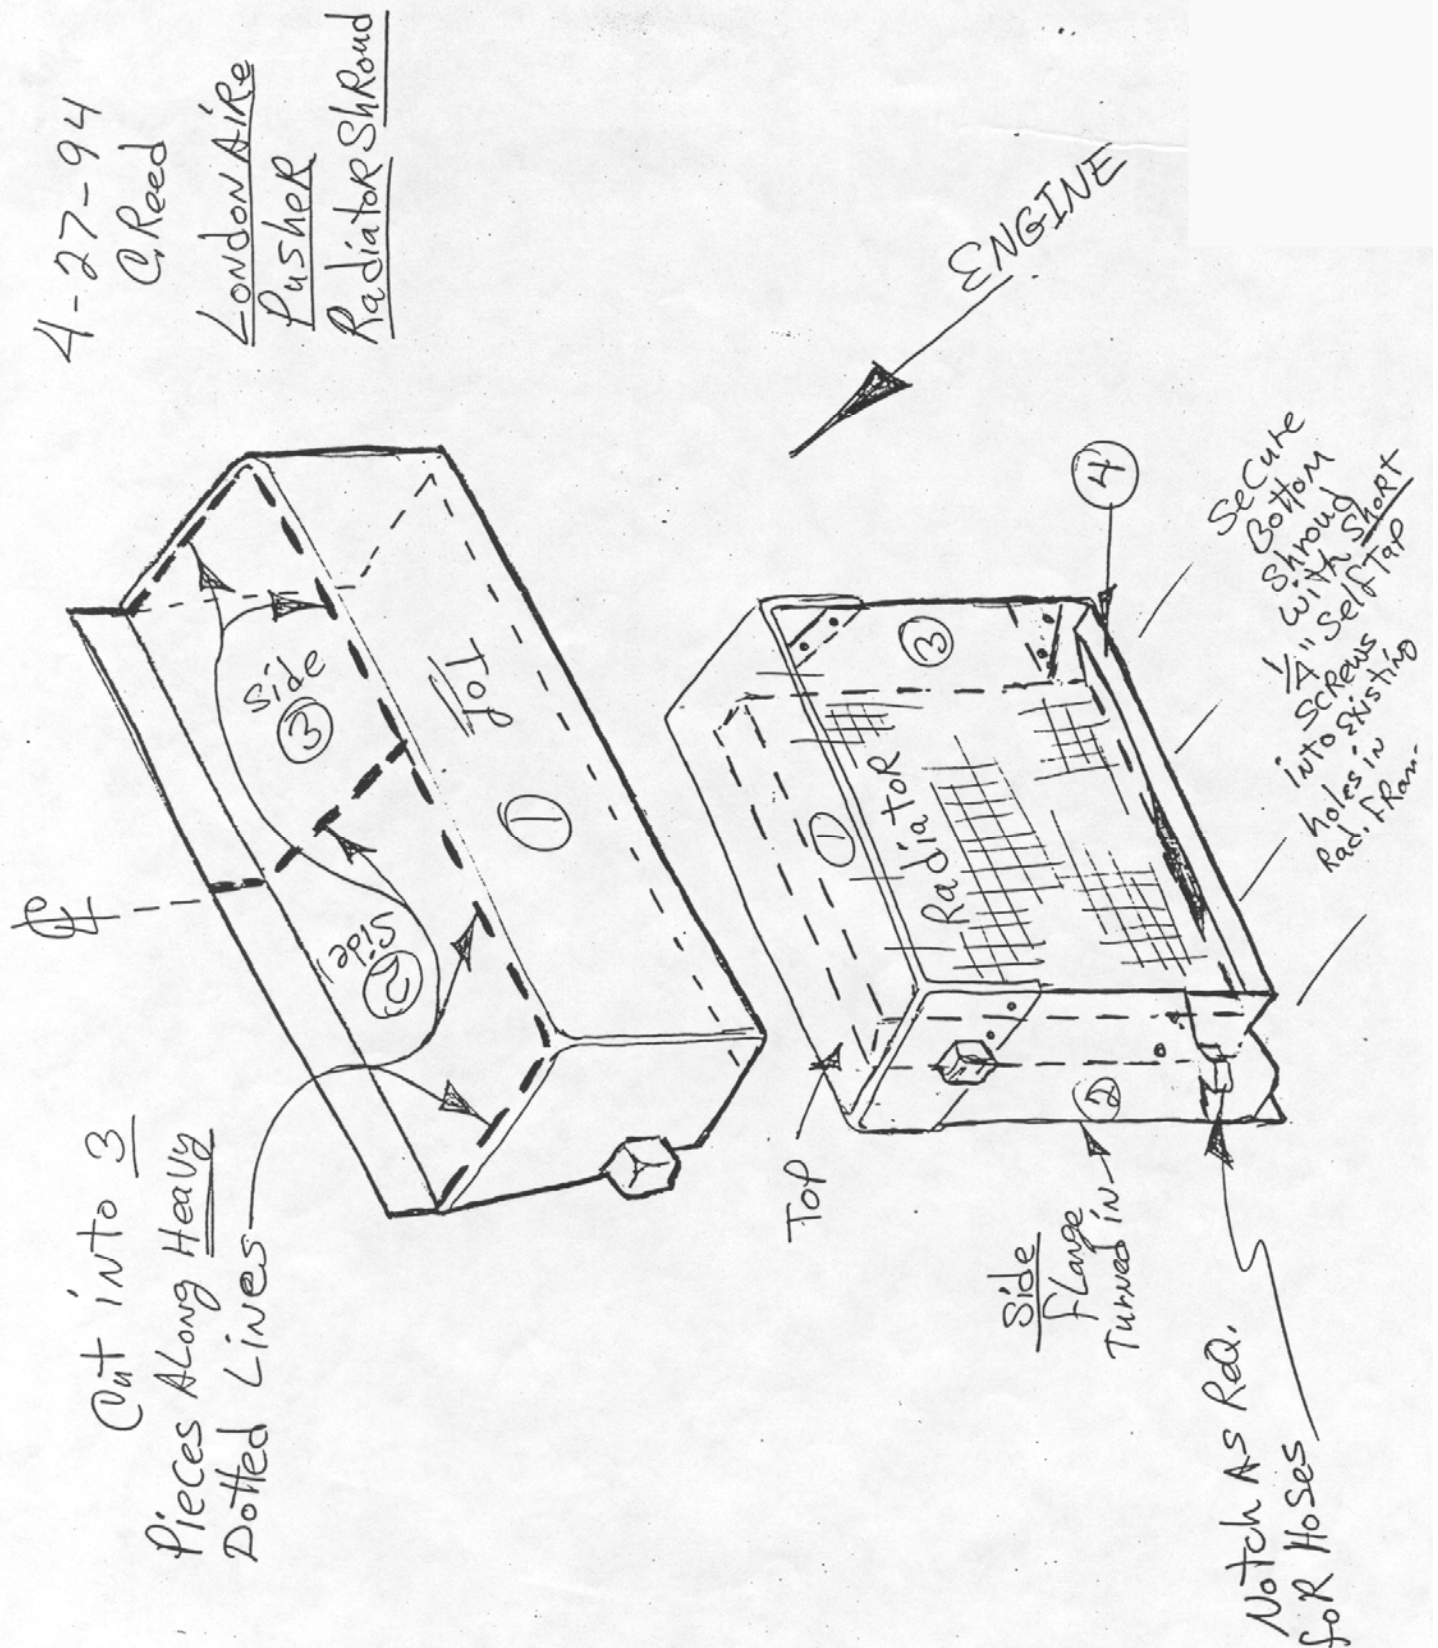
<input checked="" type="checkbox"/> Chassis Components				<input type="checkbox"/> Plumbing & Bath Components		
<input type="checkbox"/> Construction Components				<input type="checkbox"/> Windows, Awnings, Vents, & Doors		
DESCRIPTION OF PROBLEM						
Over heating problem on pusher units. This could result from not having a shroud on radiator. Check for shroud.						
RECOMMENDED SOLUTION						
Add radiator shroud per attached print.
