NEWMAR CORPORATION WARRANTY DEPARTMENT

TECHNICAL SERVICE BULLETIN						
DATE ISSUED	MODEL YEAR(S) AFFECTED	MODEL(S) AFFECTED	TSB #			
7/26/95	1991-1995	ALL	113			
BRAND		TYPE				
All <input checked="" type="checkbox"/>	American Star <input type="checkbox"/>	Kountry Star <input type="checkbox"/>	Dutch Star <input type="checkbox"/>	All <input type="checkbox"/>	T T <input type="checkbox"/>	F W <input type="checkbox"/>
NewAire <input type="checkbox"/>	Mountain Aire <input type="checkbox"/>	Kountry Aire <input type="checkbox"/>	London Aire <input type="checkbox"/>	C A <input type="checkbox"/>	D P <input checked="" type="checkbox"/>	D B <input type="checkbox"/>
<input type="checkbox"/> Air Conditioning & Heating				<input type="checkbox"/> Electrical Components		
<input type="checkbox"/> Appliances & Accessories				<input type="checkbox"/> Exterior Components		
<input type="checkbox"/> Cabinets & Furniture				<input type="checkbox"/> Interior Components

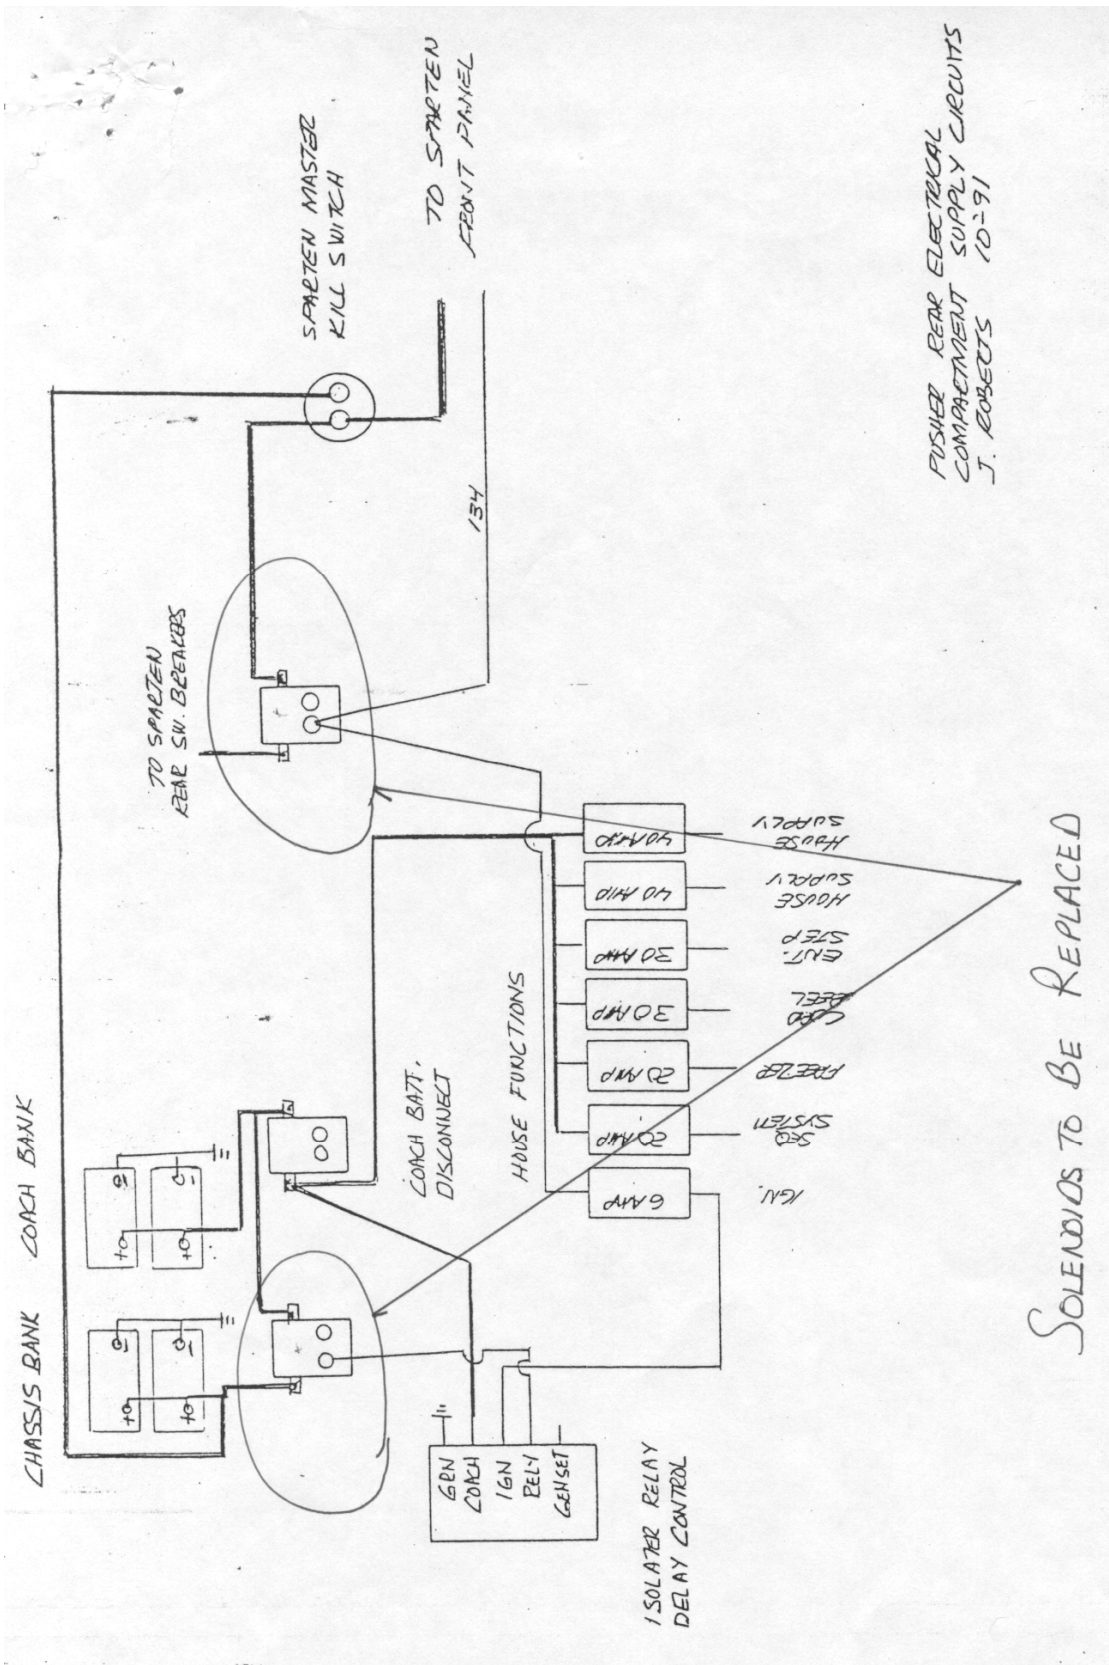
<input checked="" type="checkbox"/> Chassis Components				<input type="checkbox"/> Plumbing & Bath Components		
<input type="checkbox"/> Construction Components				<input type="checkbox"/> Windows, Awnings, Vents, & Doors		
DESCRIPTION OF PROBLEM						
Spartan chassis engine shutting down when going up steep grade or when driving in hot weather.						
RECOMMENDED SOLUTION						
Replace both the solenoid in the front panel and the solenoid either in the engine compartment of the power cord compartment with the Napa ST80 silver contact solenoid. This is all the information from Spartan we have at this time. We will keep you updated. Please check the enclosed print for location of solenoids.
