NEWMAR CORPORATION

TECHNICAL SERVICE BULLETIN																			
DATE ISSUED		MODEL YEAR(S) AFFECTED			MODEL(S) AFFECTED			TSB #											
3/14/96		1996			ALL			132											
BRAND					TYPE														
All	<input type="checkbox"/>	American Star	<input type="checkbox"/>	Kountry Star	<input checked="" type="checkbox"/>	Dutch Star	<input checked="" type="checkbox"/>	All	<input type="checkbox"/>										
NewAire	<input type="checkbox"/>	Mountain Aire	<input checked="" type="checkbox"/>	Kountry Aire	<input checked="" type="checkbox"/>	London Aire	<input checked="" type="checkbox"/>	T T	<input type="checkbox"/>										
								F W	<input type="checkbox"/>										
								C A	<input checked="" type="checkbox"/>										
								D P	<input checked="" type="checkbox"/>										
								D B	<input type="checkbox"/>

INSTRUCTIONS FOR THE REPLACEMENT OF SLIDE TOPPER AWNINGS

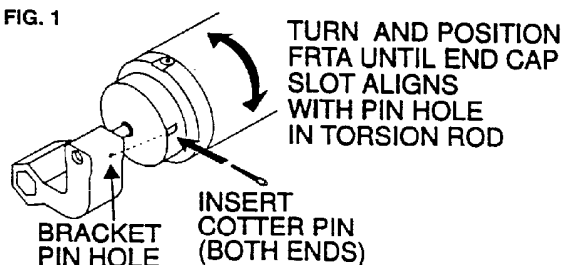
FIG. 1

1. Remove the TEK screws securing the awning fabric/aluminum guard at each end of the awning rail. (See FIG. 2, Page 2).
2. Insert a 7/64" x 2-3/4" cotter pin into each end cap and through the hole in the torsion rod. It may be necessary to turn the roller tube and slide the end bracket toward or away from the FRTA to align with the hole in the torsion rod. (See FIG. 1). Repeat on the opposite end.

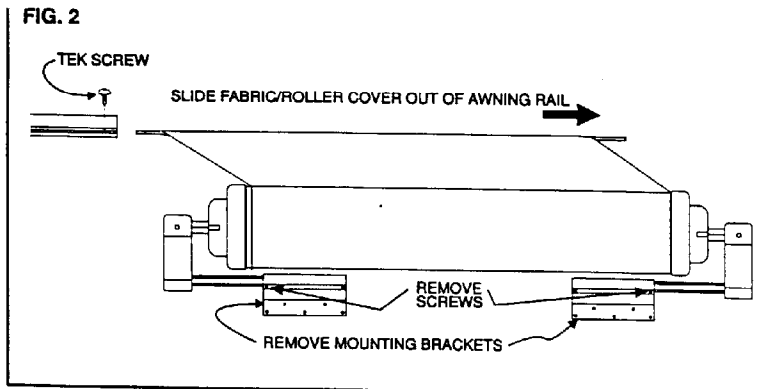
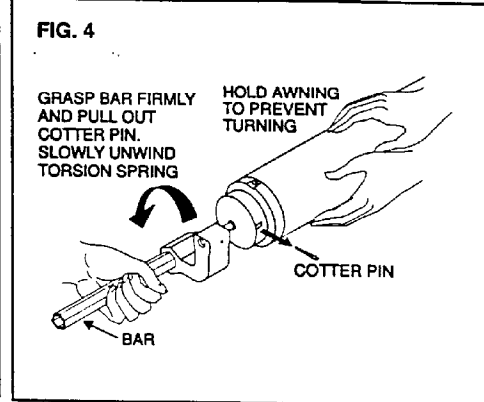
Remove both mounting brackets from the slide out.
(See FIG. 2)

- Slide the awning out of the mounting bracket and awning rail. (See FIG. 2) This may require two people.

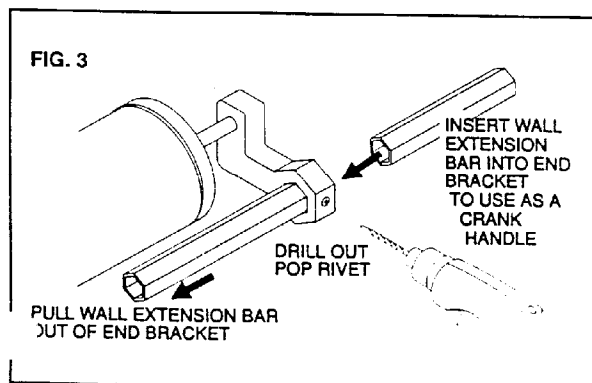
- Remove Slide Topper awning from the coach. See Section B, Steps 1-4.
NOTE: Do not pull cotter pin at this time.
- Drill $3/16" \times 3/8"$ pop rivet out of end bracket. This will allow the wall extension bar to be removed and inserted from the other side. It then will act as a crank handle. (See FIG. 3). If the other torsion needs to be removed, repeat Step 2.
- Two people are required when the torsion spring is unwound. Have one person hold the awning tube. The second person tightly grasps the wall extension bar and removes the cotter pin. (See FIG. 4)
- Slowly unwind the torsion spring. (See FIG. 4)
- Drill out pop rivets that attach the end cap to the roller tube. Pull the torsion out from the roller tube.

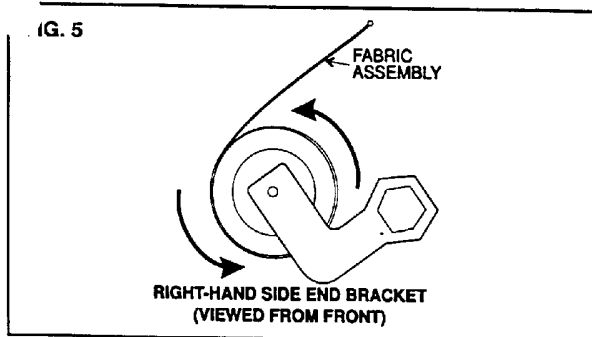
- Center the fabric assembly on the roller tube and hand-roll the entire assembly in the same direction as the original fabric assembly (See FIG. 5). Trim off any rope protruding from the roller tube.

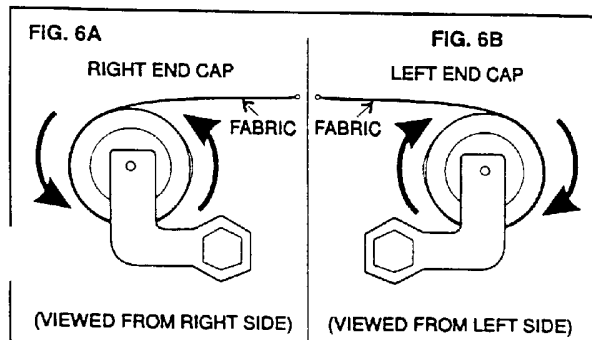
- When facing the awning, the end bracket on the right is to be turned counterclockwise (see FIG. 6A). The end bracket on the left is turned clockwise (see FIG. 6B).

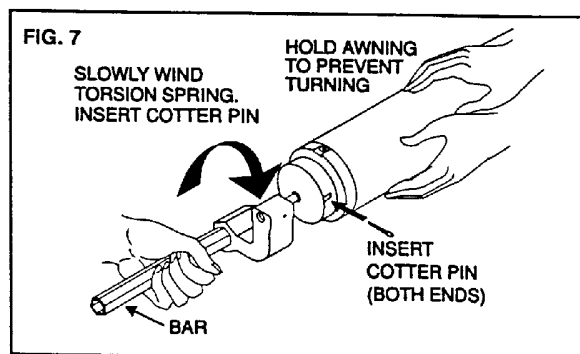
- Turn the end bracket the number of turns specified in the chart. Two people are required for this procedure.
- Insert the cotter pin into the end cap and through the hole in the torsion rod to lock spring tension into torsion. (See FIG. 7). It may be necessary to slide the end bracket toward or away from the FRTA to align with the hole in the torsion rod.

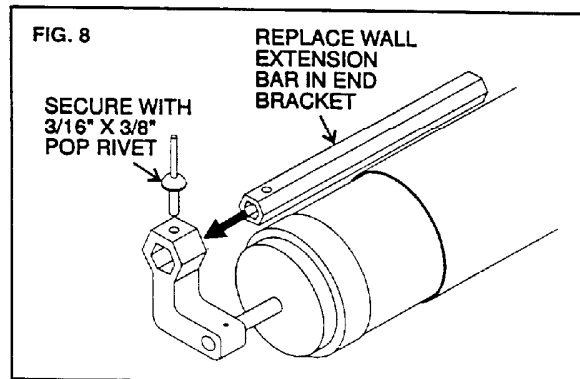
- Make sure the end brackets are in the same position on each end of the roller tube.
- Replace wall extension bar in end bracket. Secure with 3/16" x 3/8" aluminum pop rivet. (See FIG. 8)
