# NEWMAR CORPORATION WARRANTY DEPARTMENT

TECHNICAL SERVICE BULLETIN						
DATE ISSUED	MODEL YEAR(S) AFFECTED	MODEL(S) AFFECTED	TSB #			
12/19/88	1989	CLASS A	14			
BRAND		TYPE				
All <input type="checkbox"/>	American Star <input type="checkbox"/>	Kountry Star <input checked="" type="checkbox"/>	Dutch Star <input type="checkbox"/>	All <input type="checkbox"/>	T T <input type="checkbox"/>	F W <input type="checkbox"/>
NewAire <input type="checkbox"/>	Mountain Aire <input type="checkbox"/>	Kountry Aire <input checked="" type="checkbox"/>	London Aire <input checked="" type="checkbox"/>	C A <input checked="" type="checkbox"/>	D P <input type="checkbox"/>	D B <input type="checkbox"/>
<input type="checkbox"/> Air Conditioning & Heating				<input type="checkbox"/> Electrical Components		
<input type="checkbox"/> Appliances & Accessories				<input type="checkbox"/> Exterior Components		
<input type="checkbox"/> Cabinets & Furniture				<input checked="" type="checkbox"/> Interior Components

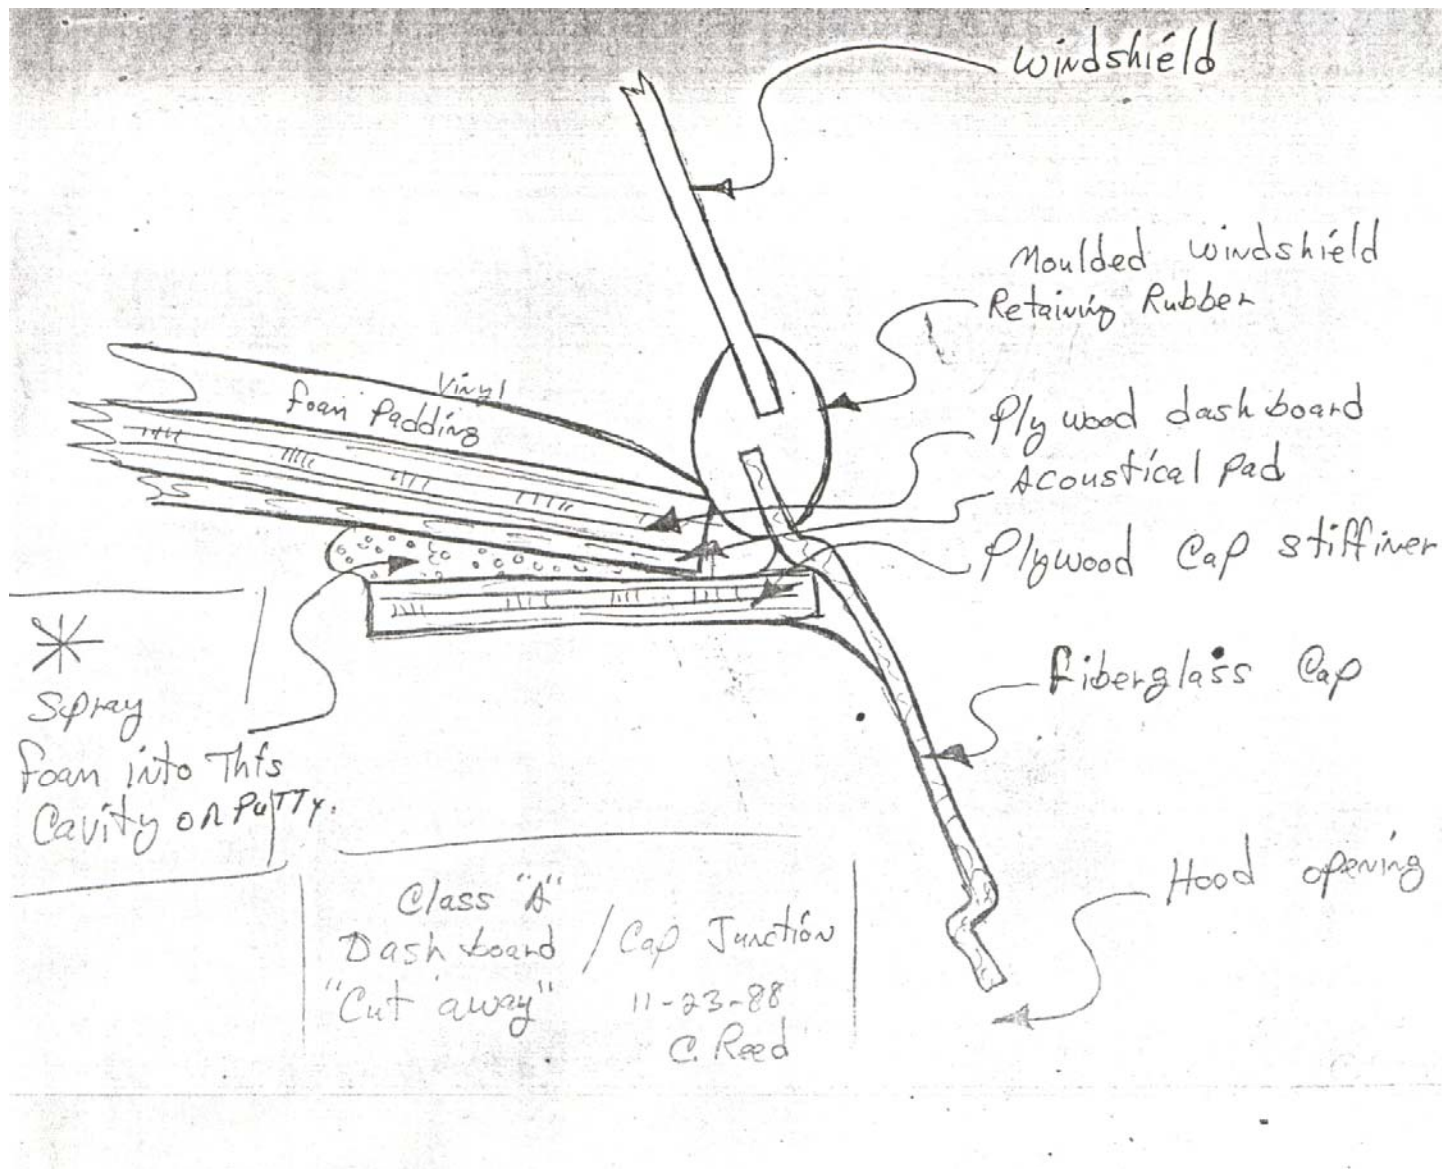
<input type="checkbox"/> Chassis Components				<input type="checkbox"/> Plumbing & Bath Components		
<input type="checkbox"/> Construction Components				<input type="checkbox"/> Windows, Awnings, Vents, & Doors		
DESCRIPTION OF PROBLEM						
Air leaking between engine compartment and interior of motorhome.						
RECOMMENDED SOLUTION						
Seal area off with roll putty or spray foam. See attached print.						
Note: All unit built after 11/23/88 will already have been corrected.
